Grounding Caption

Medical Report

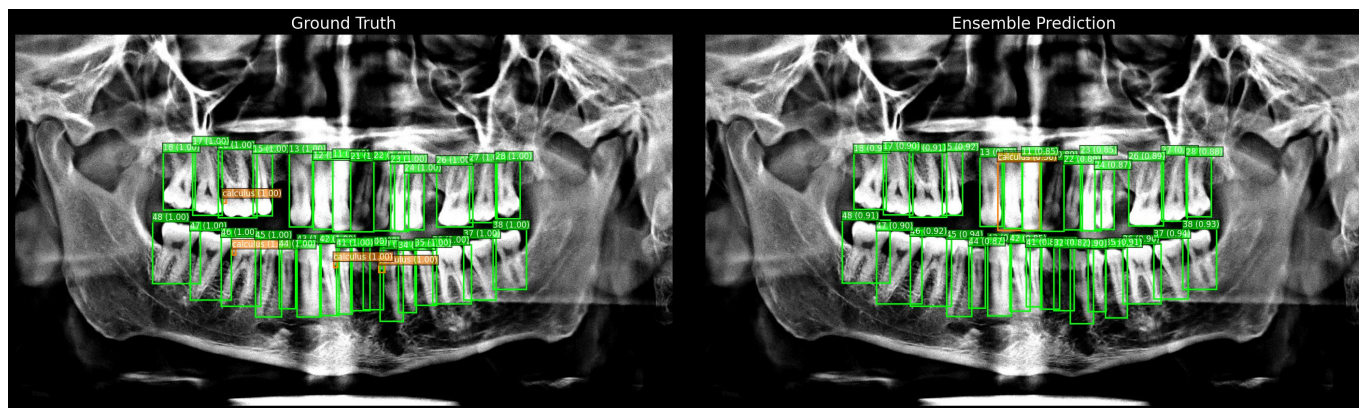
```
[
{'box_2d': [767, 332, 876, 511], 'tooth_id': '12', 'label': 'calculus', 'score': 0.36}
]
```

A total of 30 teeth are visualized within the panoramic image. All four wisdom teeth (FDI #18, #28, #38, #48) are present and non-impacted, with normal anatomical positioning. No evidence of missing or supernumerary teeth is observed.

Areas of concern noted for **calculus on #12 (upper right lateral incisor)**. The finding appears localized to the root or interproximal surfaces, though further clinical correlation is recommended to confirm. No other pathological lesions, caries, or periapical radiolucencies are evident.

- **Areas of concern for calculus on #12.** While not definitively confirmed radiographically, this finding warrants immediate attention for professional debridement and assessment.

- Schedule a **6-month recall** for scaling and reassessment of calculus on #12.
 - Consider referral to a periodontist if clinical evaluation confirms significant subgingival calculus or early periodontal involvement.
 - Maintain routine panoramic imaging every 3–5 years for monitoring wisdom teeth and systemic screening.
-
