## Grounding Caption

# Medical Report

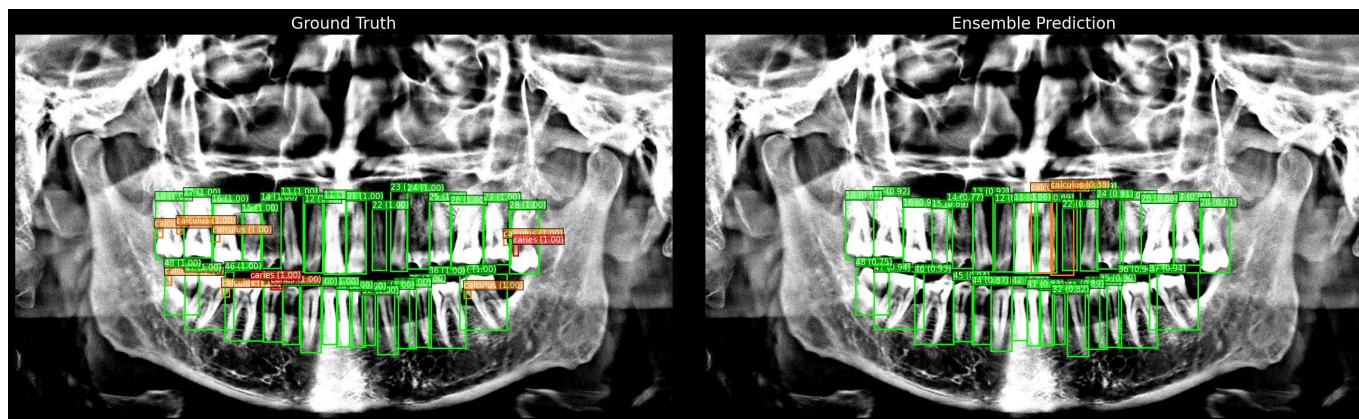
This localization caption provides multi-dimensional spatial analysis of anatomical structures and pathological findings for this panoramic dental X-ray image, including:

- A total of 31 teeth are visualized within the panoramic field.
- All three wisdom teeth (#18, #28, #48) are present and not impacted.

- **#21**: Suspicious for calculus deposits.
- **#22**: Suspicious for calculus deposits.
- **Near #48**: Areas of concern noted for unclear visualization, potentially affecting diagnostic accuracy.

- Suspected calculus deposits on **#21** and **#22** require professional evaluation to confirm presence and mitigate periodontal risk.
- Reduced visualization of **#48** may necessitate supplementary imaging (e.g., periapical radiograph) for definitive assessment.

- Reinforce oral hygiene protocols, emphasizing interproximal cleaning for **#21** and **#22** to address suspected calculus.
- Schedule periodic prophylaxis to prevent calculus progression.

- Immediate referral for scaling and root planing if calculus is confirmed clinically.
- Repeat panoramic imaging in 3–6 months to reassess **#48** visibility and monitor calculus status.
- Recall in 6 months for comprehensive periodontal evaluation.
