## Grounding Caption

This localization caption provides multi-dimensional spatial analysis of anatomical structures and pathological findings for this panoramic dental X-ray image, including:

# Medical Report

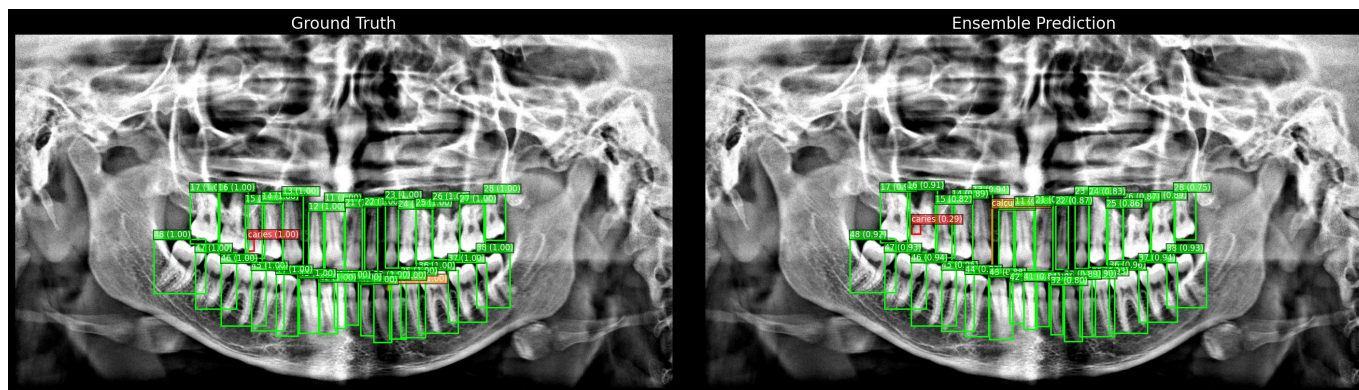
A total of 31 teeth are visualized within the panoramic field. All detected third molars (#38, #48, #28) are present and not impacted. No evidence of missing or supernumerary teeth is observed.

- Suspicious for **calculus** on #12, noted as a radiopaque deposit on the root surface.
- **Caries** observed as a radiolucent lesion near tooth #16, with low confidence in localization (score < 0.80).

No restorations, crowns, root canal treatments, or implants are identified.

- **Suspicious calculus on #12** requires professional scaling and polishing.
- **Area of concern near #16** (suspicious for caries) warrants further evaluation with intraoral imaging or clinical examination to confirm.

- Reinforce patient education on plaque control and interdental cleaning techniques.
- Monitor suspicious areas for progression during routine recall visits.

- Schedule a 6-month recall to reassess calculus on #12 and evaluate the lesion near #16.
- If caries is confirmed, refer for restorative treatment.
- Consider targeted imaging (e.g., periapical radiograph) for the #16 region to clarify the lesion's extent.
