Our Ref No.: 14813/ICICI/19-20

Claim No. FIR002136854

IMMEDIATE LOSS ADVICE

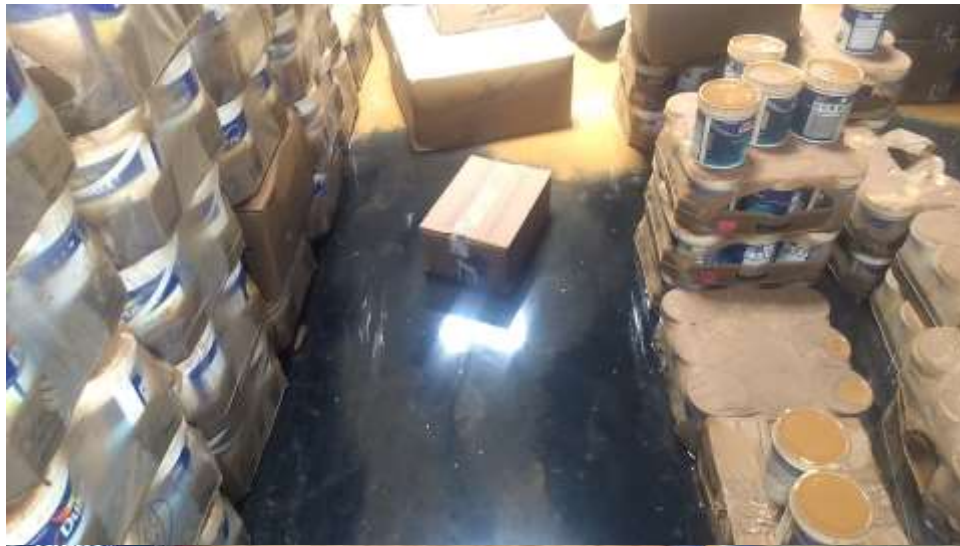
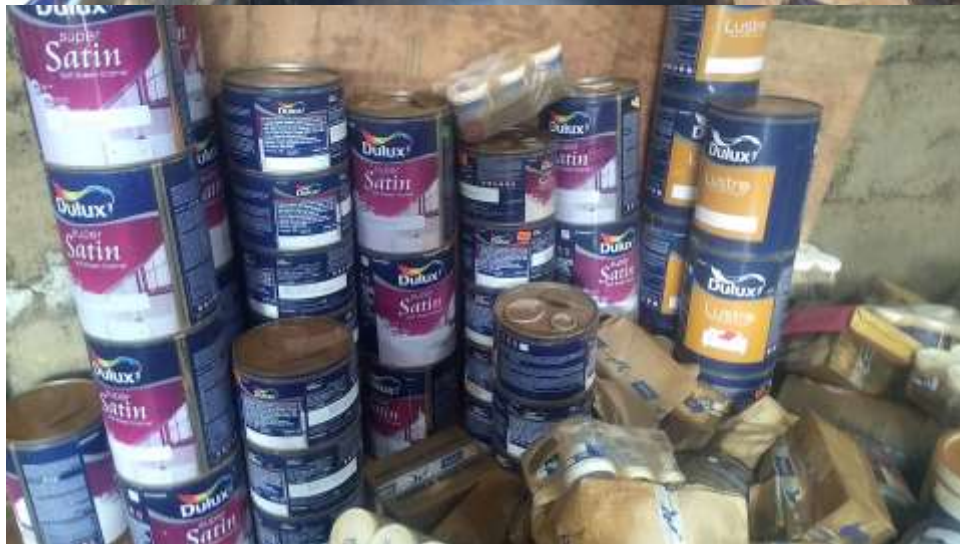
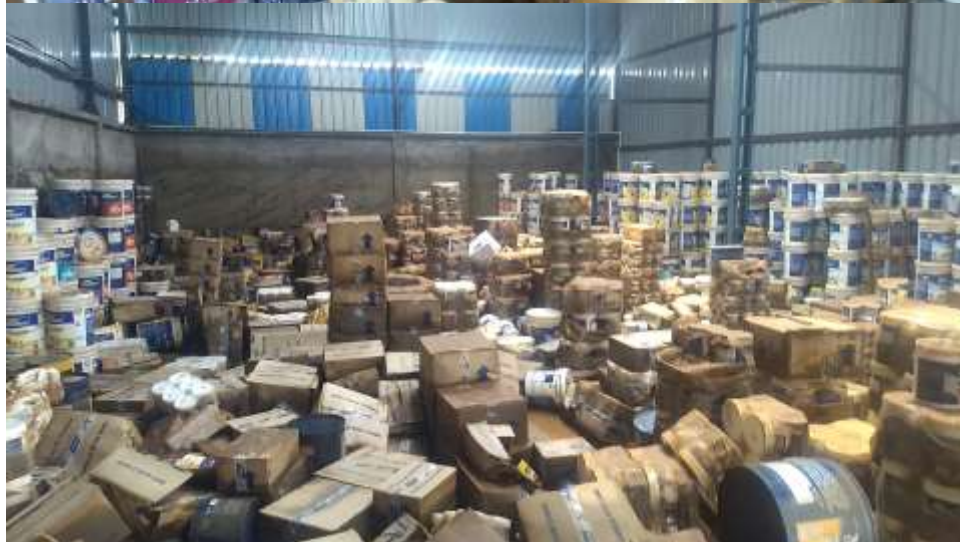
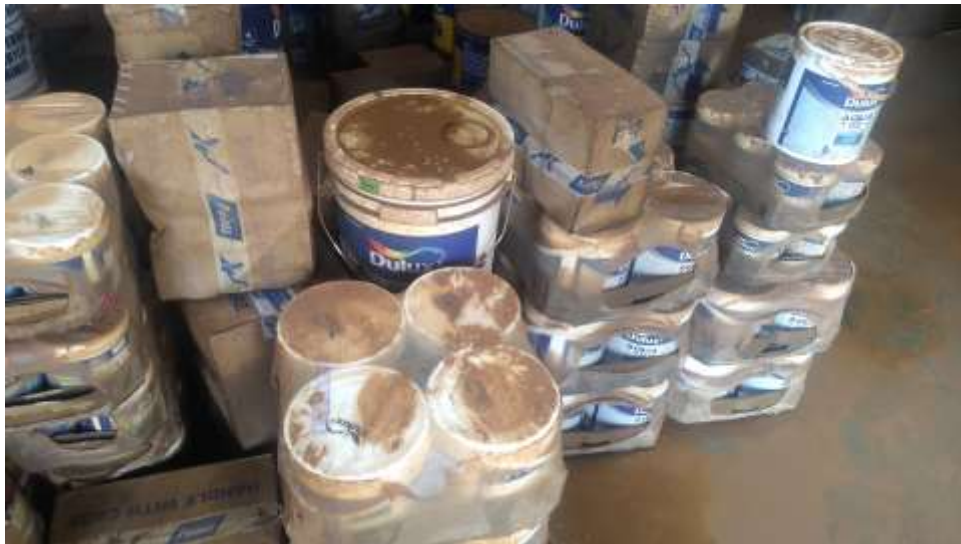
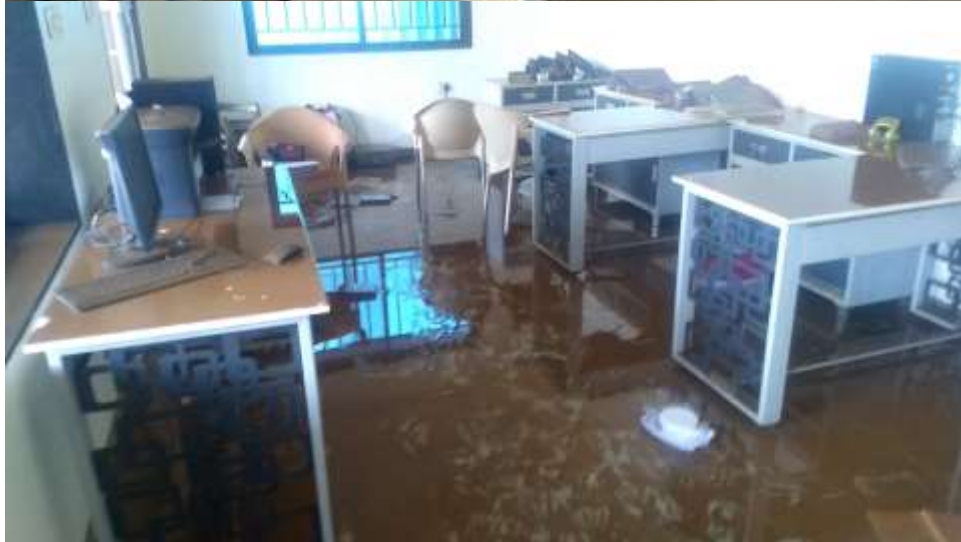
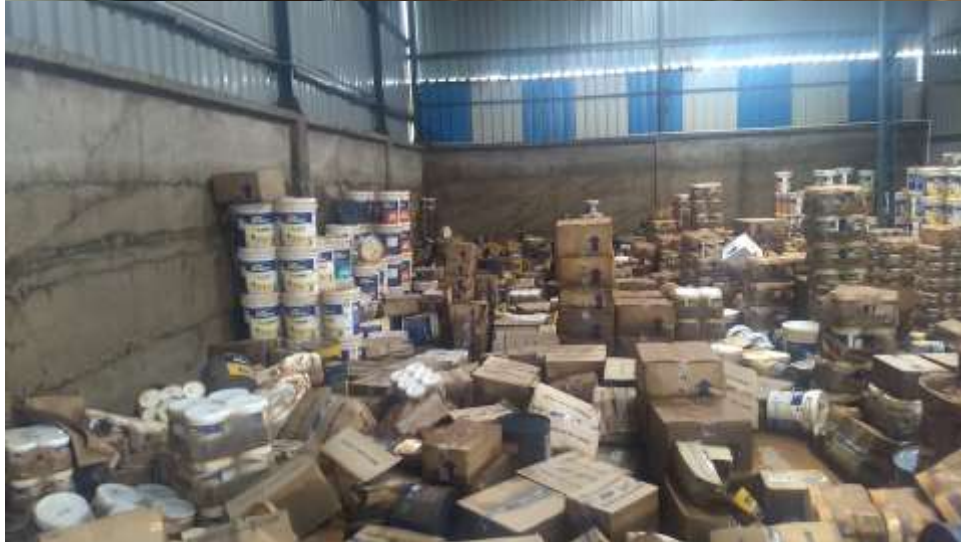
1. The FFF such as tables, desk, chair etc. were submerged in water and were damaged
2. The electrical wiring & painting of the building was affected
3. The machinery such as computer, printer, and coloring machine were found affected.

4. The stock consisted of various types oil paints & enamels of Dulox brand. All the stock was submerged under water for a period of almost 9 days. The water level was clearly visible inside the warehouse. The paint drums/ tins/ buckets were stored at a height of 3 or 4 buckets/drums per stack, while the water level inside the warehouse was 6.5 feet, as a result, the stock was completely submerged under water. Water traces were present inside the warehouse. The cardboard packing was completely damaged while the tins (of oil paint) were found rusty. Considerable amount of mud deposition was found on the drums. The quantity of drums and tins was inspected jointly and noted down. The batch numbers on few drums was slightly faded due to prolong exposure to water. The inner composition was also found changed in few drums.

- To provide the list of damaged items along with the repairs estimate.
- Testing of the affected machinery
- To start the cleaning activity.
- Confirm us the schedule for final inspection.
- To provide the requisite documents /information vide email dated 19th August 2019
