FINAL REPORT

Our Ref No.:	Insurers Ref
14096/ICICI/18-19	Insured Name: M/s. Rise N Shine Biotech Pvt. Ltd
	Policy No. 1001/121652841/01/000
	Type of policy: Standard Fire & Special Perils Policy
	Claim No.: FIR000457188
	Date of loss: 14 th September 2018
Report Date: March 27, 2019	Date of survey: 14 th September 2018

Final survey report regarding claim preferred by M/s. Rise N Shine Biotech Pvt. Ltd for reported loss/damage to their property due to reported fire, insured under Standard Fire and Special Perils Insurance Policy

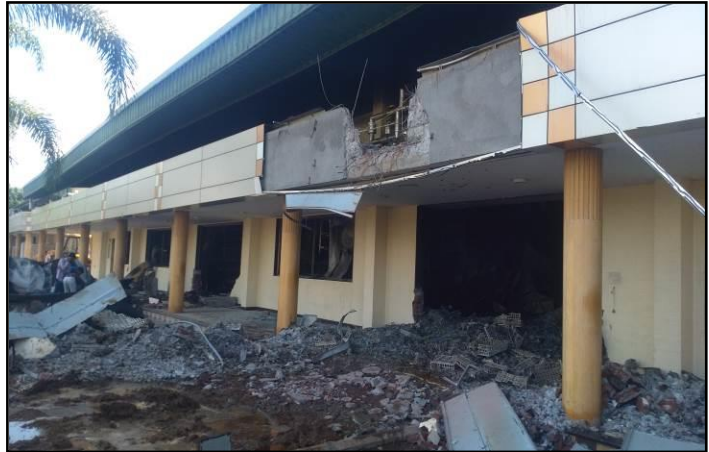
5.3 A detailed inspection of the building damages carried out along with the insured's civil contractors. The building was damaged

considerably. MS steel members of trusses were found bent/uprooted.

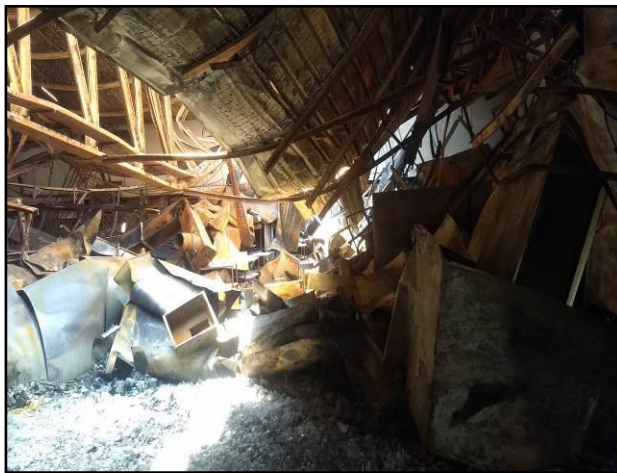
5.4

The portion of the roof caved in. The foundation plates at various places found uprooted. GI sheets uprooted at various places and found bent. The side walls were also found cracked. The aluminum sliding windows glasses

broken. To create access for firefighting, few portions of civil work was broken by the fire brigade officials. The flooring was also found affected partially. The condition of the RCC frames required further testing and validation. Soot deposition observed on walls and roofing sheets. A passage between lab 1 and 2 was broken to avoid spreading of fire. The fabricated structure of roofing sheets was broken by the insured. During NDT and core tests, the top portion above the false ceiling was found affected. The bottom portion of RCC was found sound. Accordingly, the scope of repairs was decided.

The insured have lodged claim of Rs. 4,11,05,894/-, The insured has submitted quotations of various items of the building. During survey, the detailed examination of the items were carried out to ascertain the exact extent of damages. The insurers have appointed an expert, M/s Aaryan Structcon Pvt. Ltd for evaluation of the damages. The expert had submitted the detailed estimate of repairs. The claim value of the insured was generally found in sync with the estimate provided by the expert. The assessment is carried out on the basis of such estimate. However, the expert had not evaluated few items under the building heading. These items were assessed on the basis of the quotations provided by the insured, which were suitably adjusted. In case of PIR panels, the insured had submitted a quotation of different specification. Reasonable value of the original specification was considered.

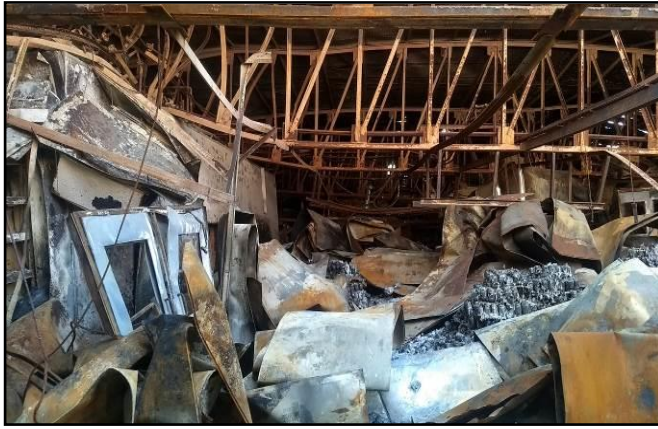
5.5

The entire puff paneling were burnt completely. The AC ducts were collapsed all over the lab area on the floor and bent/De-shaped. The LAF (Laminar airflow cabinet) units were also

affected due to fire. Various equipments like steryp pot, PGR racks, plant bottles, PH meter, Auto clave etc. were also damaged and burnt.

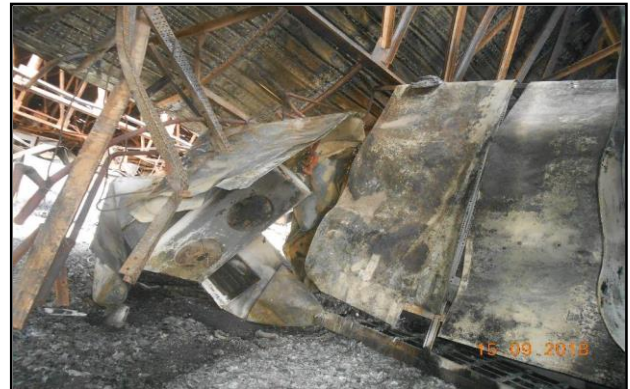
5.6 The AC compressor units were also affected due to fire and were installed on porch slab. The Vents, pipes of the cooling system found burnt and bent. During survey, list of the

affected machines was prepared (elaborated in the assessment Annexure). During our subsequent visits, detailed inspection was carried out and scope of repairs/replacement was ascertained. Except AHU units, the machineries were found completely damaged. Few electrical panels were found sound and not considered in the assessment.

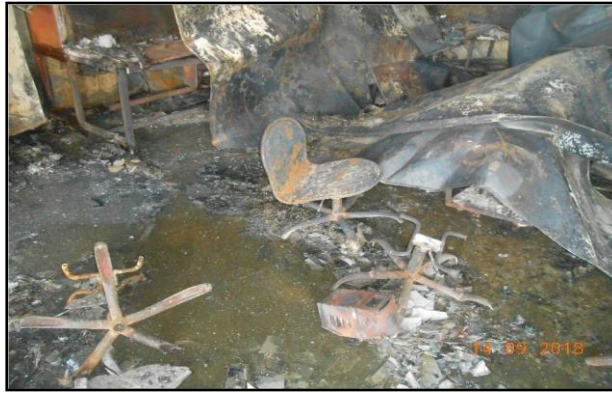
5.8

The furniture inside the lab 2, reception area, cabins, chairs, computers etc. affected and burnt due to fire. Electrical wiring and cabling with switches found melted and burnt out

completely. Steel racks and tables were also burnt in the PIR room.
