R&D Report: **Summer Trials**

Title: TML_CEV5_497_NA_41KW@2200RPM_THCM_BHL_Summer
trials_Report

THCM 41kW Backhoe-Loader Summer Trials

- ***Jaisalmer, Rajasthan***

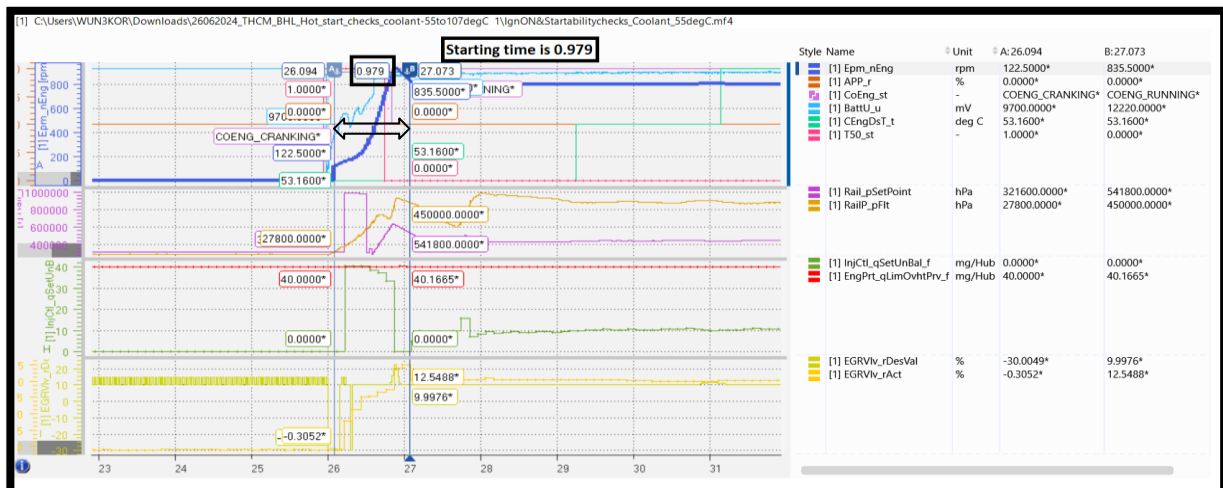
8.2.1. Start check at ~55°C coolant temperature and 40°C Ambient temperature.

➤ **Observation: Starting time is 0.979s, No visible smoke & stable start.**

- During start, battery voltage dropped to 8.46V (at 43°C ambient and 55°C coolant temperature) which is within ECU working threshold. Battery voltage is regained subsequently, and engine starts with repeatability.
- The rail pressure builds up adequately to release ET and consistently follows the set point without any lag.
- The starter engages for less than 0.8 seconds, and the engine starts within 1 second on the first crank, which is acceptable to TML.
- No visible smoke was observed during startup or low idle conditions at the test location.

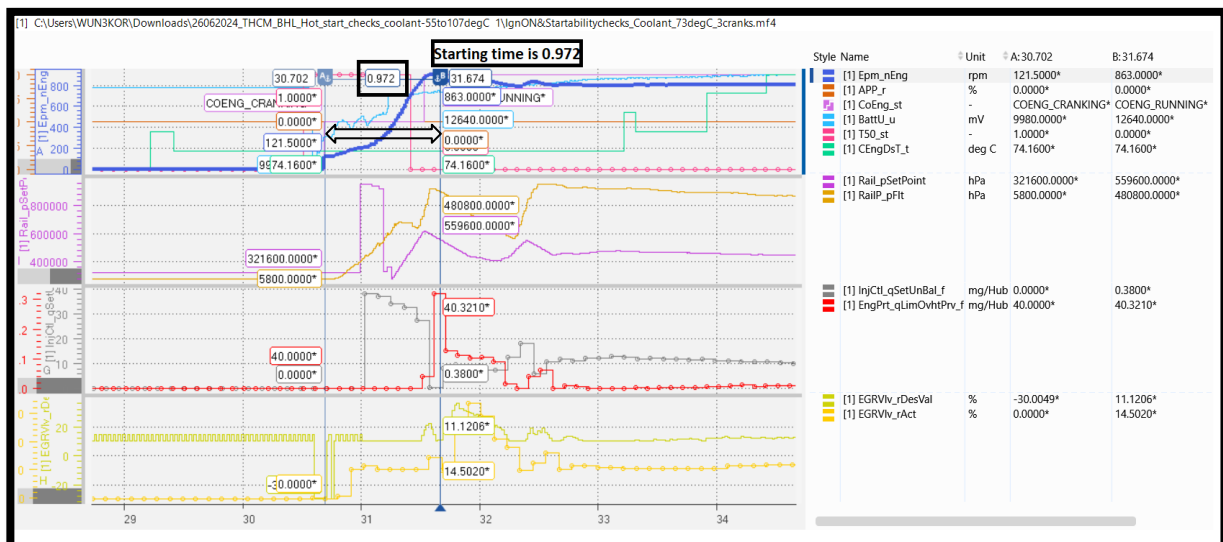
8.2.3. Start check at ~73°C coolant temperature and 40°C Ambient temperature.

➤ **Observation: Starting time is 0.972s, No visible smoke, stable start**

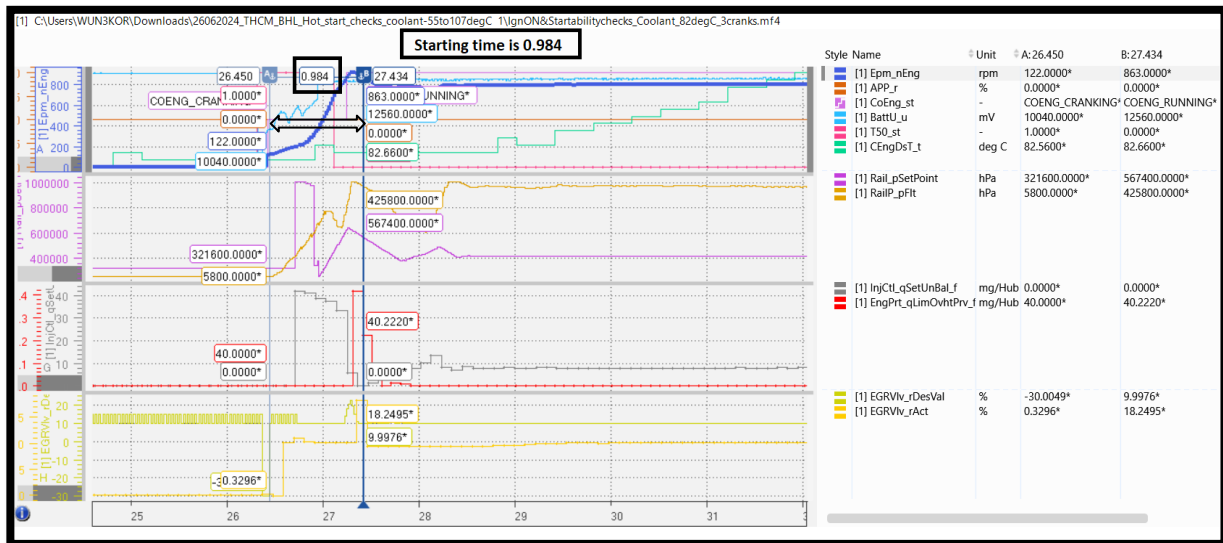
8.2.4. Start check at ~82°C coolant temperature and 40°C Ambient temperature.

➤ **Observation: Starting time is 0.98s, No visible smoke, stable start**

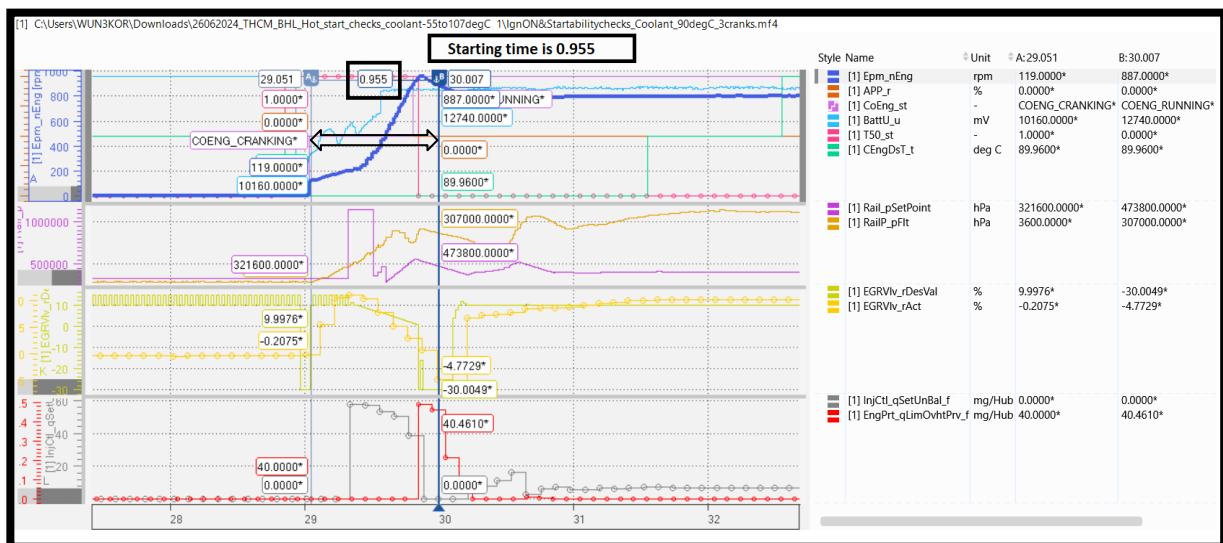
8.2.5. Start check at ~90°C coolant temperature and 40°C Ambient temperature.

➤ **Observation: Starting time is 0.95s, No visible smoke, stable start**

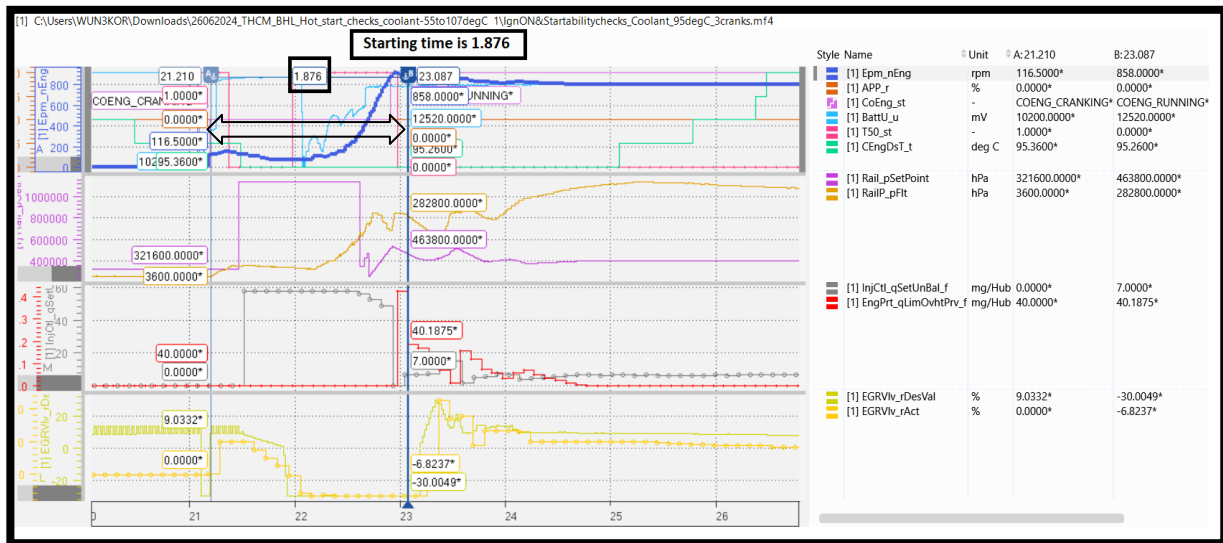
8.2.6. Start check at ~95°C coolant temperature and 40°C Ambient temperature.

- **Observation: Rail pressure builds in 0.99 seconds, causing a delayed start time of 1.87 seconds. There's no visible smoke, and the start is stable.**

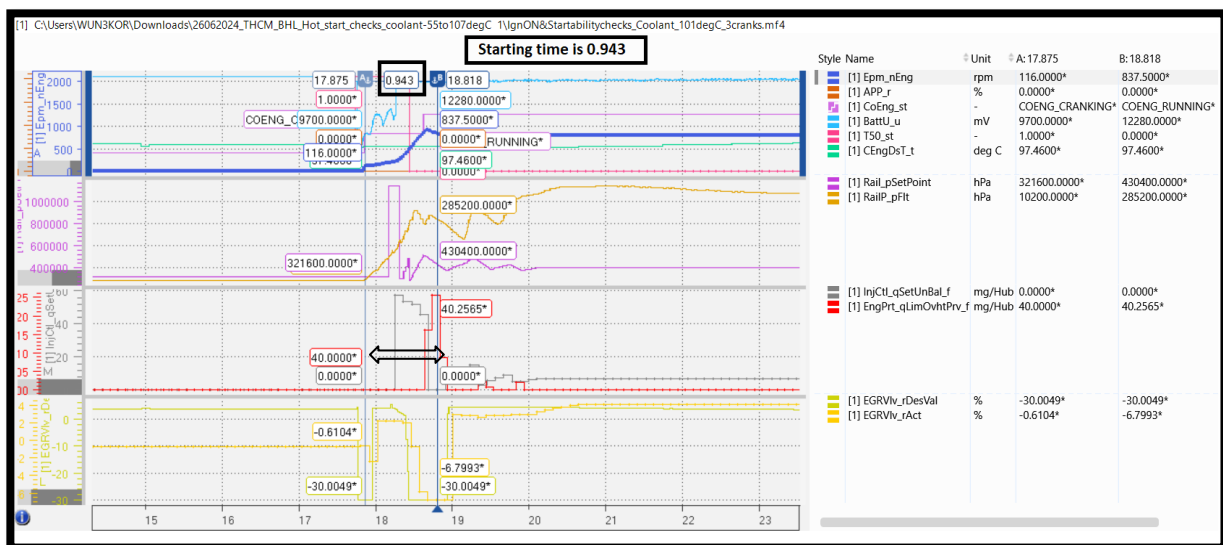
8.2.7. Start check at ~101°C coolant temperature and 40°C Ambient temperature.

- **Observation: Rail pressure builds in 1.4 seconds, causing a delayed start time of 2.57 seconds. There's no visible smoke, and the start is stable.**
