Commodore Super PET - SP9000 Diagnostics Manual

Version 2.1 Created in September 2024

This manual will only cover the **SuperPET with the "Single Board Version"** The other versions with additional\separate boards are not covered in this manual. The SuperPET board I used to create this manual is the:

**SUPER PET COMBO BD. ASSY NO. 9000007 1482
FAB NO. 9000008 REV. B
ARTWORK NO. 9000017 REV. B**

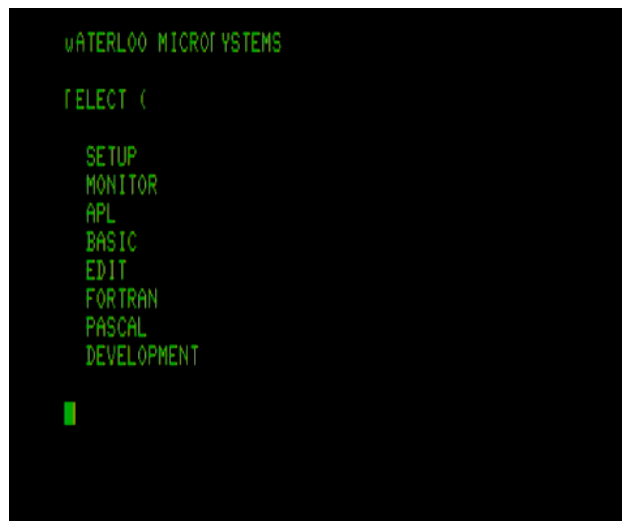
Symptoms: System will not boot up into 6502, no video however when switching to 6809 mode you see the following:

Diagnoses: Check\replace **U2** – 74LS04 and\or **U5** – 74LS11
