Commodore Super PET - SP9000 Diagnostics Manual

Version 2.1 Created in September 2024

This manual will only cover the **SuperPET with the "Single Board Version"** The other versions with additional\separate boards are not covered in this manual. The SuperPET board I used to create this manual is the:

**SUPER PET COMBO BD. ASSY NO. 9000007 1482
FAB NO. 9000008 REV. B
ARTWORK NO. 9000017 REV. B**

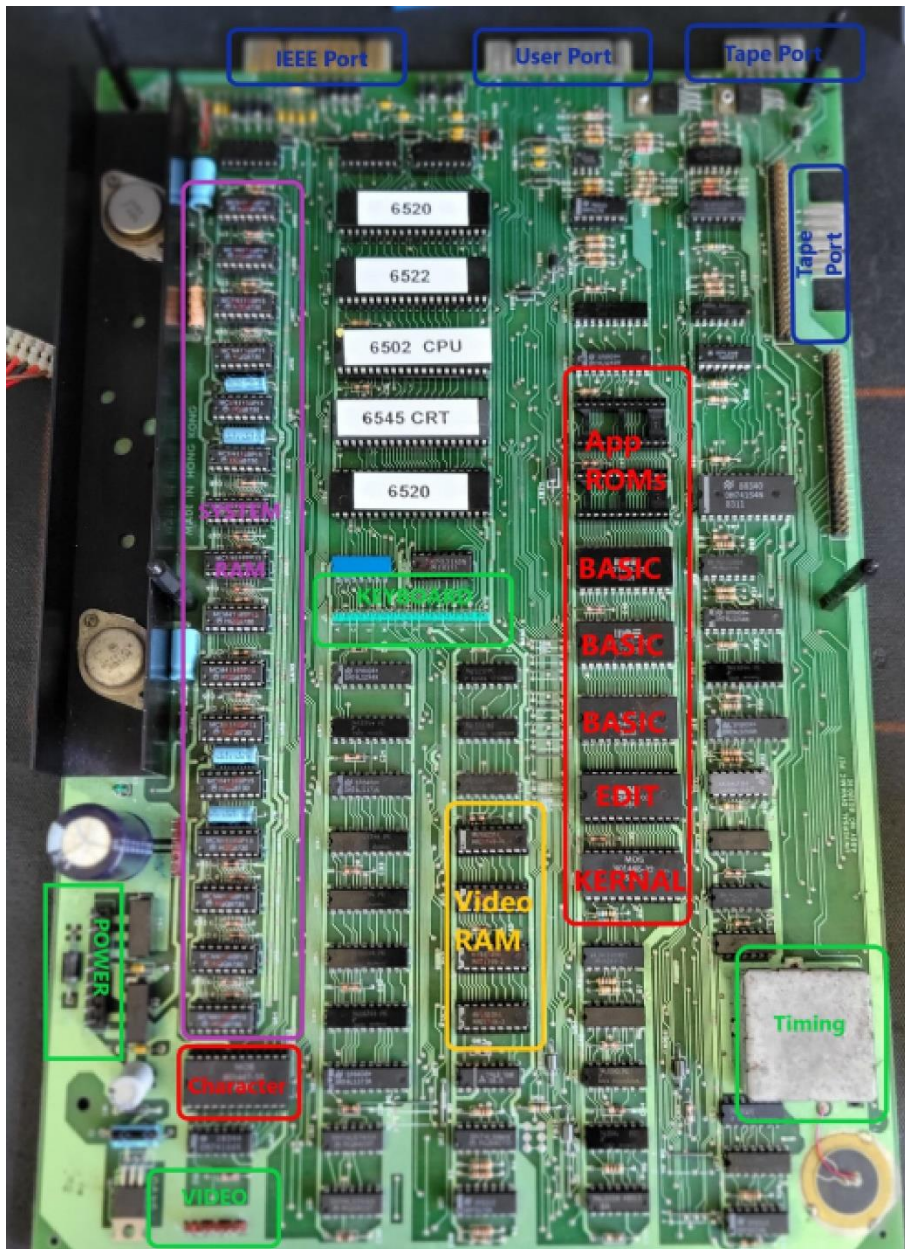
8032 Motherboard with identifications

Commodore PET 8032

Original

901465-19: BASIC ROM
901465-20: BASIC ROM
901465-21: BASIC ROM
901465-22: KERNAL ROM
Character ROM: 901447-10

BASIC ROM Bug Fix

901465-23: BASIC ROM
901465-20: BASIC ROM
901465-21: BASIC ROM
901465-22: KERNAL ROM
Character ROM: 901447-10

6545 used in 12"inch screen PETs for
H-Sync and V-Sync

6522 VIA (Versatile Interface Adapter)

6520 PIA (Peripheral Interface Adapter)

Video RAM

4 x 2114 RAM ICs

Main System RAM

16 x 4116 RAM ICs

CPU: 6502 (1 Mhz)

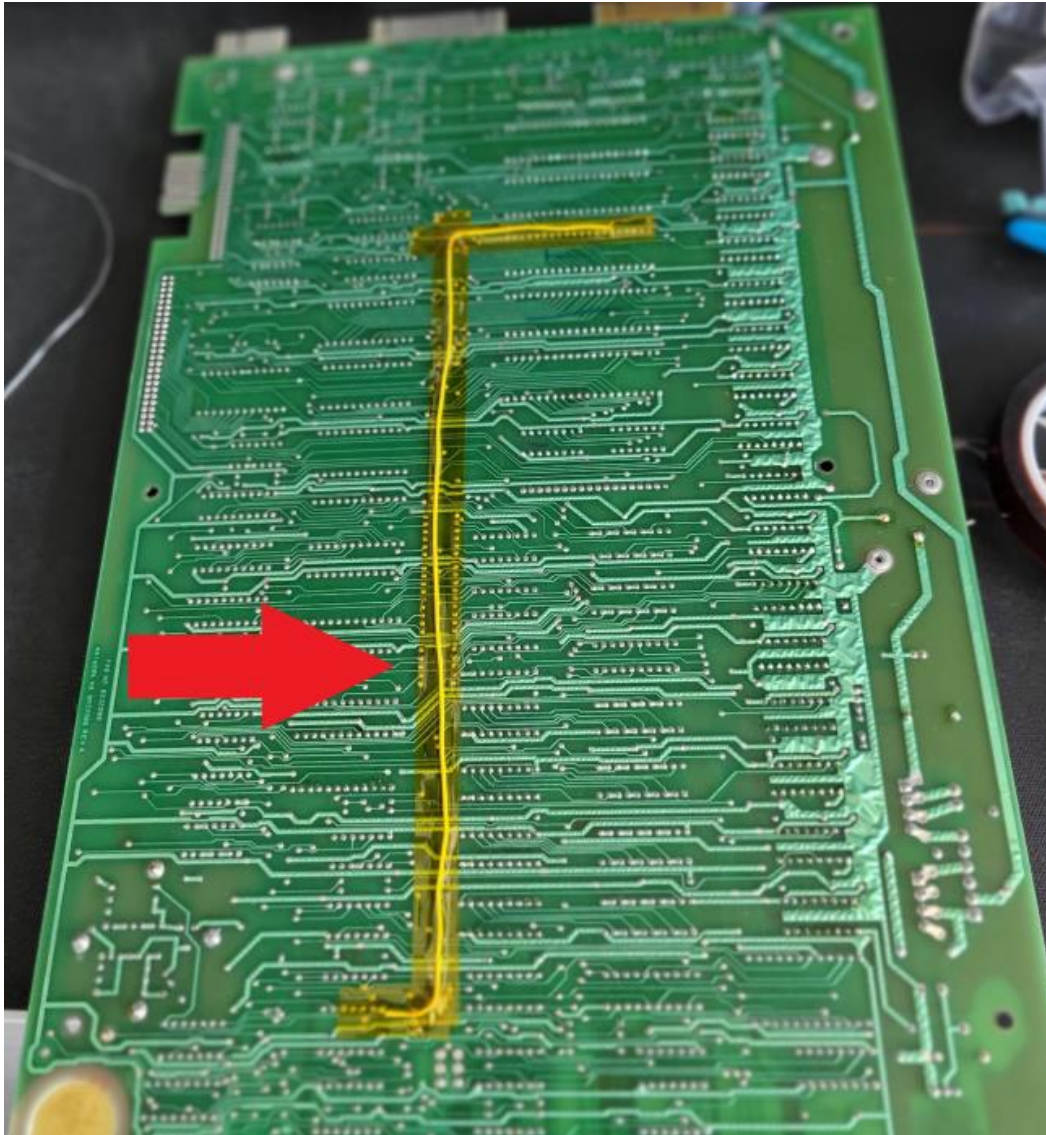
Motherboard jumper wire installation

A jumper wire is needed to pass through a clock signal from the 8032 to the daughter board

Verify\Install a wire from **UD3** pin 1 - 74LS393 connected to **U17** pin 35 – 6502 CPU

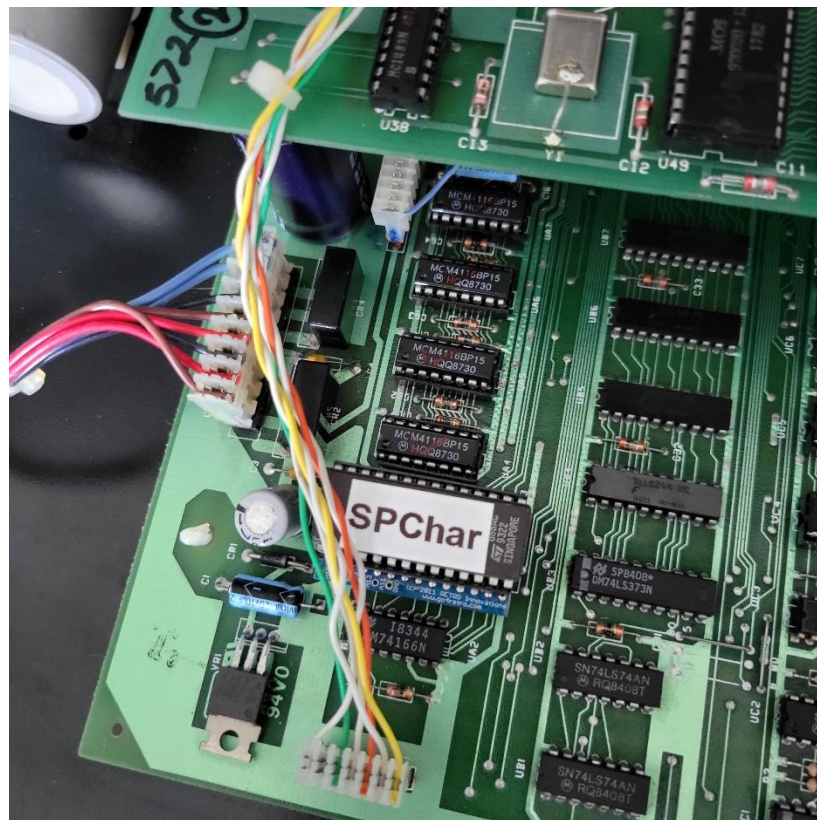
Character ROM modification

The character ROM is the 901340-01 which is different from the original character ROM found on the 8032 motherboards.

SuperPET character ROM, is made of 2 halves. The first have the original 8032-character ROM and the second half of this ROM contains a true ASCII character set and an APL character set. Without this modified character ROM, the SuperPET board will not work.

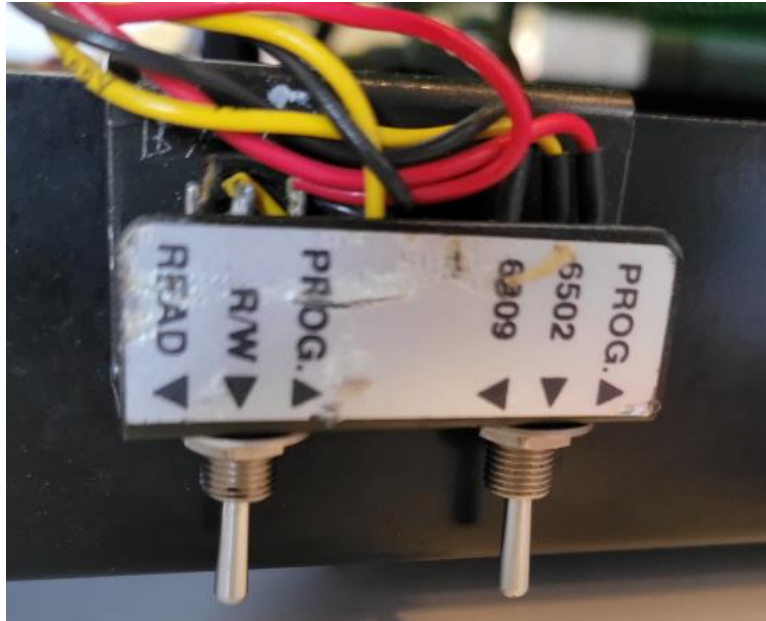
Switch Setting and Usage

For general purposes, leave the 2nd switch to **R\W** (Read and Write). The usage of these switches will not be covered in this manual. You can find the programming language manuals or SuperPET user manual for details on how\when to use these switches. The only switches used to repair a SuperPET is 1) leaving the memory switch to **R\W** and 2) switching between 6502 (8032 PET) and the 6809 (SuperPET) modes.

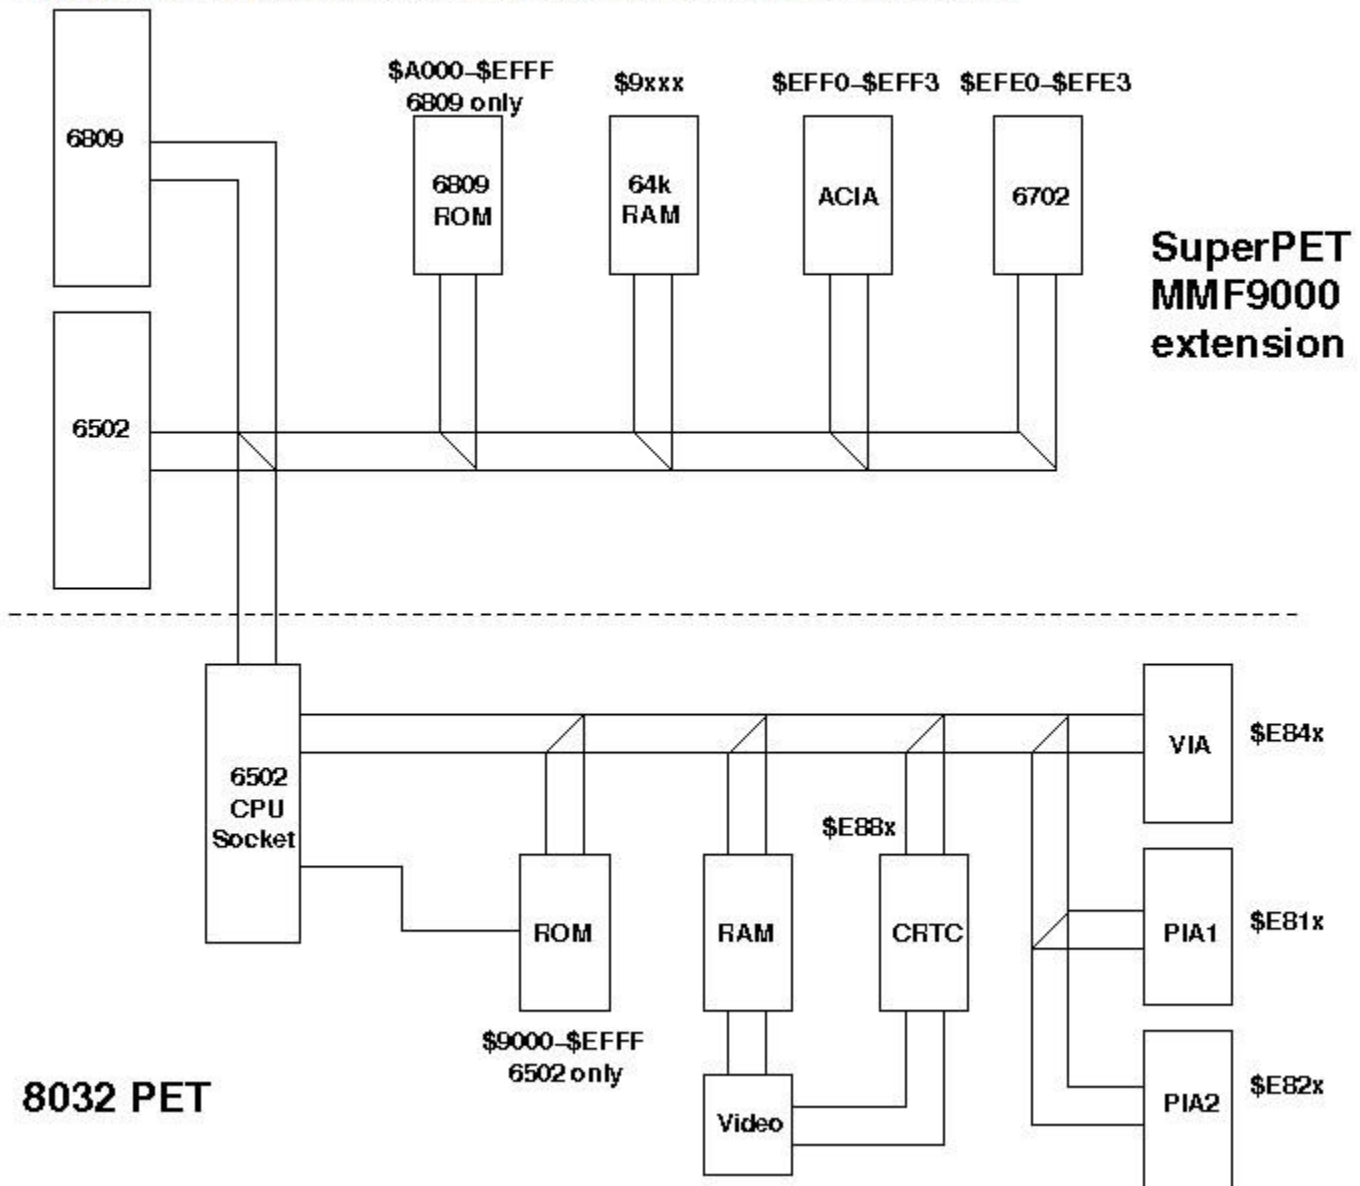
Basic Operation of the SuperPET

The following diagram shows an overview on the SuperPET extensions

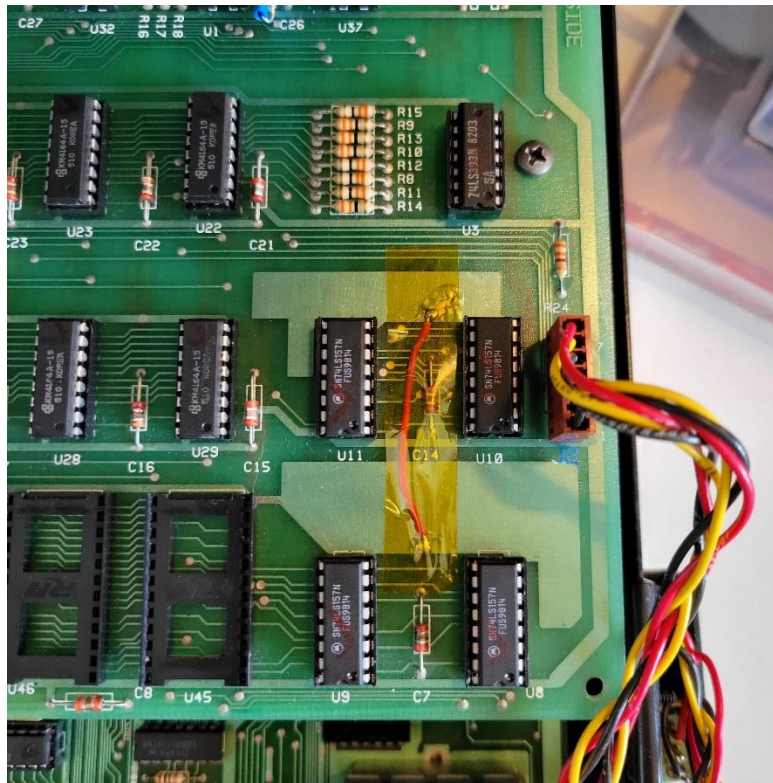
Top Side Jumper Wire

Verify\Install a wire from the 2 locations as per above picture as there are no markings on the daughter board as to where exactly to install this jumper wire.

This jumper wire is not required on the REV A board **ARTWORK NO. 9000017 REV. A*

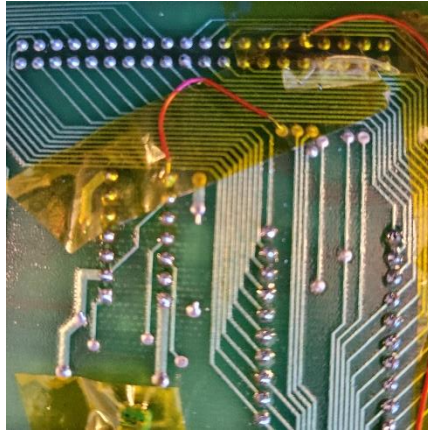
Jumper Wire (short wire) from **U6** Pin 8 connected to CPU ribbon cable connector header Pin6

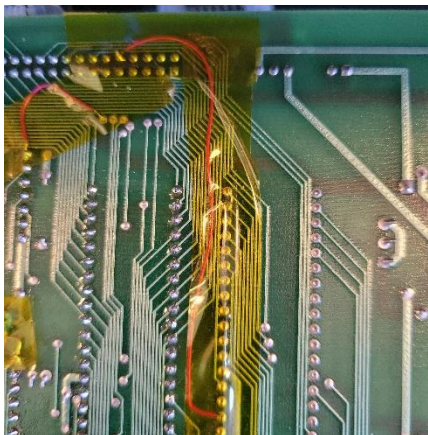
Jumper Wire (longer wire) from **U17** (6502 CPU) Pin 36 connected to Pin36 on the CPU ribbon cable connector

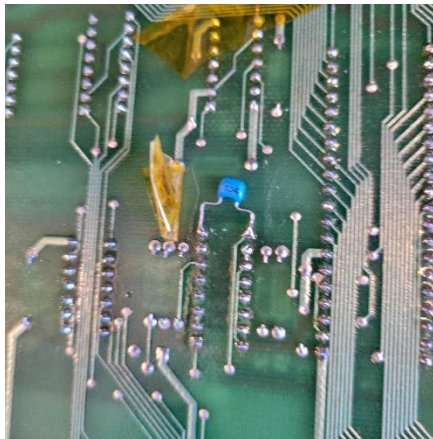
Capacitor (0.1uF) from **U12** Pin 8 connected to **U12** Pin9 (same IC).

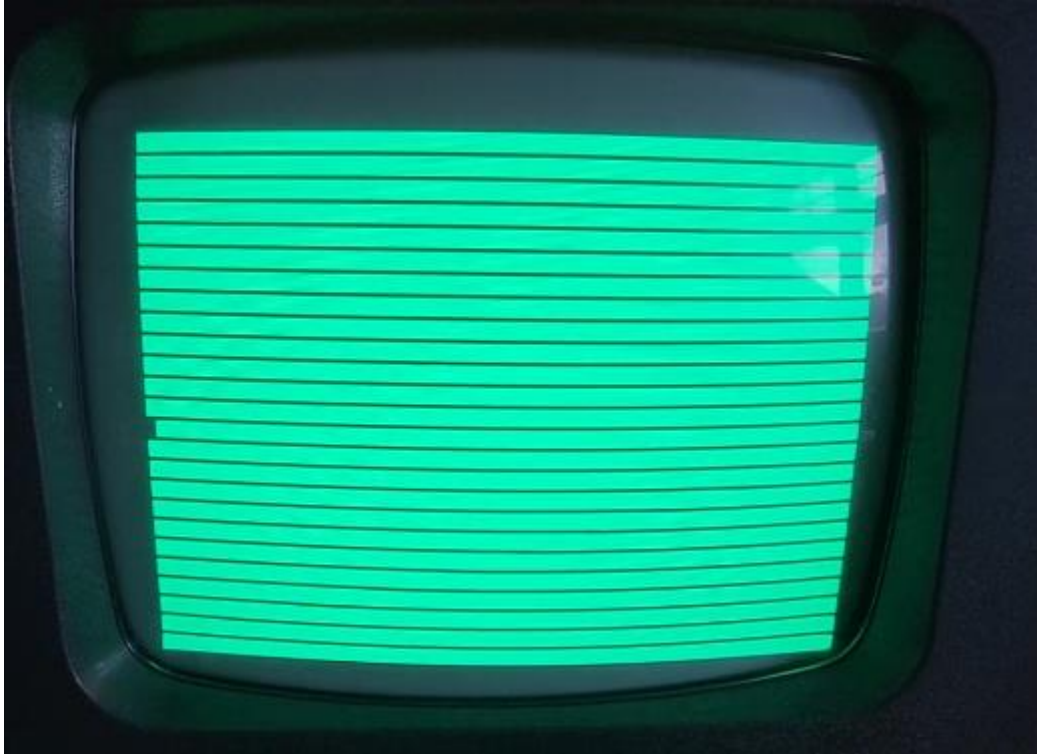
Symptoms: SuperPET is working with switch to 6502 (8032) mode, however when switching to 6809 (SuperPET) you see the following:

Diagnoses: The character ROM on the 8032 motherboard is missing the second half of the data. Replace the character ROM with the 901340-01. Burn the ROM onto an EPROM and with an adapter you can replace the ROM.

If the character ROM is correct, then issue is with the ROM itself. Burn a new EPROM and replace. Regardless of which daughter board you are using this modification needs to be done.

See **Character ROM modification** section in this manual for more information. This is located on *page 5*.

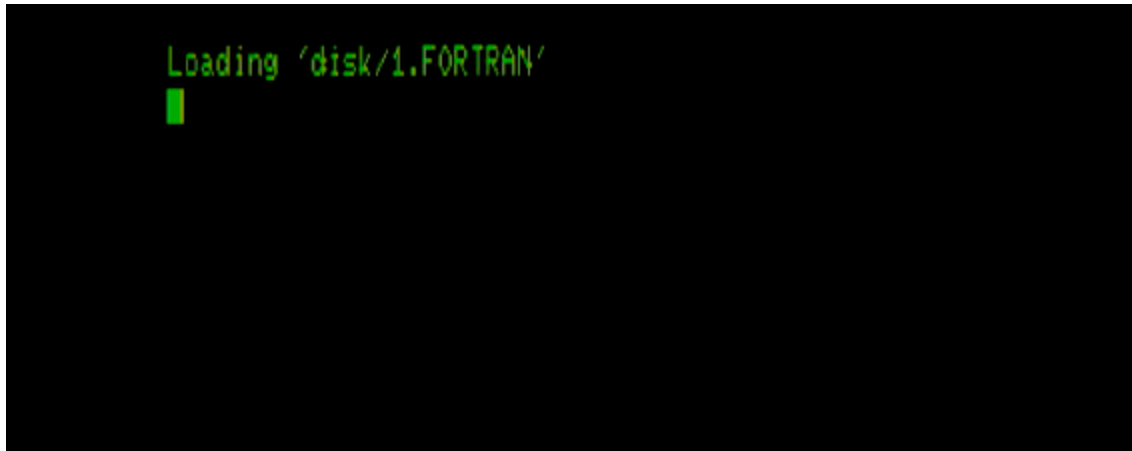
Symptoms: No programming language loads. 6502 and 6809 appears to be working and language file is on the diskette (or SD card). System tries to load the program but is never successful. 6809 mode appears suck and 6502 mode is working.

Here is an example trying to load FORTRAN language.

Diagnoses: Check\replace **U41** – 6702. This IC is required to load any development language. When testing, the language software does take a while to load.

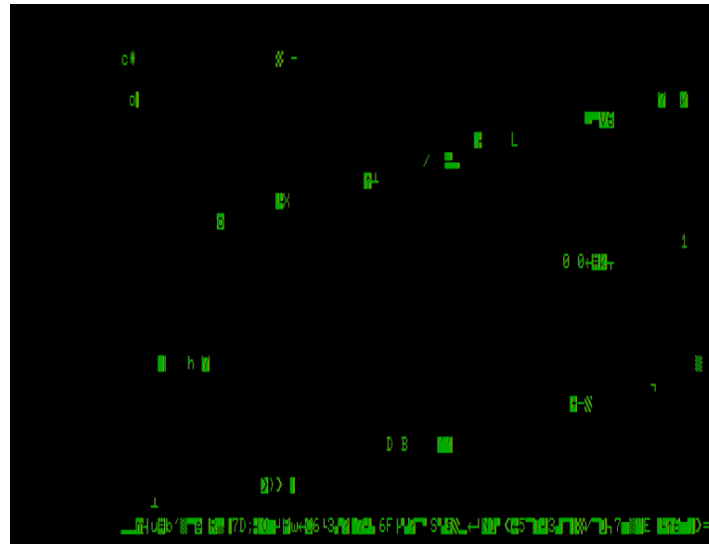
Symptoms: Turning on the SuperPET with switch in 6502 or 6809 position, you see garbage on the screen, like the following:

Diagnoses: Check\replace **U6** – 74LS164 and\or check\replace **U40** – 6551-11

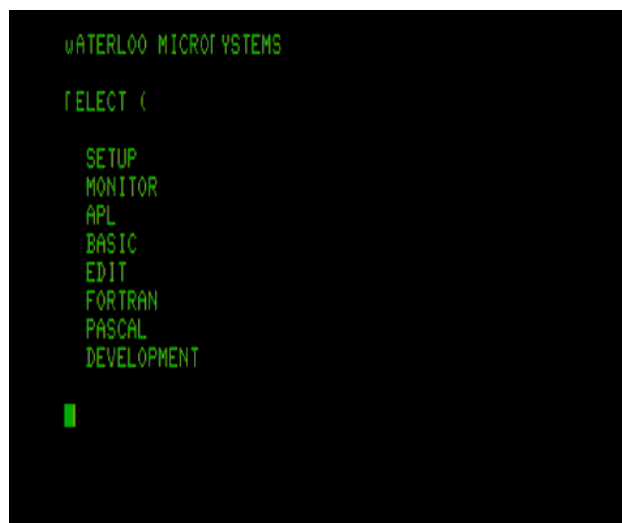
Symptoms: System will not boot up into 6502, no video however when switching to 6809 mode you see the following:

Diagnoses: Check\replace **U2** – 74LS04 and\or **U5** – 74LS11

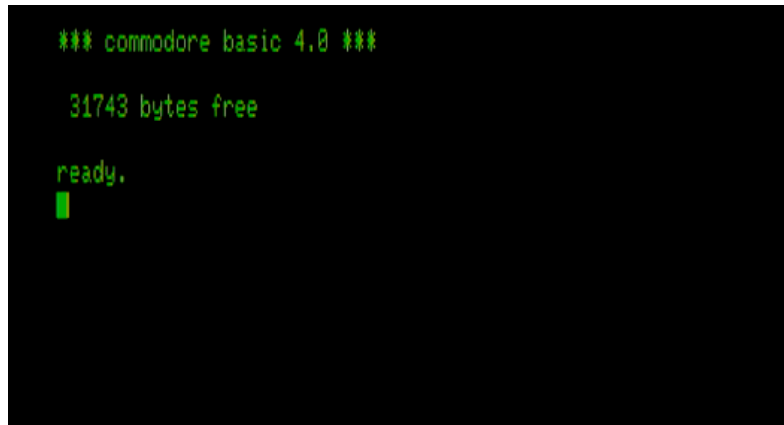
Symptoms: SuperPET boots up but hangs and not keyboard input. Both 6809 and 6502 show the following screen.

Diagnoses: Check\replace **U12** – 74LS123, **U20** – 74LS367, **U18** – 74LS367 and\or check\replace **U40** – 6551-11
