Design of an Underwater Cable Fault Location Device to Precisely Locate Submarine Cable Faults

Abstract—The objective of the paper is to develop a robust and reliable method to pinpoint submarine cable faults. Submarine cables have existed for over 100 years but there is still no single method used to determine the precise location of a submarine cable fault. The various methods used to pinpoint cable faults, both submarine and non-submarine were researched and investigated to produce a method which would accurately pinpoint submarine cable faults. From this, the idea of a hydrophone string was derived from a non-submarine pinpointing method currently used. The hydrophone string was tested and it accurately pinpointed the location of the cable fault.

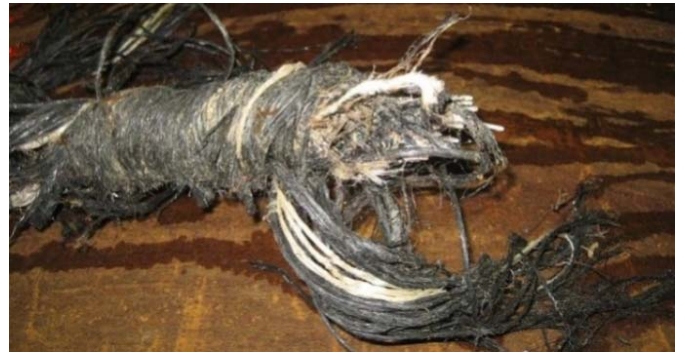
Fig. 1. Cable Interruption Example.

A cable interruption fault occurs when the cable has been sliced into two or more segments, usually the result of fishing equipment or anchors, as discussed above. An example of this is shown below in Fig. 1, where a cable which connected the islands of Malta and Sicily was dragged by a ship anchor for over 200m until the cable was completely severed.

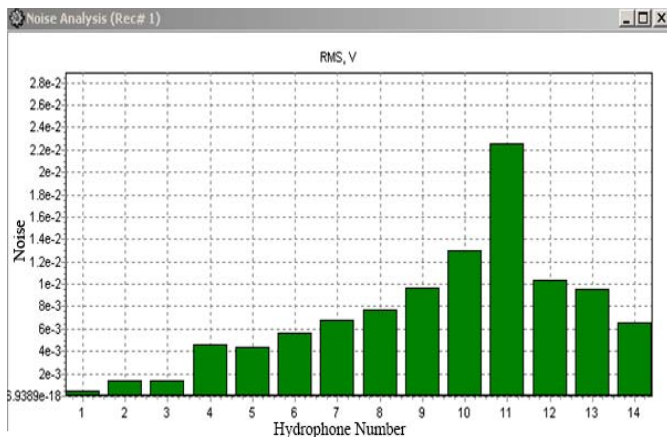
Fig. 5. Noise Analysis

The resulting noise analysis graph for the test conducted can be seen below in Fig. 5. The graph shows the noise experienced by each hydrophone over the 30 seconds and plots the hydrophone number on the x-axis, and the noise converted into a voltage on the y-axis.

From the graph, the fault can be seen to occur at hydrophone 11 as it has the biggest amplitude. After the testing was finished, the 20kV cable and the hydrophones were lifted out of the water together. This verified that fault location was just to the left of the eleventh hydrophone as shown in Fig. 7. Not only does it verify the result but it also shows the high accuracy of this method.

The noise sidebands can also be seen in Fig. 5 which show the sound waves travelling away from the origin of the noise, with less amplitude the further they travel. The analysis of the sidebands allows for a higher accuracy of fault location. As hydrophone 10 has a higher amplitude than hydrophone 12 this indicates the fault occurs just to the left of hydrophone 11.

Overall the testing proved the high accuracy and reliability of the hydrophone method. The fault was precisely located at the eleventh hydrophone. If the fault was to occur exactly between two hydrophones, the amplitude of each hydrophone on the noise analysis graph would be equal and the fault would be determined to be in the middle of the two hydrophones.
