3.5.2 Copy/Monitoring Best Practices

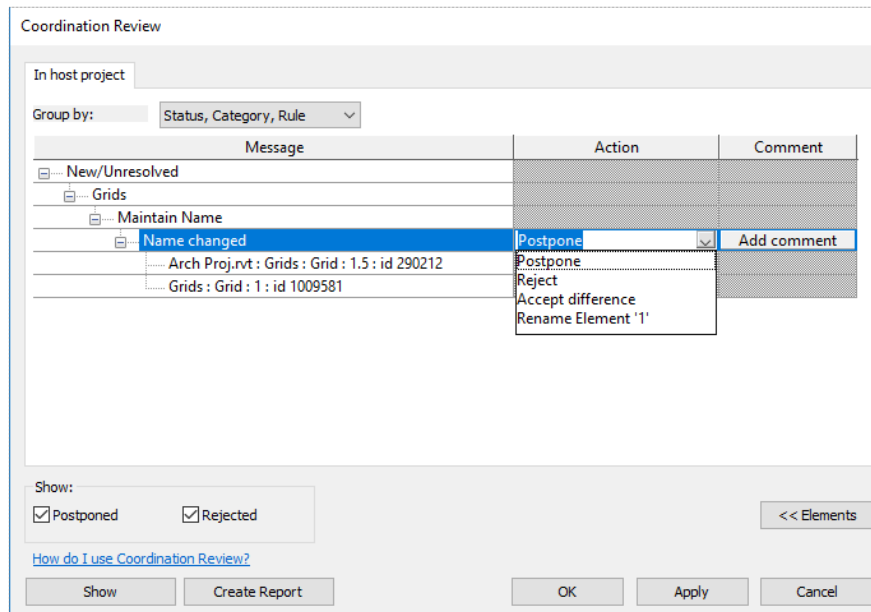
- Do not change the name of the linked Revit files when using copy/monitoring
- To improve design coordination, run the Coordination Review tool to display a list of warnings about monitored grids and levels that have moved or changed. Teams can periodically review this list and specify an action (such as reject the change or modify

Figure Error! No text of specified style in document.-1 Coordination Review

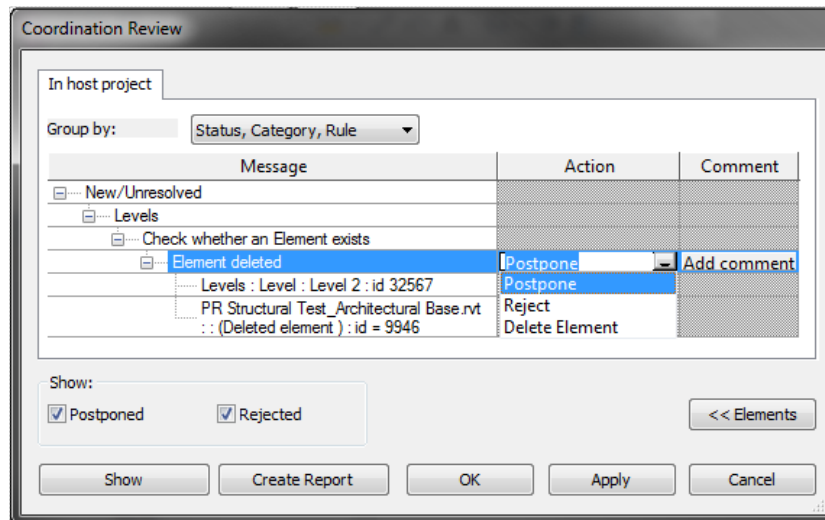
- When a copy/monitored element is deleted from the source file, the warning cannot be resolved until the copied element is re-associated with a new object. To fix this, the copied element needs to be re-associated with a new linked family, followed by a break (stop) of the monitoring relationship.

Figure Error! No text of specified style in document.-2 Postpone Action
