TRIBHUVAN UNIVERSITY
INSTITUTE OF ENGINEERING

Khwopa College Of Engineering
Department of Computer Engineering

A REPORT ON
Instrumentation-II Case Study

Visit Undertaken at
Gorkha Eco Red Bricks Company Pvt. Ltd.
Mahendrajyoti, Nepal

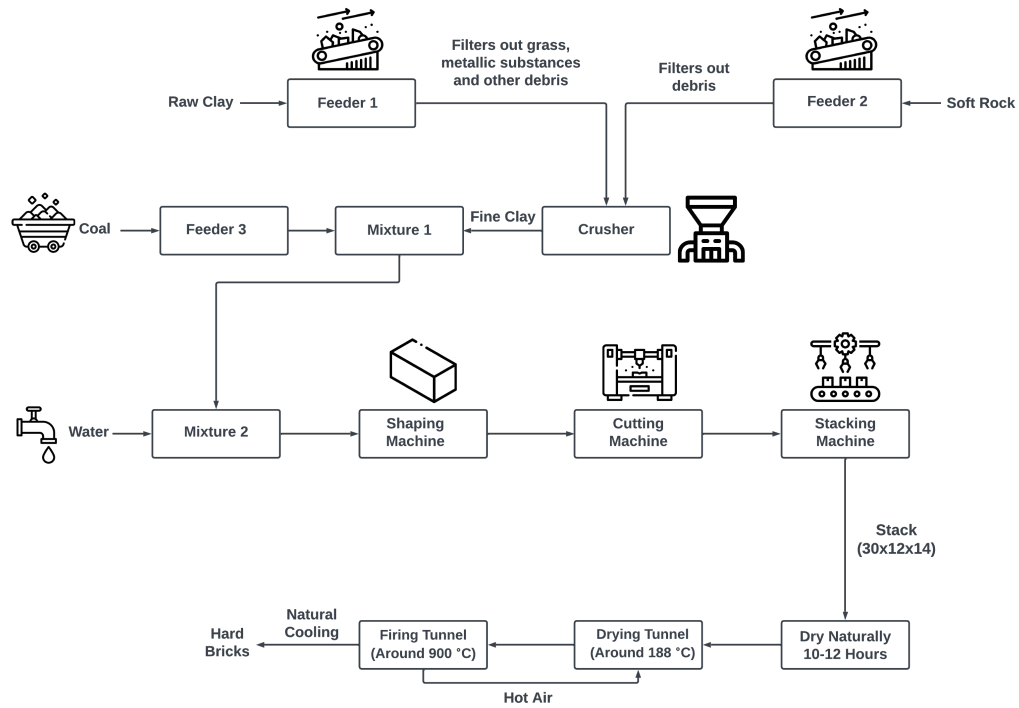
Figure 1: Block diagram for brick manufacture process
