TRIBHUVAN UNIVERSITY
INSTITUTE OF ENGINEERING

A REPORT ON
Instrumentation-II Case Study

Visit Undertaken at
Gorkha Eco Red Bricks Company Pvt. Ltd.
Mahendrajyoti, Nepal

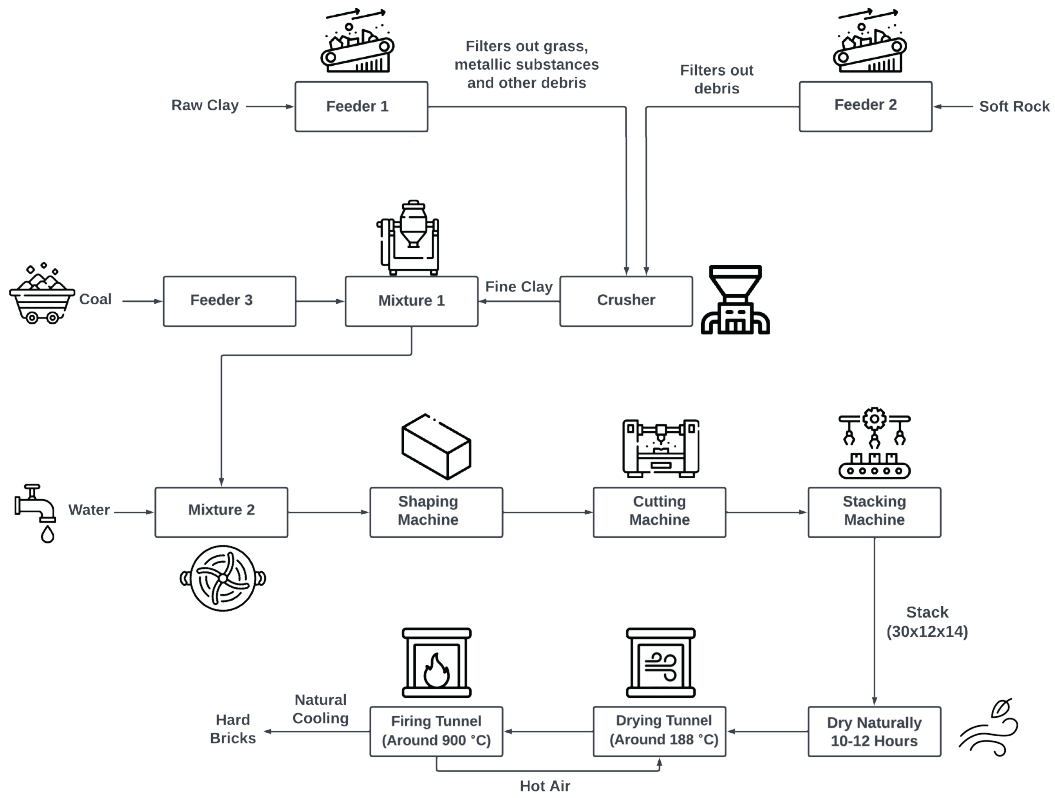
Figure 1: Block diagram for brick manufacture process
