Project Deliverables: Improvement of Reliability of 220 KV Power Transmission network

Project Name: Improvement of reliability of 220kV power transmission network

Name of the Department: Electrical Power Systems (EPS)

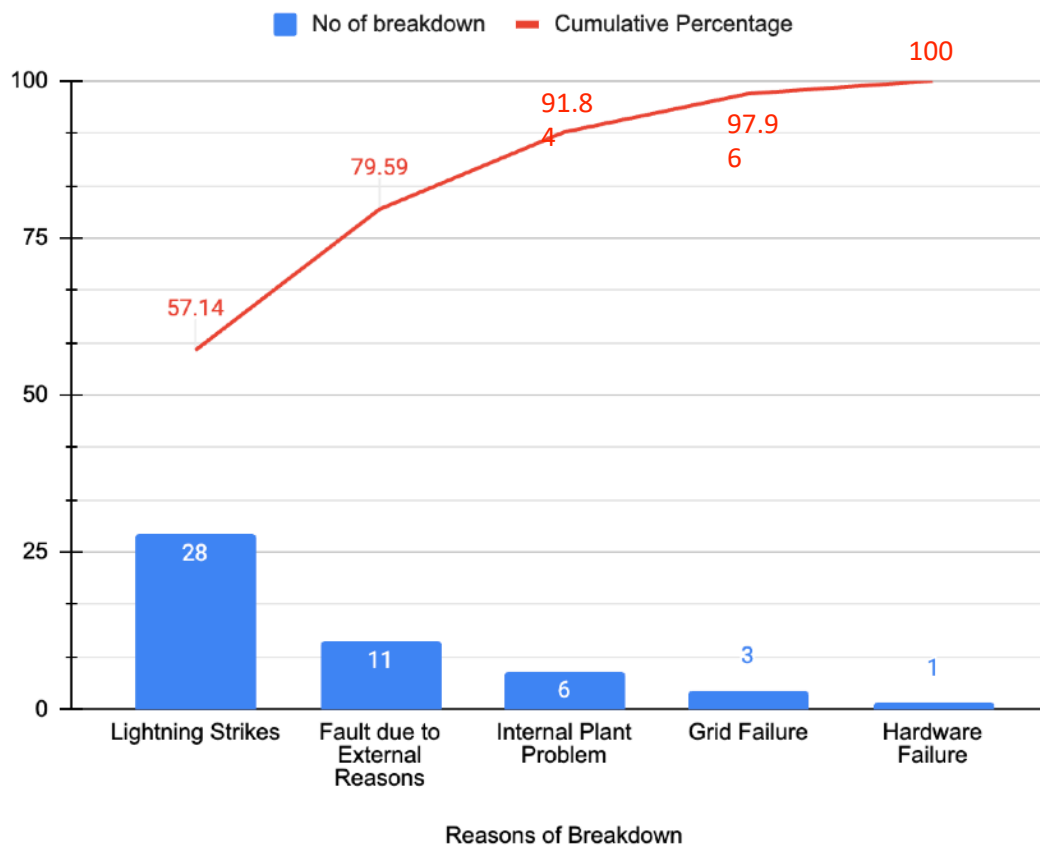
Pareto Chart of Reasons of Breakdown over the last 6 years

Reasons of 220 kV Transmission Line Tripping over the last 6 years

Reasons of Breakdown	No of breakdown	Cumulative Percentage
Lightning Strikes	28	57.14
Fault due to External Reasons	11	79.59
Internal Plant Problem	6	91.84
Grid Failure	3	97.96
Hardware Failure	1	100

NOTE: Fault due to external reasons include factors like fire on vegetation/trees, flying tree branch hit live lines, animal activities etc.

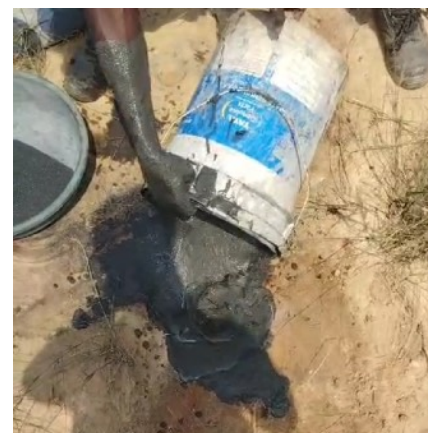
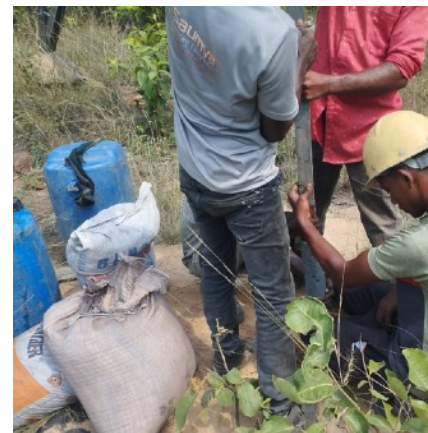
Conductive Concrete Earthing (Marconite Earthing)

Concrete conductive earthing is a specific method for improving the grounding system of structures like 220 kV transmission line towers. It utilises conductive concrete to create a low-resistance path for fault current to dissipate into the ground.

Marconite:Cement:Water ratio is **3:1:1** by weight
It is also available as premix of standard 25kg

Marconite has resistivity of **0.001 ohm m**. The final mixture has a resistivity of **0.1 ohm m**.

1. **Low resistivity**
2. **Versatile:** suits most ground conditions
3. **Long Term Reliability:** 25 years
4. **Cost effective:** Permanent solution for 25 years, with no periodic maintenance like adding water, in case of charcoal and salt earthing
5. **Chemically Inert:** Non corrosive to steel and copper

2. Concrete Conductive Earthing:

Improving grounding system by providing low resistance path.
