PC-BOT 914 5.25" IR Bay Locations Diagram

Document Id:	
Description: PC-BOT 914 5.25" IR Bay Locations Diagram	
Revision: v1.2	Date: April 27, 2007

PC-BOT 914 Bumper IR Locations Diagram

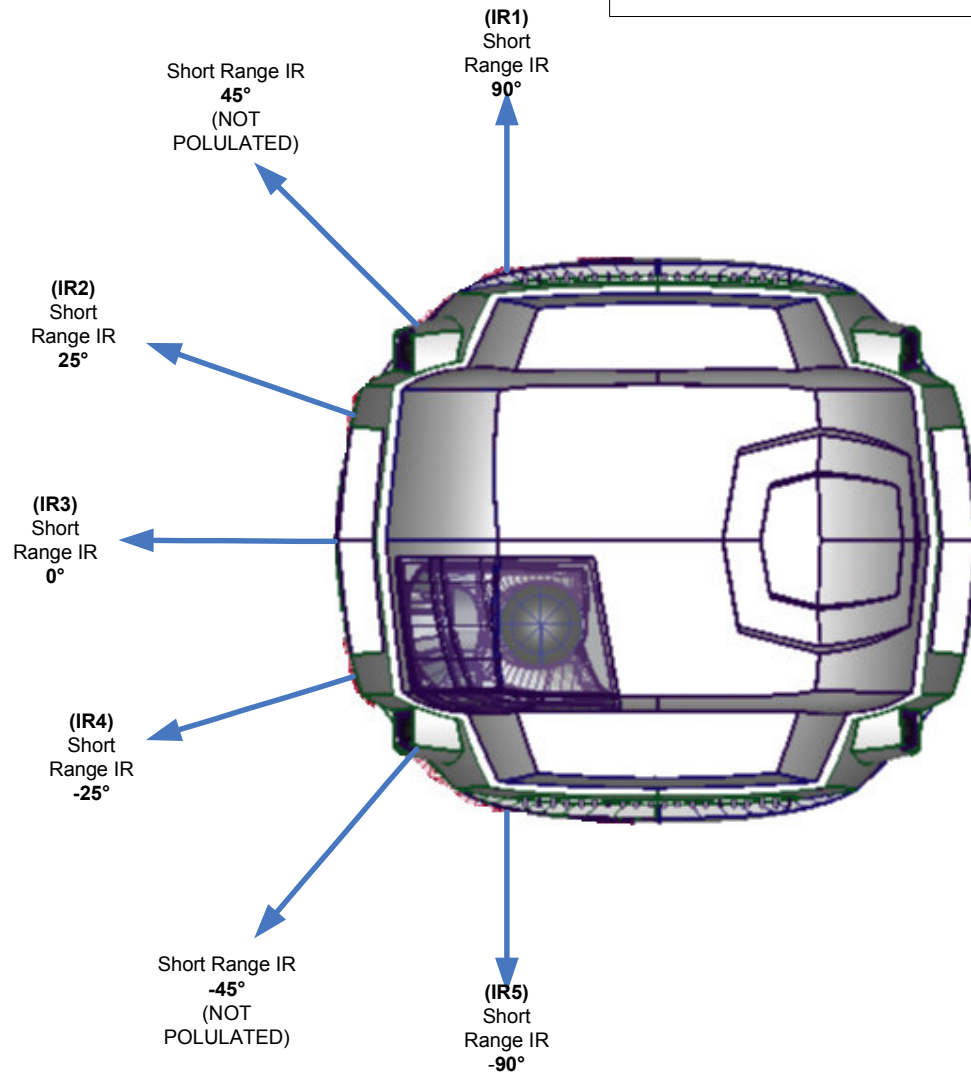
Note: Bumper Area IR sensors (Total of 7, but two not populated).
All sensors point out horizontally, 7 IR sensors are spread out equally.
