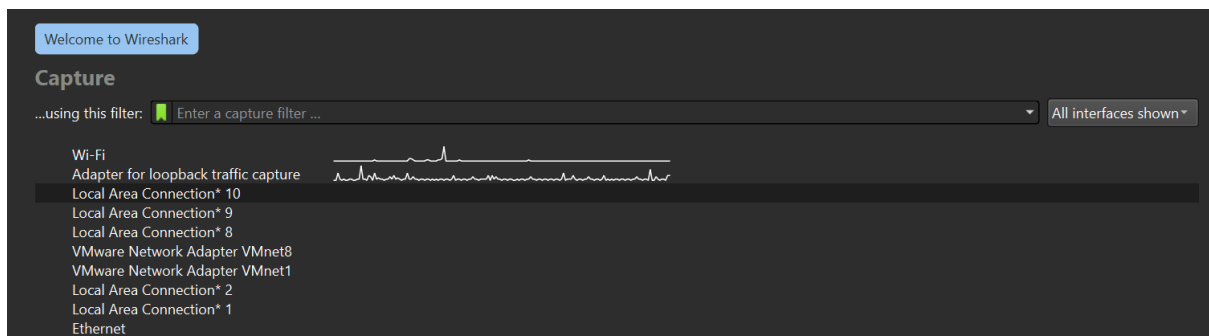
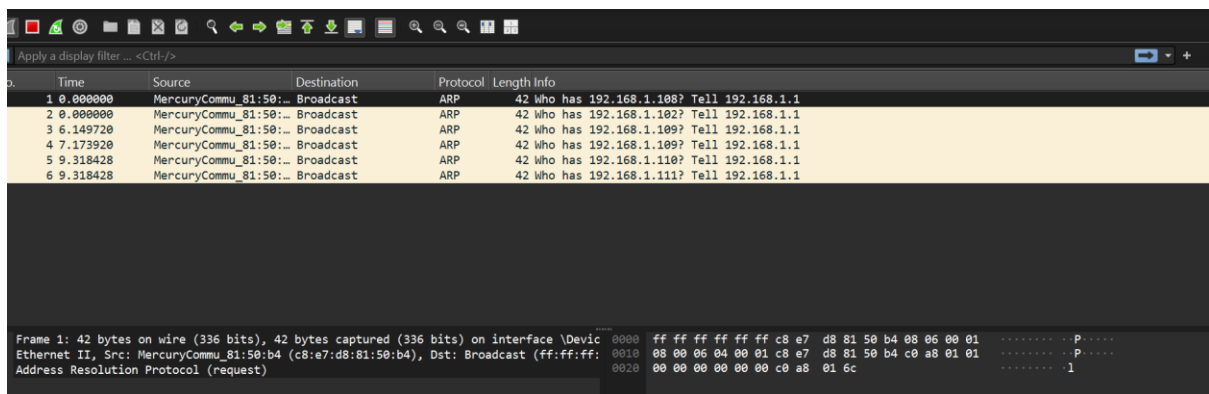
This capture shows multiple **ARP requests** broadcast on the network from the device MercuryCommu_81:50:b4 (MAC c8:e7:d8:81:50:b4).

Each request is asking which device has a specific IP address (e.g., 192.168.1.108, 192.168.1.102) so it can communicate, with the sender identifying itself as 192.168.1.1.

This pattern suggests normal ARP traffic for IP-to-MAC address resolution, likely from a router performing network mapping.
