## TEST REPORT

Report No.: 53692

Test Requested: HUMIDITY TEST

Sample Descr. (#): UNALLOYED ZINC COATED PART CODE 17825040000+KTL - BASE MAT. S420MC 4 mm THK-3 WELDING COMPONENTS  
VW 13750-OfI x632

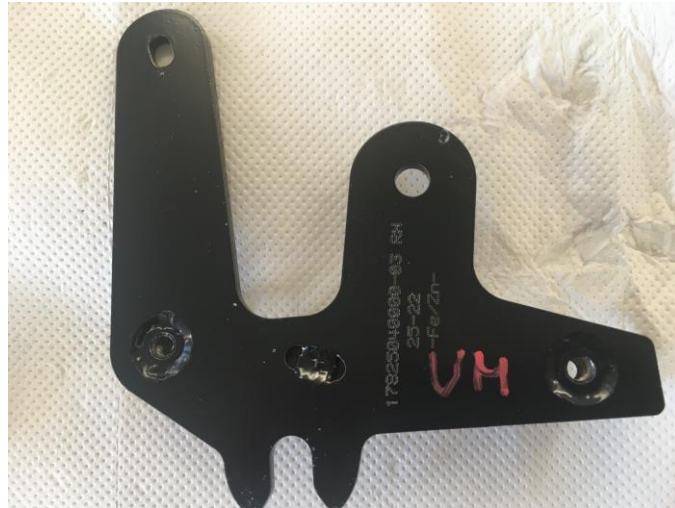
No blistering, no zinc corrosion, no base metal corrosion;  
Cross cut test ISO 2409 rating ≤1

SAMPLE AFTER THE HUMIDITY TEST
