Review Article

A focused review of the hydrogen storage tank embrittlement mechanism process

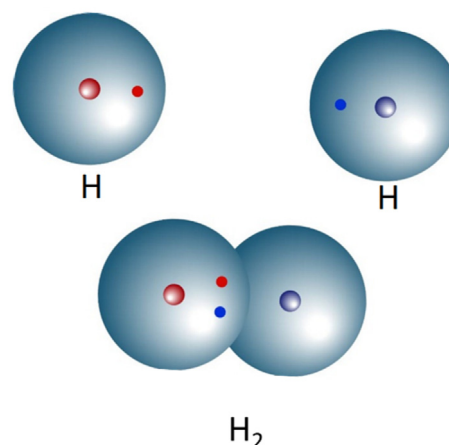
Fig. 1 – Schematic diagram of hydrogen and its molecule.

Hydrogen is the most abundant element in the universe and more than 90% of all atoms are hydrogen. Hydrogen is the simplest atom consisting of one proton and one electron only. Apart from this ordinary isotope called protium, a small fraction of hydrogen atoms exist as deuterium and an even smaller fraction as unstable tritium [19]. If the spins of two hydrogen protons are parallel, the molecule is called ortho-hydrogen and if the spins are opposed, the molecule is called para-hydrogen. Ortho-hydrogen and para-hydrogen have slightly different properties [20]. At standard conditions, molecular hydrogen is a mixture of about 75 vol% ortho-hydrogen and 25 vol% para-hydrogen, which is called normal hydrogen. With a reduction in temperature, the content of para-hydrogen increases and reaches 100 vol% below 200 °C [20]. Para-hydrogen has a lower energy level than ortho-hydrogen and during the liquefaction of hydrogen, additional energy has to be dissipated to convert ortho-hydrogen to para-hydrogen. Due to its single valence electron, hydrogen is very reactive and usually combines to yield the molecule H_2 as shown in Fig. 1.

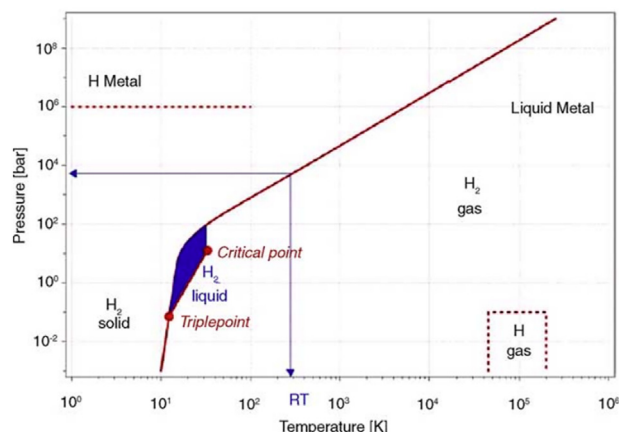
Fig. 2 – Primitive phase diagram for hydrogen [22].

Hydrogen has an ambivalent behavior toward other elements, occurring as an anion (H^-) or cation (H^+) in ionic compounds, forming covalent bonds with carbon [21]. Hydrogen behaves as metal to form alloys or intermetallic compounds at ambient temperature. Fig. 2 shows the phase diagram of the hydrogen.

According to Fig. 2, at low temperatures, hydrogen is solid with a density of 70.6 kg m^{-3} , and a gas at higher temperatures. Furthermore, hydrogen is a liquid in a small zone between the triple and critical points with a density of 70.8 kg m^{-3} at 253 °C. Studies have shown that hydrogen is rarely found in its pure

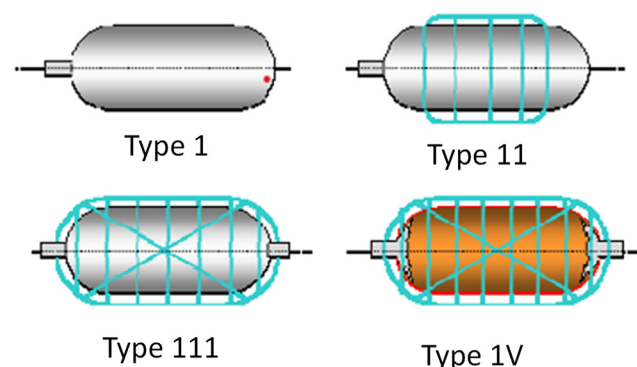
Fig. 3 – Cylinder types for hydrogen storage tanks [32].

Types of hydrogen storage vessels due to several unique hydrogen properties should be compatible with the materials the walls of the storage tanks are made of [37]. As a result, four types of vessels have been developed and used for hydrogen transportation and storage as shown in Fig. 3.

As shown in Fig. 3, type I tanks are seamless containers made of steel or aluminum and are very heavy, with thick walls. Type I tanks are designed for pressures not higher than 25 MPa and can be considered a relatively cheap storage option for some stationary applications [38]. The type I containers offer good properties concerning safety and strength, but at a high weight. The steel type 1 tanks are available with net volumes from 2.5 to 50 L. To reduce the weight, steel

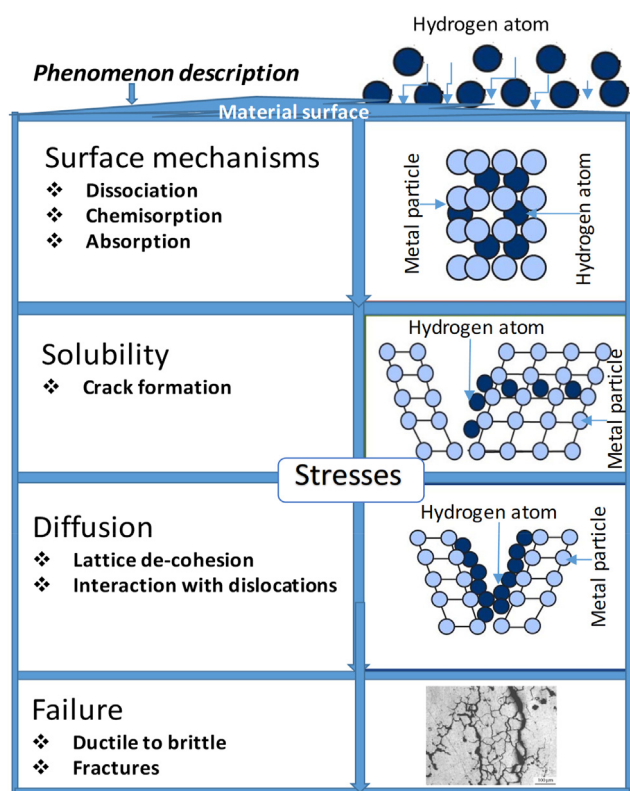
Fig. 4 – Schematic diagram of hydrogen embrittlement mechanism.

Fig. 4 shows the schematic diagram of the proposed hydrogen embrittlement mechanisms in a hydrogen storage tank. In accordance with Fig. 4, hydrogen penetrates the material in aqueous or gaseous state and spreads via various pathways, leading to material failure and degradation. Dissolved hydrogen may exist as atomic or molecular hydrogen, or in a mixed molecular form, once absorbed by a material [68]. Because these molecules are too big to permeate through the material, pressure builds at crystallographic defects (dislocations and vacancies) and discontinuities (voids, inclusion/matrix contacts), resulting in minute cracks. The combination of material strength, external forces, pressure, and

This type of embrittlement occurs when hydrogen is concentrated or absorbed in certain areas of metallurgical defects. As shown in Fig. 4, aqueous or gaseous hydrogen embrittlement mechanisms entail the entry of hydrogen into the material, which reduces its ductility and load-bearing capacity. Stress below the vulnerable material's yield stress leads to cracking and catastrophic brittle failures (see Fig. 4). There are several other mechanisms proposed to explain the hydrogen embrittlement mechanisms in hydrogen-material interactions by different authors [8,69]. Amongst them are hydride formation and fracture mechanism, HEDE and hydrogen enhanced local plasticity (HELP) shown in Fig. 5.

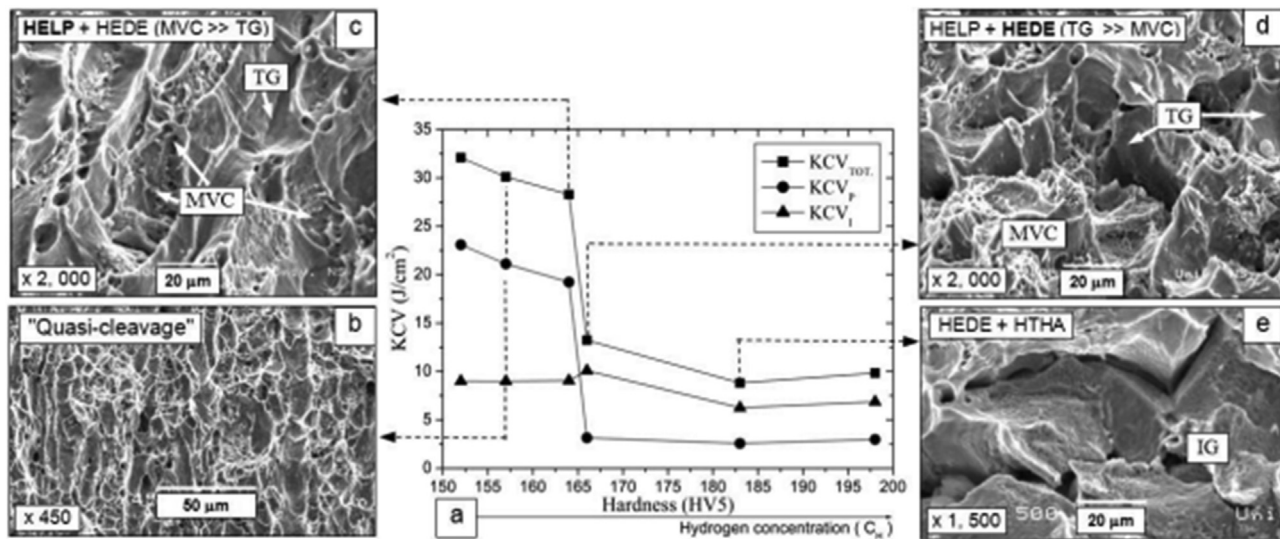
Fig. 5 – Different mechanisms of hydrogen embrittlement of carbon steel showing: (a) Changes in the impact strength (KCVTOT) of a Charpy specimen as a function of the specimen's hardness (hydrogen content), as well as its crack propagation component (KCV_P) and crack initiation component (KCV_I); (b–e) SEM fractography of the examined Charpy specimens' fracture surfaces [70].

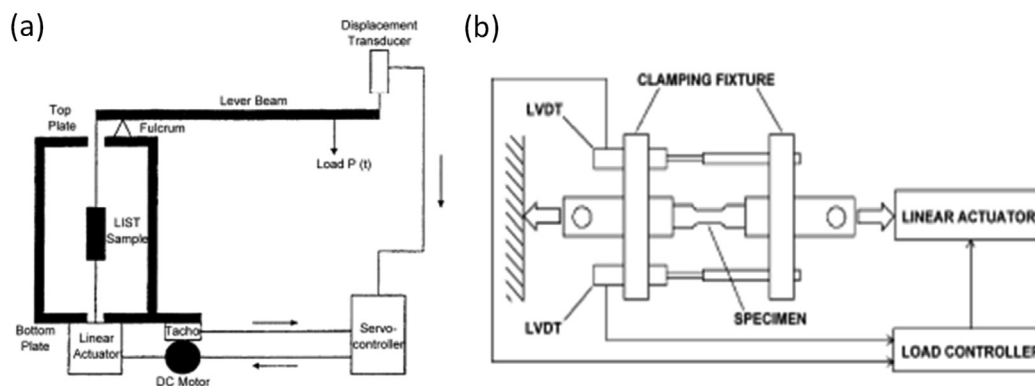
Fig. 6 – Image of the test set-up of (a) LIST and (b) CERT apparatus [73].

However, the constant extension rate test (CERT) and Slow strain rate testing (SSRT) are other methods employed to address the deficiencies of the LIST method. In the SSRT, a constant progressive elongation is applied to the specimen with time till it fails or fractures. Nevertheless, the downside of this testing is that if the sample reaches the threshold limit (threshold stress), it will take longer to fail. Furthermore, the process is a time-consuming method, and a fresh revolutionary technique is required. The CERT test provides the capacity to relate SCC to strain rate in addition to providing information about the critical strain rate at or below which susceptibility to SCC occurs. For instance, in some alloy systems, reducing the strain rate first results in a decrease in the failure strain and time to failure, then a return of the ductile values at extremely slow strain rates. The specimens are tested in the CERT at 600 °C in a salt media with initial strain rates ranging from 4×10^{-8} to $2 \times 10^{-5} \text{ s}^{-1}$. When tested in molten salt, the structure of the oxide film on the specimens is altered by the continual deformation that is applied. The LIST and CERT methods are depicted schematically in Fig. 6.

the servomotor, a tach0 generator generates an analogue signal proportional to the motor's direction and velocity; this signal is used as feedback to the servo controller, allowing accurate control of the velocity and acceleration. One challenge encountered while doing these tests is that the component does not fail in a definite or predictable length of time, and fracture or failure takes a long time to occur.

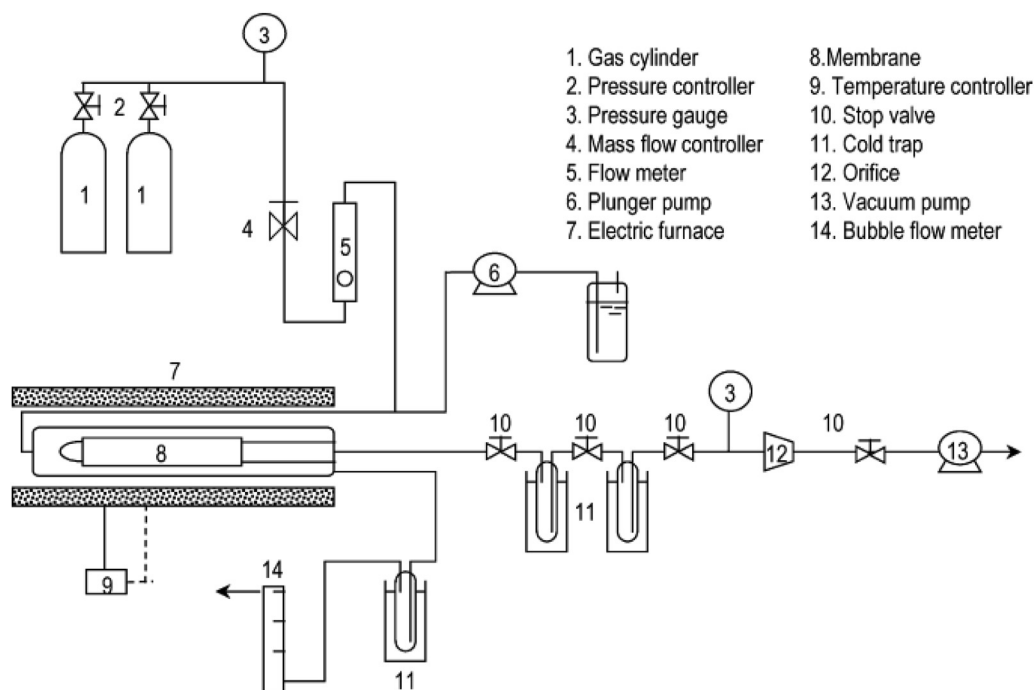
Fig. 7 – Schematic diagram of experimental apparatus [78].

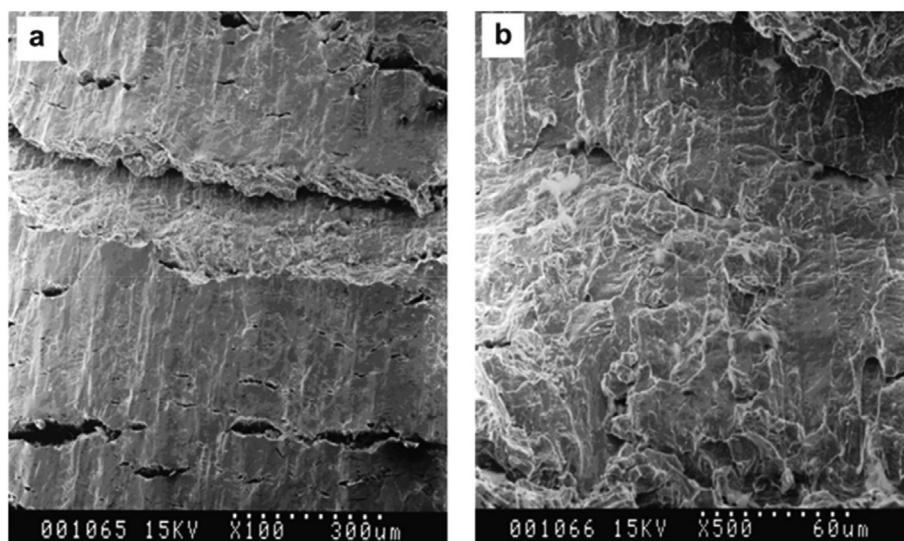
Fig. 8 – Shows a SEM image taken at a secondary crack after 48 h of cathodic charging in 0.1 M H₂SO₄ for a sample of 12% plastic strain; (a) the image shows the exterior surface and (b) a close-up of the secondary fracture [79].

The electron gun, which is located at the top of the column of the SEM, generates the electrons and accelerates them to energies ranging from 0.1 to 30 keV. A high-resolution image cannot be formed because of the diameter of the electron beam that the hairpin tungsten cannon produces. Therefore, the electron beam is focused, defined, and formed into a narrow-focused electron spot on the specimen using electromagnetic lenses and apertures. With this method, the electron source's size (around 50 mm for a tungsten filament) is reduced to the desired spot size (1–100 nm). It requires a high vacuum to prevent air from scattering electrons as they move. Real-time observation and image capturing of the specimen surface are made possible by the specimen stage, electron beam scanning coils, signal detection, and processing equipment. In addition, compared to other techniques, sample preparation is simpler and a three-dimensional image of the fractured surface and secondary cracks morphology is also produced by SEM as shown in Fig. 8.

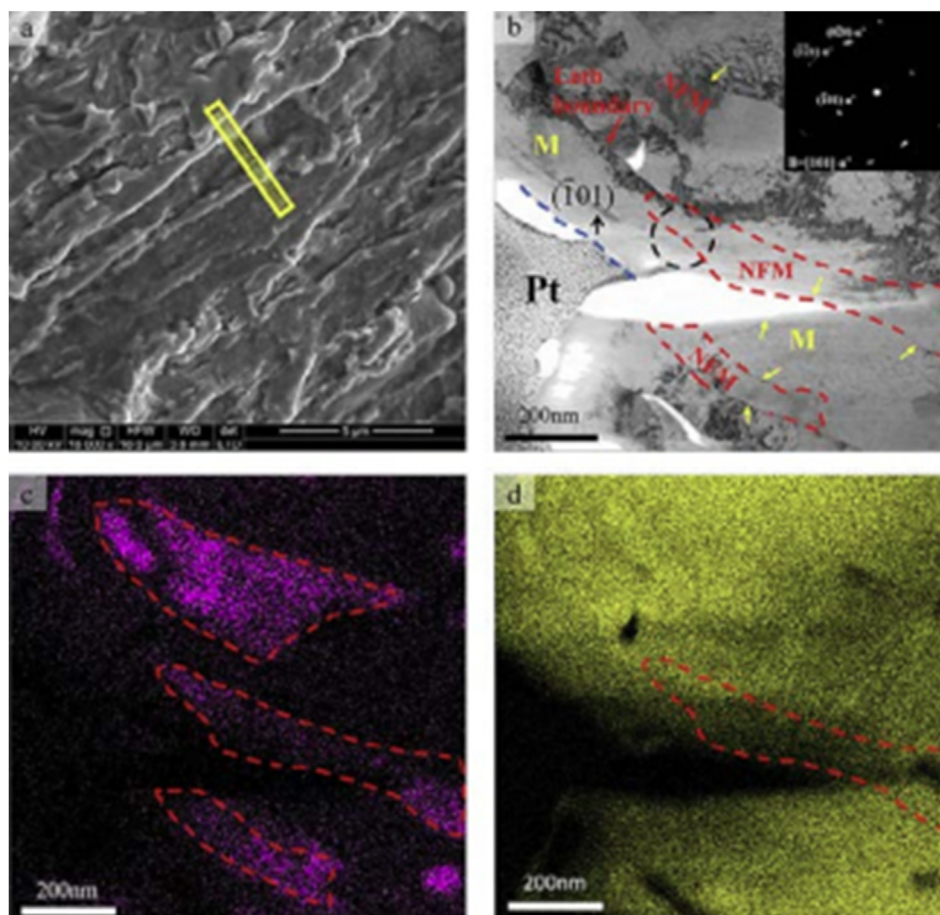
Fig. 9 – TEM images depicting the microstructure beneath the fracture surface and the behavior of crack propagation in DT samples subjected to dynamic hydrogen charging. **Fig. 9a**, FIB sample extraction position, **9b** shows the bright-field picture and accompanying SAED pattern, **9c** is the EDX elemental mapping of Ni in **9b**, and **9d** is the EDX elemental mapping of Fe in **9b** are all examples of information that is given. Phase boundaries are indicated by yellow arrows [81]. (For interpretation of the references to colour in this figure legend, the reader is referred to the Web version of this article.)

interactions, and some of the more beneficial ones are those that result in quantifiable effects. The simulations that follow allow for individual interactions between high energy electrons typically 20 keV or higher and a single aluminum atom. This atom donates three electrons to a valence band or conduction band and is thought to be a component of a solid metallic specimen. Fan et al. [81] investigated the role of reversed austenite in hydrogen embrittlement fracture of a martensitic stainless steel using TEM for the microstructural analysis as shown in Fig. 9.
