# Breakwater revetment made from Elastocoast® in Harlingen (the Netherlands)

## Case Study

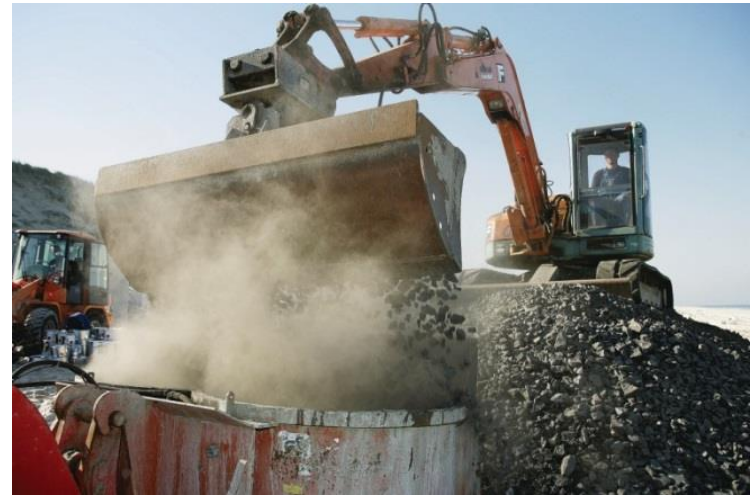
The breakwater revetments in the port of Harlingen consisted of concrete elements which are destroyed by now. In order to fill up the space between these elements Elastocoast® was used in combination with small granulate stones. As a result, the surface could be stabilized.

Construction: Granulate gravel (11/16 mm) and Elastocoast®
