Service Information Bulletin

Preventive Workaround to avoid Detector Cable Damaging

DD+DIS039.11E

To inform about a workaround to prevent the detector cable of getting damaged.

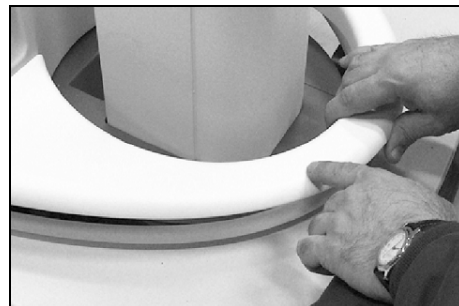
Figure 2

- (2) Disengage the three snaps.

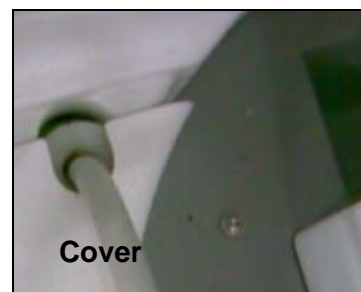
Figure 4

- (4) Pull the detector cable slightly out of the frame.

Make sure there is enough tension on the cable by pulling it upwards.
