MODEL 463 as of model year 2013
/model refinement package 2012

N70 Overhead control panel control unit

P82.20-4006-06

Remove/install

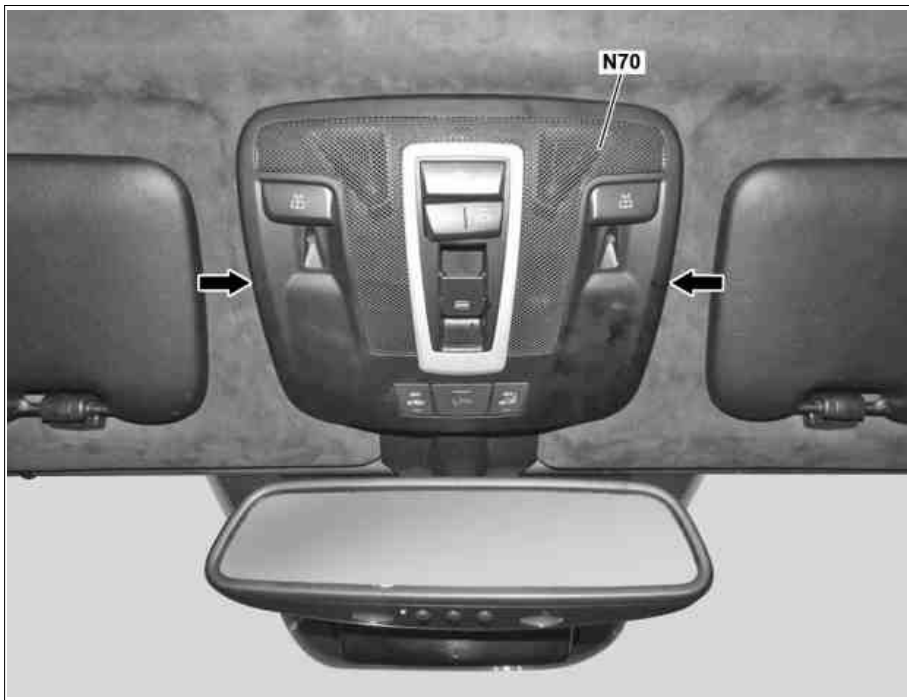
Detach ground line from battery Notes on battery		AR54.10-P-0003GW AH54.10-P-0001-01A
2	Pry side covers (arrows) out of overhead control panel control unit (N70)

*110589035900
3	Unclip overhead control panel control unit (N70) in direction of vehicle interior		
4	Disconnect electrical connectors at overhead control panel control unit (N70)		
5	Install in the reverse order		
6	Check all functions of the overhead control panel control unit (N70)		
7	Read out and erase the fault memory using Star Diagnosis		AD00.00-P-2000-04A
