Coopercabruca site visit 21st Sep 2023

This document established record for FSVP compliance requirements of our site visit to Coopercabruca facility

Facility A - roasting facility

Facility A - cracking and winnowing facility

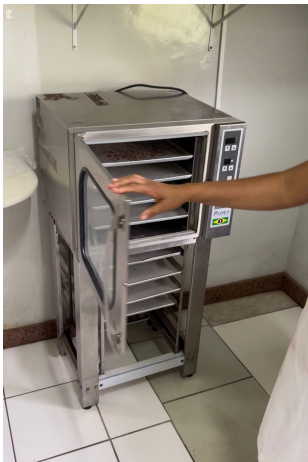
<p>The roasting process itself will kill off the microbial growth.</p> <p>The internal temperature of the cacao nibs during roasting reaches 180°C for 30 minutes.</p>	<p>Equipment observed to be in working order.</p> <p>It's been confirmed that equipment is able to heat up to indicated temperature level and time</p>
	<p>Daily cleaning to ensure properly functioning equipment</p> <p>Required maintenance is performed when malfunction is observed before cacao nibs are processed</p>	<p>Equipment is observed to be in good working order</p> <p>Corrective Action</p> <p>To include instructions on how to use</p>

<p>The stove is sealed during roasting</p> <p>Regular maintenance is done on the stove.</p>	<p>Equipment is observed to be in good working order</p> <p>Equipment is observed to be sealed during operations</p>
---	---	--

Proposed corrective action

- Make instructions on proper usage prominently visible
- Make schedule of maintenance and cleaning prominently visible

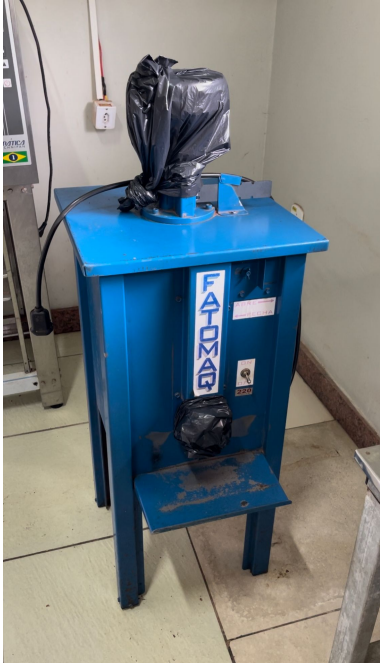
<p>The machine is sealed.</p> <p>Daily cleaning to ensure properly functioning equipment</p> <p>Required maintenance is performed when malfunction is observed before cacao nibs are processed</p>	<p>Machine itself is sealed</p> <p>In between each usage, it's openings are sealed with plastic bag covering to prevent entry of contaminants</p>

Proposed corrective action

- Make instructions on proper usage prominently visible
- Make schedule of maintenance and cleaning prominently visible

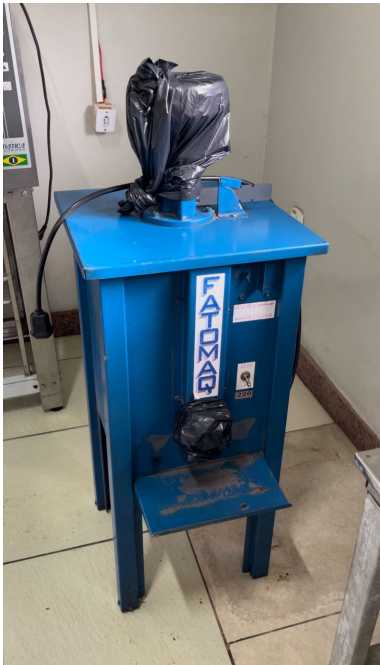
<p>Clean and sanitize winnowing equipment between batches. Implement proper allergen controls to prevent cross-contact.</p> <p>The facility only processes cacao nibs</p>	<p>No other materials were observed to be processed at operating facility other than cacao nibs</p>

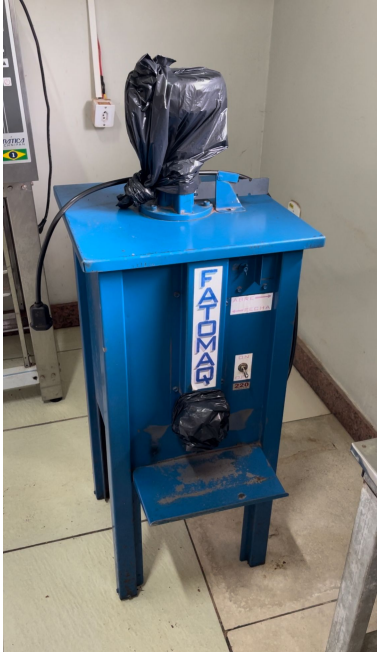
<p>Use proper cracking and winnowing equipment to minimize shell fragments. Implement visual inspections and sieving to remove foreign materials.</p> <p>Workers are to wear hair mesh and gloves.</p>	<p>Its been observed proper cracking and winnowing equipment is in use to automate removal of shell fragment</p> <p>Hair mesh was seen worn.</p>
---	--	--
