WINTER GRAPPLE YARDING IN THE INTERIOR OF BRITISH COLUMBIA

Dennis Araki, R.P.F.

Abstract

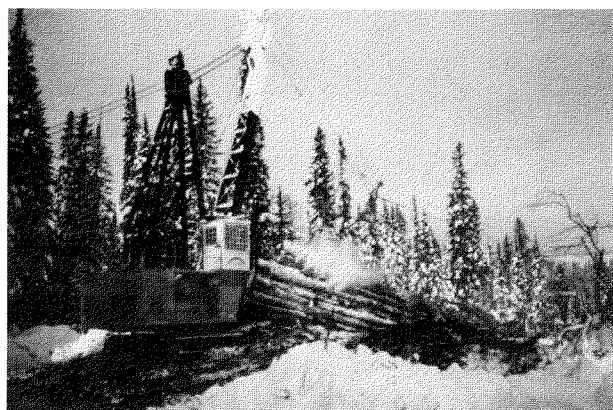
While the Cypress 6280 swing yarder can work in highlead, choker, and dropline yarding, as well as in variations of skyline yarding, in this study FERIC observed it only grapple yarding. The Cypress 6280 swing yarder studied (Figure 1) weighed approximately 57 000 kg. The boom height was 18 m and the gantry height was 12.7 m. The machine was capable of yarding up to 600 m with a maximum bare-drum line pull of 29 500 kg. The yarding equipment also included

Figure 1. Cypress 6280 swing yarder operating in winter conditions near Prince George.

a Mitsubishi MS 120 excavator as a mobile backspare, and a Caterpillar D8 tractor as a mobile guyline anchor. A Hitachi hydraulic log loader put the yarded stems onto off-highway logging trucks that transported them 5 km to a sortyard where buckermen manufactured the stems into logs; the logs were then reloaded onto off-highway log trucks. FERIC monitored only the grapple yarder performance during this study.
