Copyright (c) 2021 Jake Little  
Licensed under the MIT License.  
[github.com/Upcycle-Electronics/game-and-watch-hardware](https://github.com/Upcycle-Electronics/game-and-watch-hardware)

**Title: G&W**

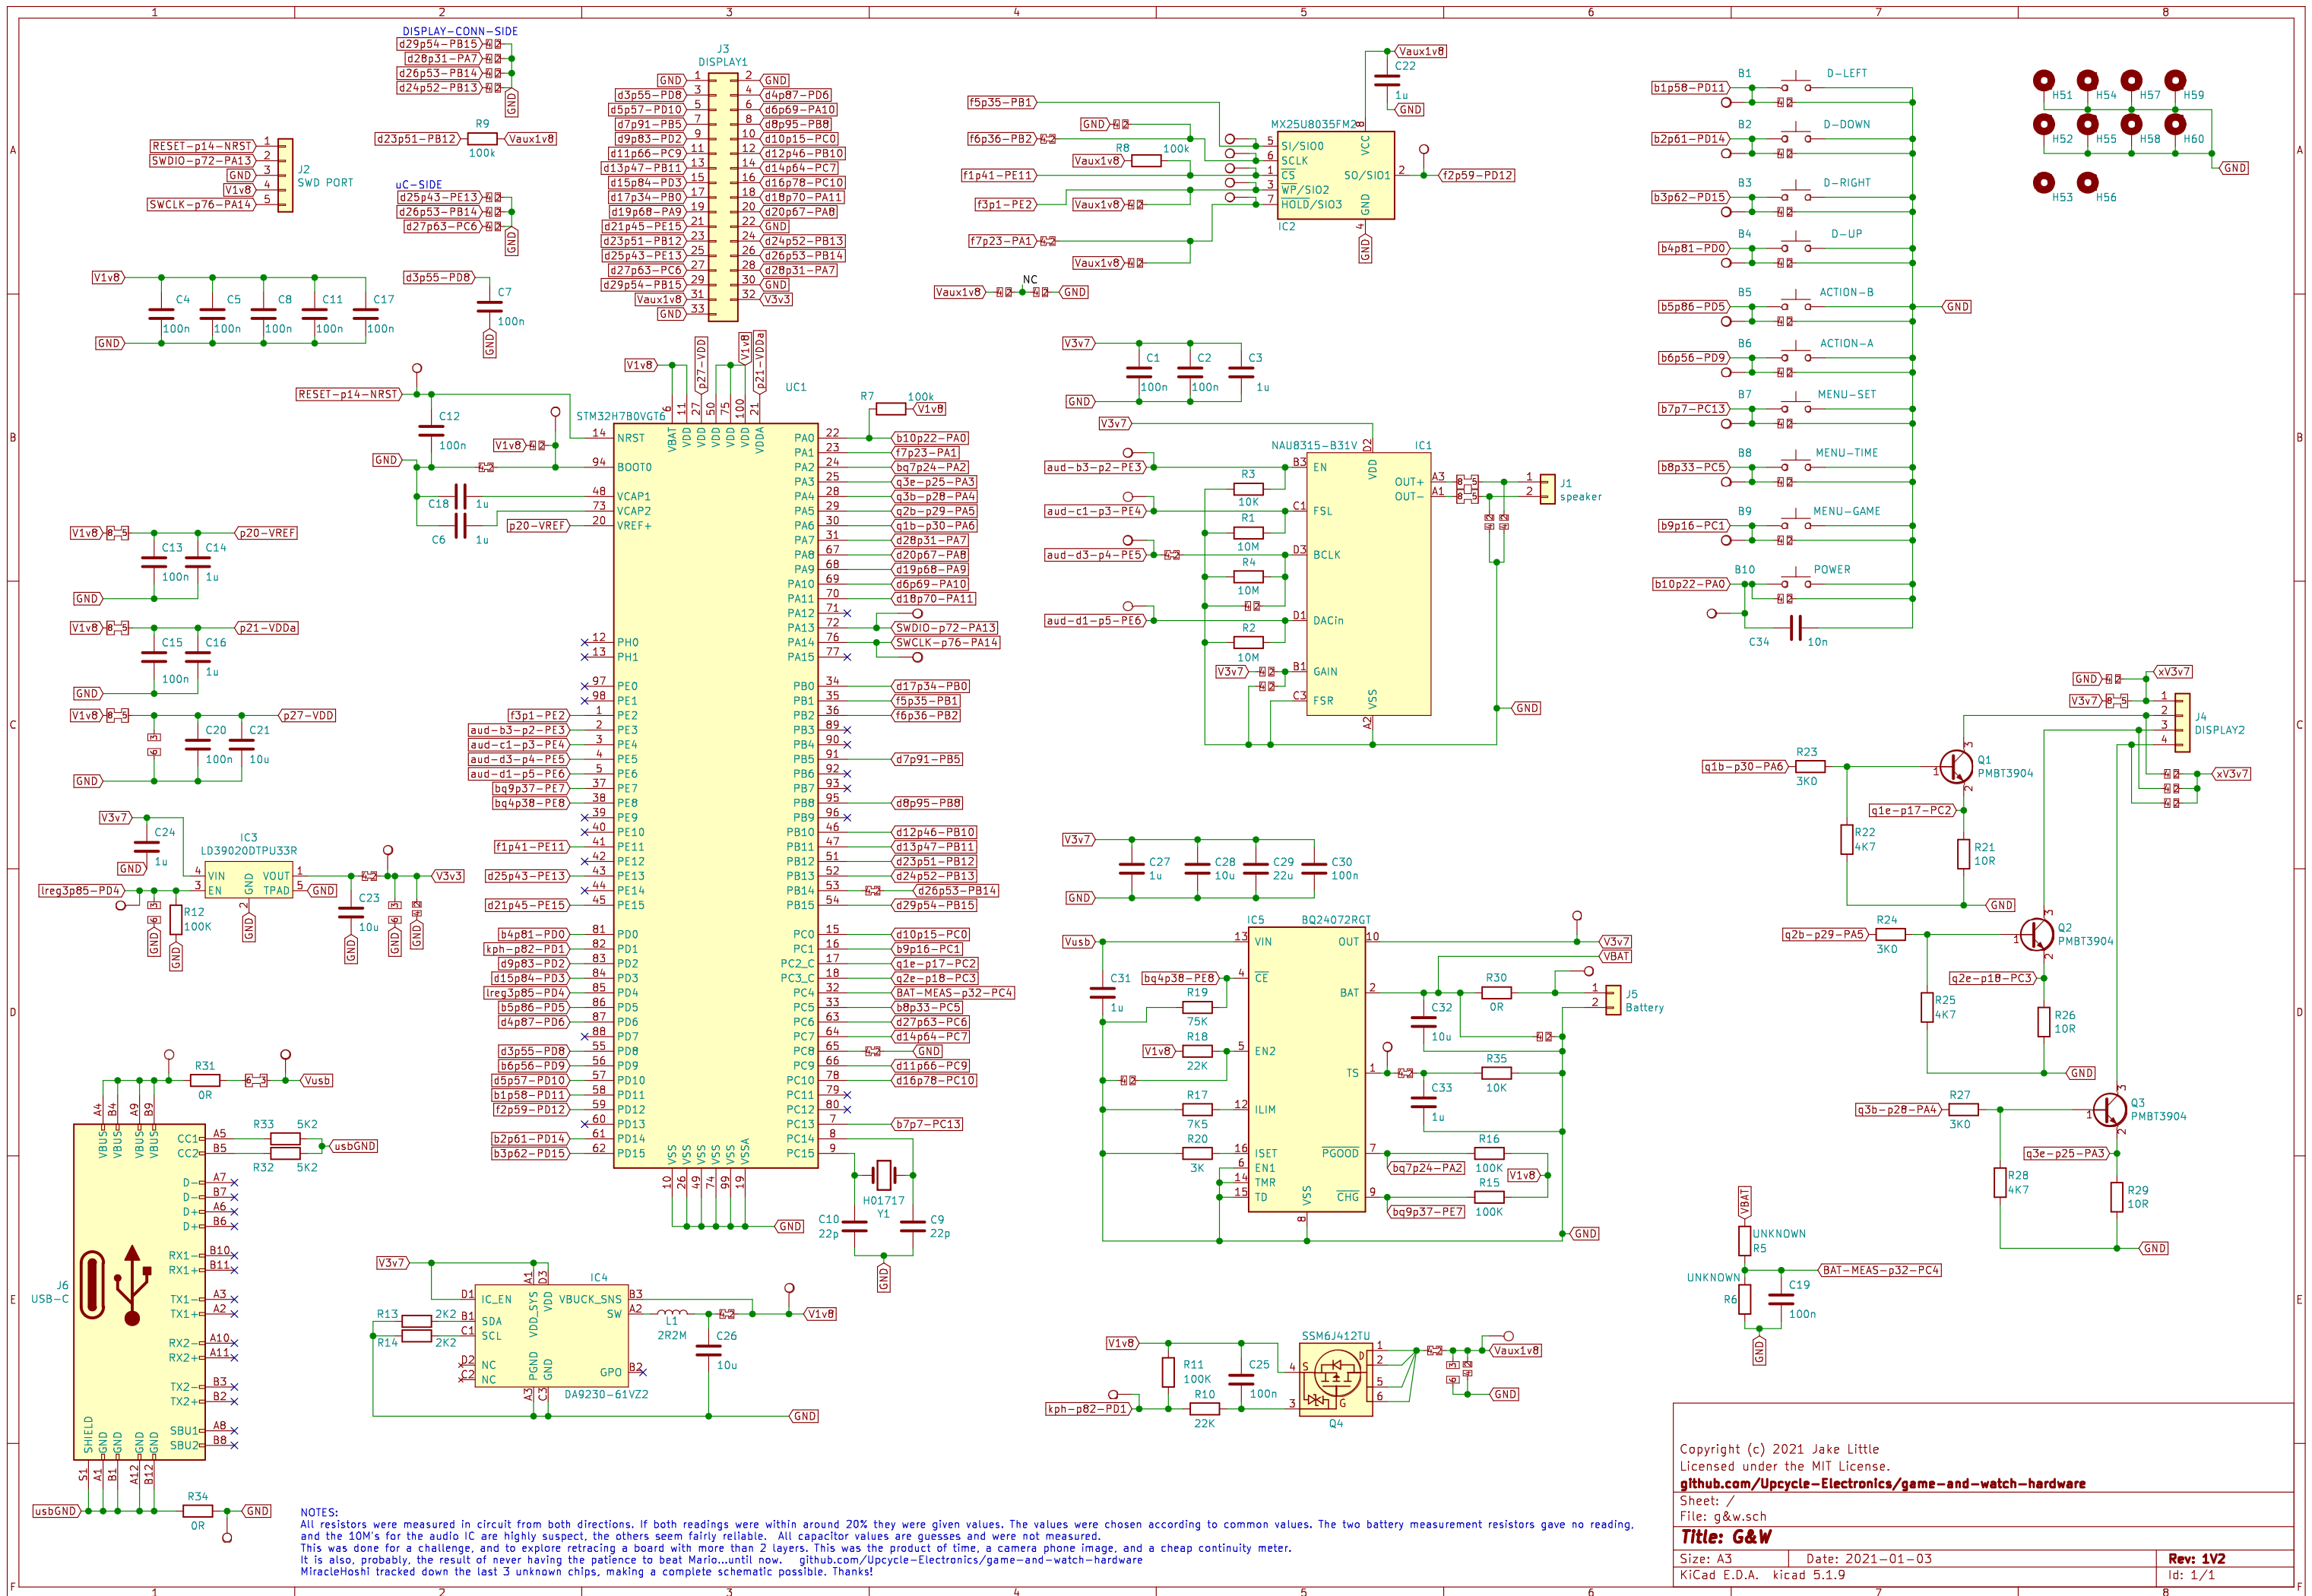
Sheet: /  
File: g&w.sch

NOTES:  
All resistors were measured in circuit from both directions. If both readings were within around 20% they were given values. The values were chosen according to common values. The two battery measurement resistors gave no reading, and the 10M's for the audio IC are highly suspect, the others seem fairly reliable. All capacitor values are guesses and were not measured. This was done for a challenge, and to explore retracing a board with more than 2 layers. This was the product of time, a camera phone image, and a cheap continuity meter. It is also, probably, the result of never having the patience to beat Mario...until now. [github.com/Upcycle-Electronics/game-and-watch-hardware](https://github.com/Upcycle-Electronics/game-and-watch-hardware)  
MiracleHoshi tracked down the last 3 unknown chips, making a complete schematic possible. Thanks!
