Development and Experimental Testing of a Health Monitoring System of Electro-Mechanical Actuators for Small Airplanes

Abstract—This paper reports the preliminary results of the REPRISE (Reliable Electromechanical actuator for PRImary Surface with health monitoring) project, which aims to design a novel Electro-Mechanical Actuator (EMA) to be used on primary flight surfaces of small aircrafts. An important element of the actuator control system is a Health Monitoring (HM) module. This component is an algorithm able to detect anomalies in the device even if there is no evident loss of ability in pursuing its main function (position tracking). In particular, the project aim is to identify any degradation in the mechanical transmission elements, the ballscrew and other components such as bearings. Moreover, it is strongly advisable that the HM algorithm is based on a feature whose value can be easily computed and monitored during the actuator life. In this work, a large experimental activity has been carried out with the purpose of bringing the actuator close to failure, by progressive fault injection in overload operating conditions. A feature named Σ , that is, the mean of the RMS

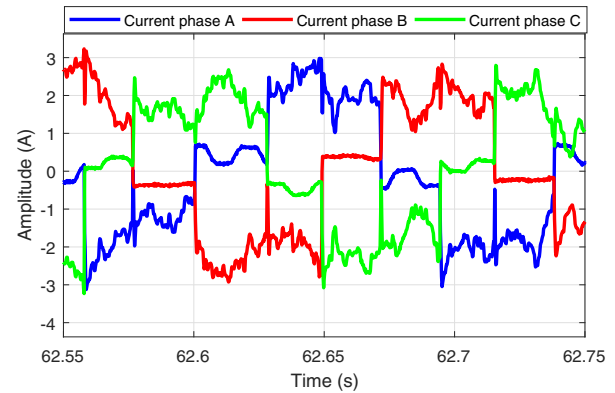
Fig. 4. Example of phase currents measurement

Consider the three phase currents $i_a(t)$, $i_b(t)$, $i_c(t)$ (see Figure 4 as example) measured during an experiment. Since the reference trajectory are sinusoids, the measured position is approximately $x(t) = A \sin(\omega t)$, being A the reference

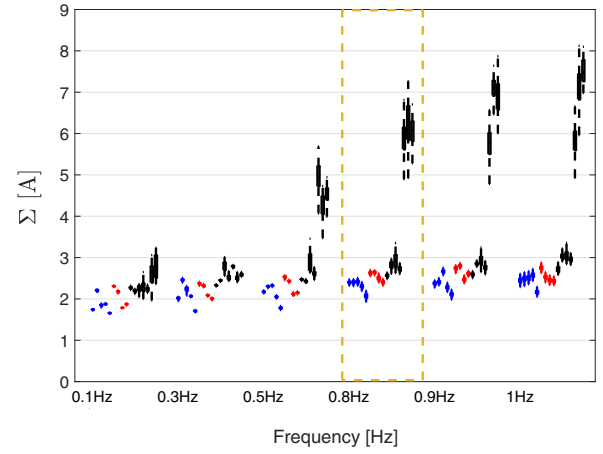
Fig. 5. Sampling distributions of Σ at different dates and frequency values. The evidenced part at 0.8 Hz has been depicted in Figure 6

The sampling distribution of the elements of Σ is used to represent and explain the results. Specifically, in Figure 5 box plots at different dates and frequency values are represented. There are 6 groups of box plots, one for each frequency (0.1 Hz, 0.3 Hz, 0.5 Hz, 0.8 Hz, 0.9 Hz, 1 Hz); each group is made of 16 box plots, one for each test date. Each box plot represents the median, the 75th and 25th percentiles, the maximum and minimum values of the available values of $\Sigma(n)$. So, Figure 5 represents the time evolution of the sampling distribution of $\Sigma(n)$ as a function of frequency. From Figure 6 it is clear that changing the operating conditions of the system brings to a change in the statistical distribution of Σ . Specifically, in normal operating condition (but for the load exceeding the nominal one), the feature median value is slightly decreasing (due to the breaking in of the mechanical components) and its variance is very small. This last characteristic is kept also after that the lubrication is slightly reduced, but with larger median values. The loss of lubrication leads, first, to a rapid increase of the variance of the distribution; second, to a very large increase both in the median value and the variance. Currently, the research work is devoted to the definition of a terse indicator that takes into account this behaviour. The fact that, in Figure 6, the median of the boxplots decreases with time at first instance can be due to the break-in of the actuator. Since Σ can be influenced by load conditions, it follows that a possible test for degradations has to be performed in controlled conditions.

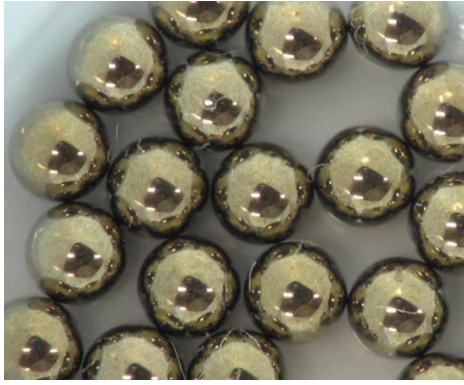
Fig. 7. Balls from one of the circuits after the tests without lubricant. They appear like hammered and opaque.

Figure 6), are stressed and appear like hammered and opaque (see Figure 7). In fact, due to the high contact pressures and the absence of lubricant, the balls could slide instead of rolling. Furthermore, the radial load induces a different contact angle with which the balls work, and so the balls work nearer the screw's crest. The sliding contact produces a material transfer from the balls to the screw thread and a deformation of the thread itself. In Figure 8 it is possible to see the lucid areas into the thread, due to the balls' passage. Finally, in Figure 9 it is shown the thread profile measured in October 2017 with a profilometer with $0.05 \mu\text{m}$ resolution. Notice that the profile is different from the ideal one. In particular, on the left and right side of the thread the balls' pressure has created a channel by plastic deformation, moving the thread material away from the contact point with the ball (on the sides) and pulling it in the center of the profile.

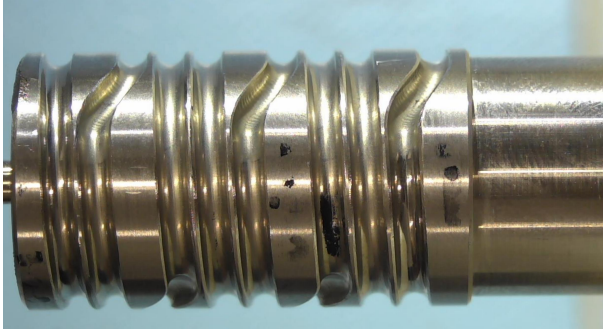
Fig. 8. The screw thread after the tests without lubricant. It is possible to notice the lucid areas where the balls passed, due to high contact pressures.
