# Assessment of intraoral image artifacts related to photostimulable phosphor plates in a dentomaxillofacial radiology department

A Gulsahi, CK Secgin

Department of Dentomaxillofacial Radiology, Faculty of Dentistry, Baskent University, Ankara, Turkey

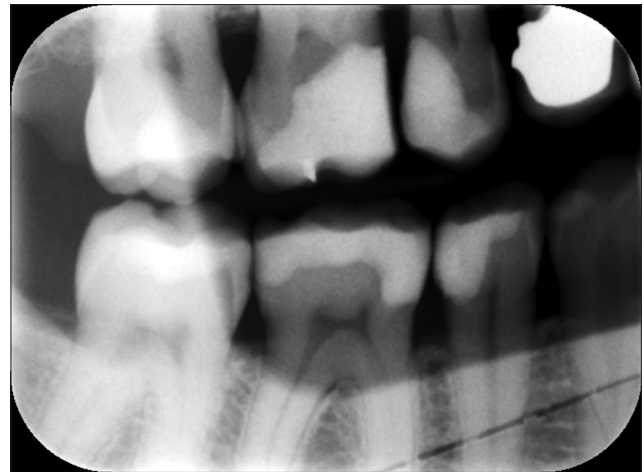
**Figure 2:** Non-uniform image density and an image with an additional horizontal black line

The types of image artifacts most commonly observed and their number percentages are listed in Table 3. These were related to non-uniform image brightness [Figure 1], non-uniform image density [Figure 2], and the movement of the phosphor plates in the disposable packets [Figure 3]. A reduction in the image size displayed after scanning was seen in 0.7% of all the images [Figure 4]. Artifacts related to delayed phosphor plate scanning [Figure 5] and plate surface contamination [Figure 6] were 5<sup>th</sup> and 6<sup>th</sup> most frequently observed artifacts. A few artifacts occurred owing to the phosphor plates being exposed from the backside [Figure 7], because of noisy images [Figure 8], the presence of an

additional horizontal black line after scanning [Figure 2], and the use of damaged plates [Figure 9]; these were seen in only a few images and were detected only in the 1<sup>st</sup> month. The artifact caused by the movement of the phosphor plates in

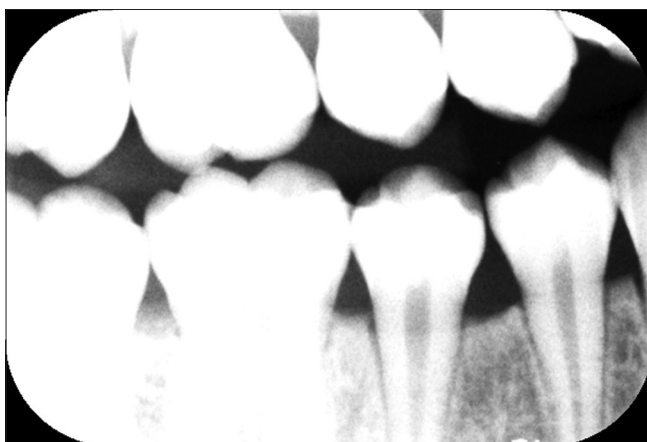
**Figure 5:** Delayed phosphor plate scanning. An image is too bright resulting from a delay in phosphor plate scanning

that PSP plates be scanned no later than 10 min after exposure. If this is not possible, they should be kept in a light-tight environment until scanning.<sup>[16]</sup> One study showed that plates placed in complete darkness before scanning exhibited no change in image quality, even after several days of storage.<sup>[18]</sup>

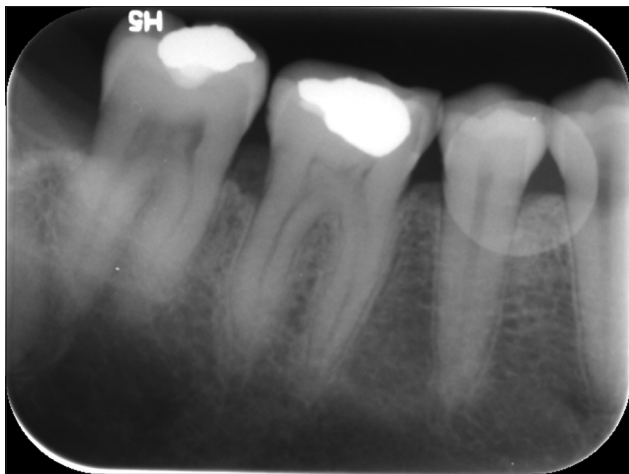
**Figure 7:** Imaging plate exposed backside. A round metal disk becomes visible on the image due to the backward exposure

Artifacts caused by factors such as plate surface contamination, backwards phosphor plate exposure, noisy images, the presence of an additional horizontal black line after scanning, and the use of damaged plates were detected in only a few images in the present study. These artifacts occurred owing to the image recorder's lack of familiarity with the PSP system. Indeed, all of these image artifacts could have been eliminated through sufficient training in PSP techniques. In the Digora® PSP system, phosphor plates exposed backward can be recognized easily because a metal dot is seen in such cases. In contrast to the case with conventional radiography, the resultant image can be corrected by using the mirror function of the image acquisition software that accompanies the PSP system.<sup>[3,12]</sup> Further, the sensors can be physically damaged if they are dropped on the floor or if a patient bites hard into their surface.<sup>[5]</sup> Disposable packets are used for infection control; however, they also act as a barrier against ambient light, and do not provide adequate protection against damage to the plates from bending, pressure from the positioning device, or tooth marks.<sup>[10,12]</sup> In this study, only a few PSP plates were damaged and replaced, mostly in the initial stage of using the PSP system. However, a previous study showed that a large number of PSP plates are usually damaged during imaging.<sup>[12]</sup> Another study concluded that the main reason for the replacement of plates was damage to the phosphor layer.<sup>[10]</sup>

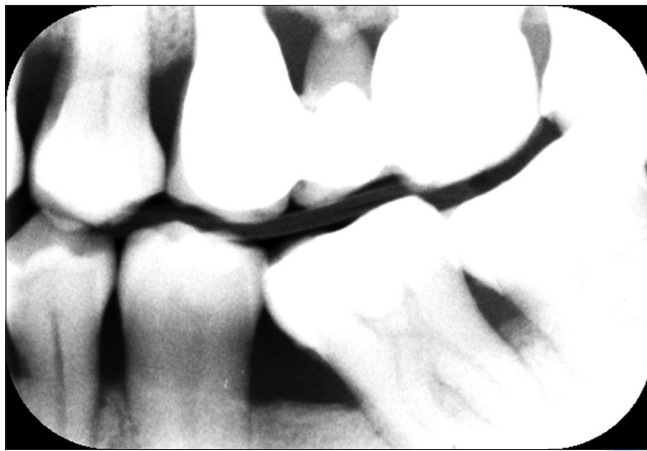
**Figure 8:** A noisy image. Excessive exposure to ambient light between image acquisition and scanning
