### 3.46 Naphthenic Acid Corrosion

#### 3.46.1 Description of Damage

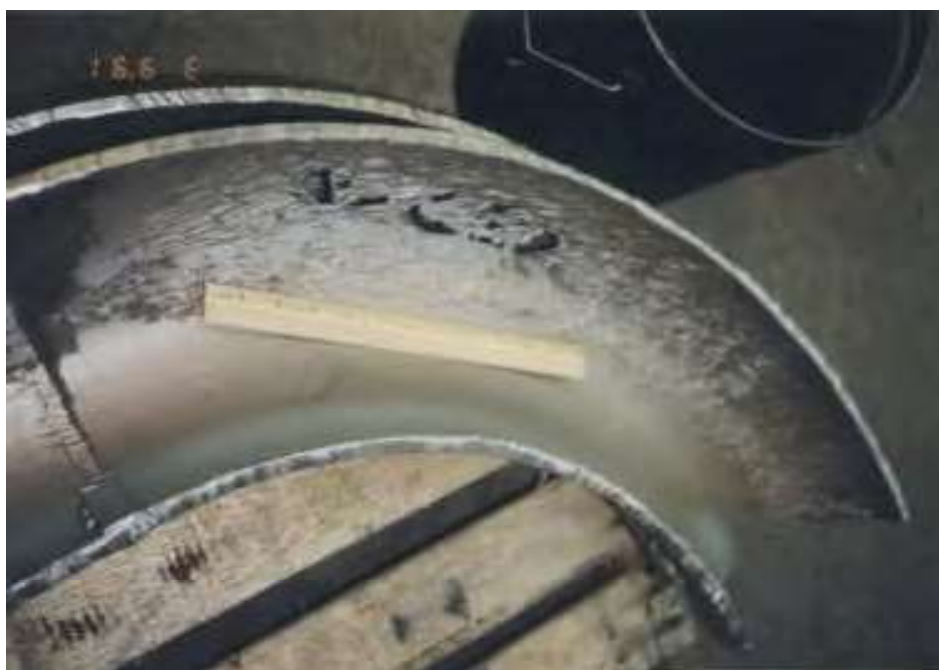
Figure 3-46-1—Erosion-corrosion damage due to NAC in a 10-in. 5Cr- $\frac{1}{2}$ Mo elbow in the outlet of a vacuum heater in a vacuum distillation unit.

- a) NAC is characterized by localized corrosion, pitting corrosion, or flow-induced grooving in high-velocity areas. (Figure 3-46-1 and Figure 3-46-2)
- b) In low-velocity condensing conditions, many alloys including carbon steel, low-alloy steels, and 400 series SS may show uniform loss in thickness and/or pitting.
- c) At temperatures below ~450 °F (230 °C), NAC can have a smoother, more uniform appearance than is typical at higher temperatures.

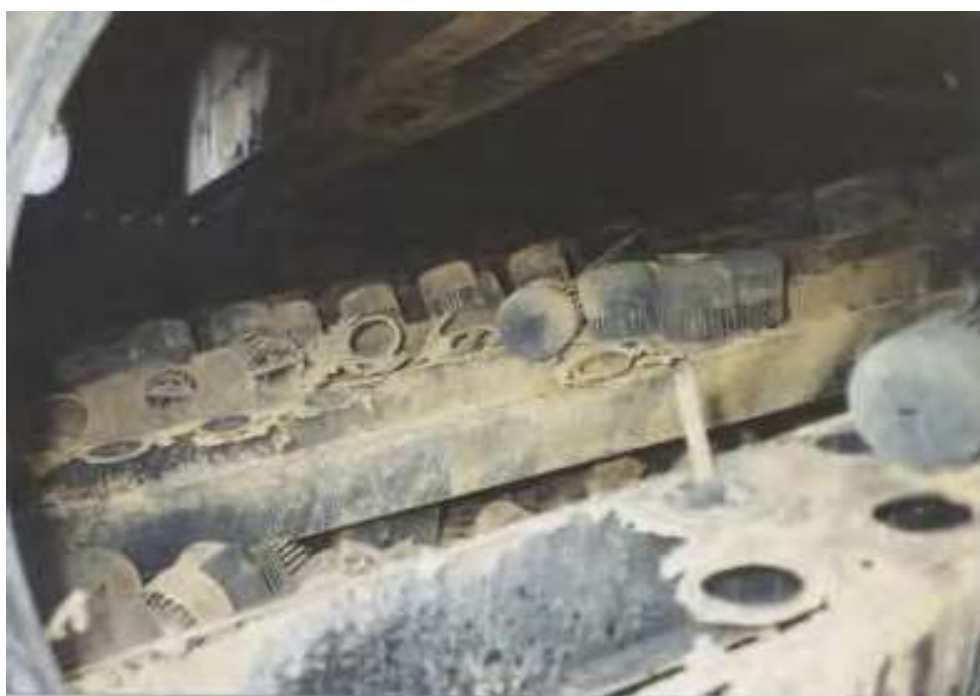
Figure 3-46-2—Severe NAC of 410 SS trays and bubble caps in the HVGO section of the vacuum tower fed by the vacuum heater referred to in Figure 3-44-1.
