Report No. C-16-04

Phase 2 - High Visibility Crosswalk Pedestrian Study: Concept to Countermeasure – Research to Deployment Using the SHRP2 Safety Data

Final Report
March 2020

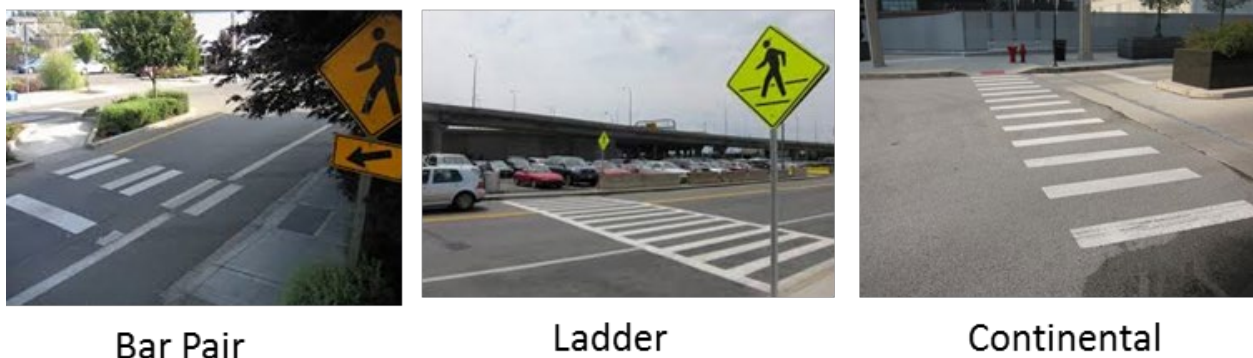
Figure 1. HVC configurations.

The present study focuses on the relatively low cost and widely used pedestrian safety strategy of HVC markings. HVCs feature pavement marking styles including textured pavement, longitudinal, bar-pair, continental, or ladder markings that allow for better crosswalk visibility to the motorists, as compared to conventional pedestrian crossings, especially in cases of high approach speeds ^(13,14). These HVC configurations are shown in Figure 2. There is an ongoing debate in the traffic safety community regarding the effectiveness and placement of HVC markings ^(4,13,14,15). The overall goal of the study is to provide an evaluation of the effectiveness of HVCs in terms of improving pedestrian safety at uncontrolled locations.

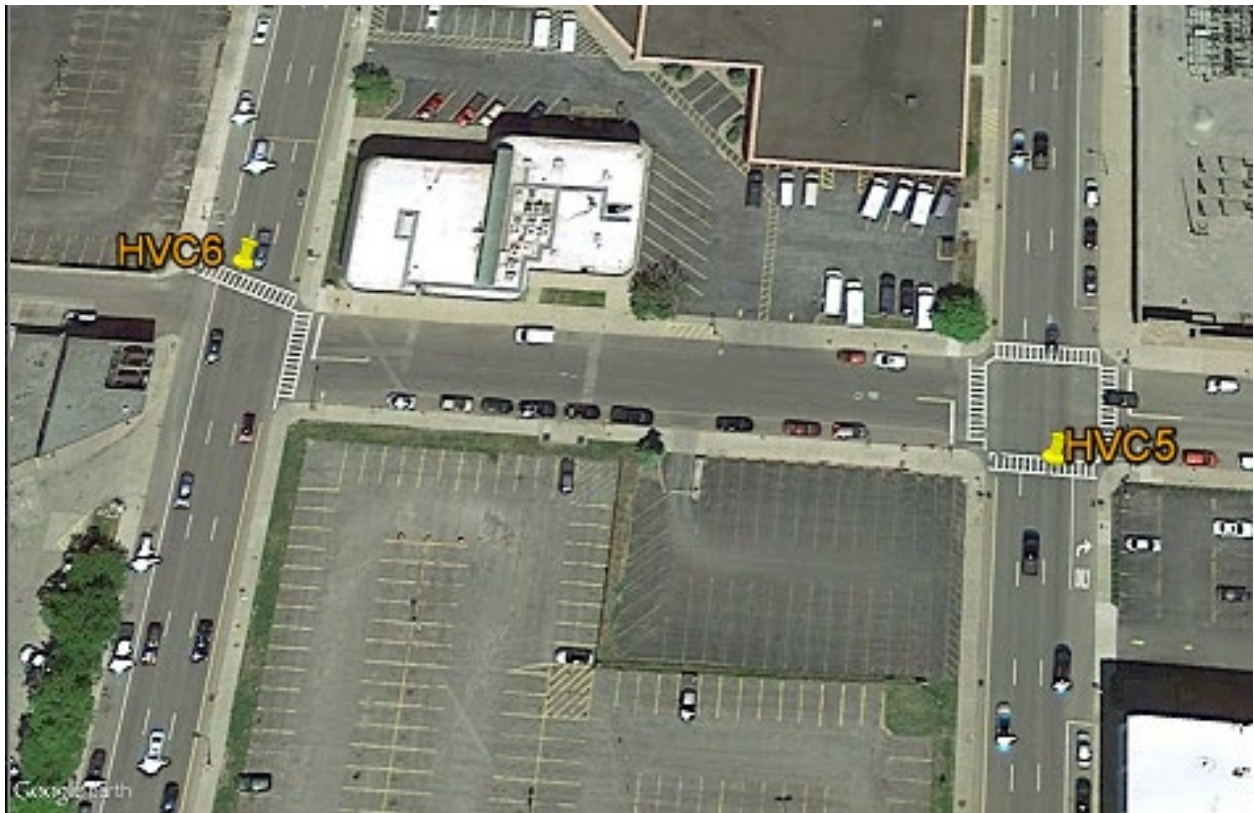
Figure 2. Aerial views of the two HVC locations used in the analysis.

The SHRP2 NDS data offer detailed information on the everyday driving behavior of a large number of participants in six test sites across the U.S. including Buffalo, New York; Tampa, Florida; Raleigh, North Carolina; Seattle, Washington; Bloomington, Indiana; and State College, Pennsylvania. This analysis utilizes a sample of the data from five of the six sites, excluding Bloomington, due to the lack of suitable HVC sites for analysis. The driving behavior of SHRP2 NDS participants was analyzed at 18 uncontrolled locations with HVC markings. The data used for the analysis span was gathered over the three-year SHRP2 NDS data collection period from 2011 to 2013. The sites were selected based on the availability of sufficient traversal data through the locations both before and after the HVC was installed. An example of an aerial view of two of the HVCs is shown in Figure 1.

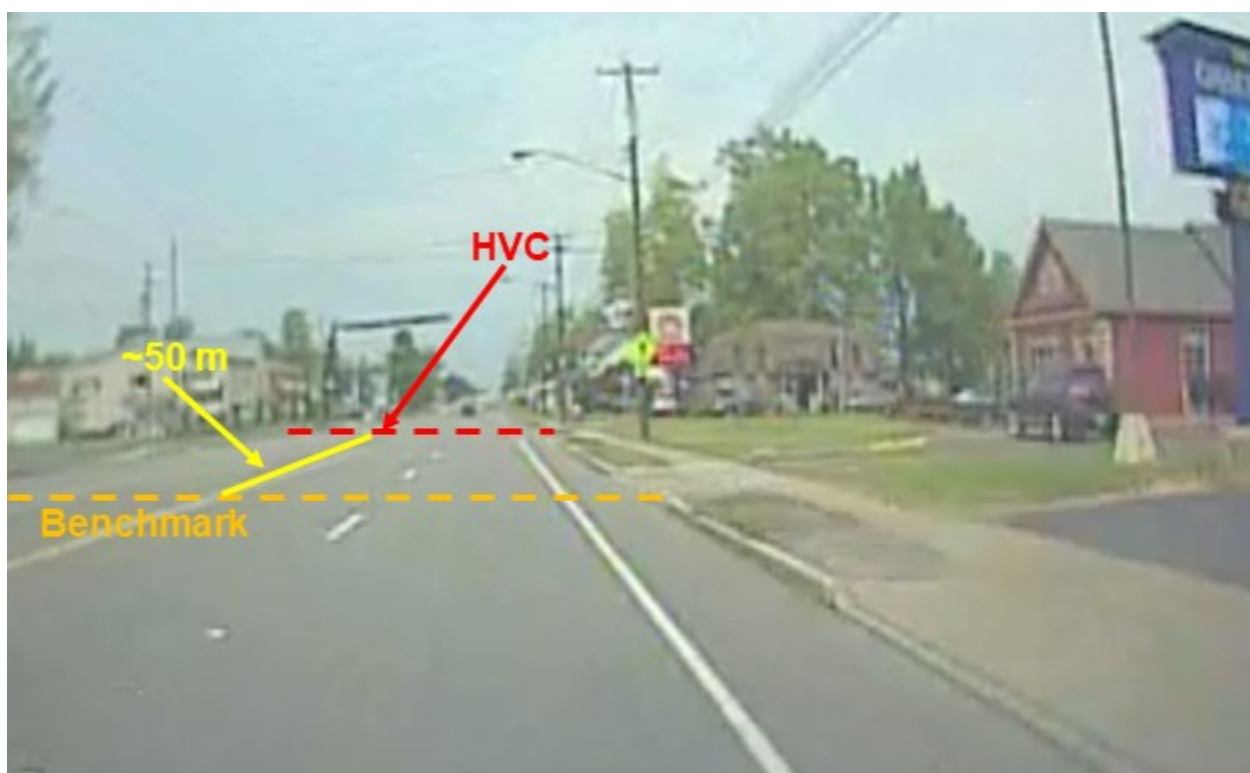
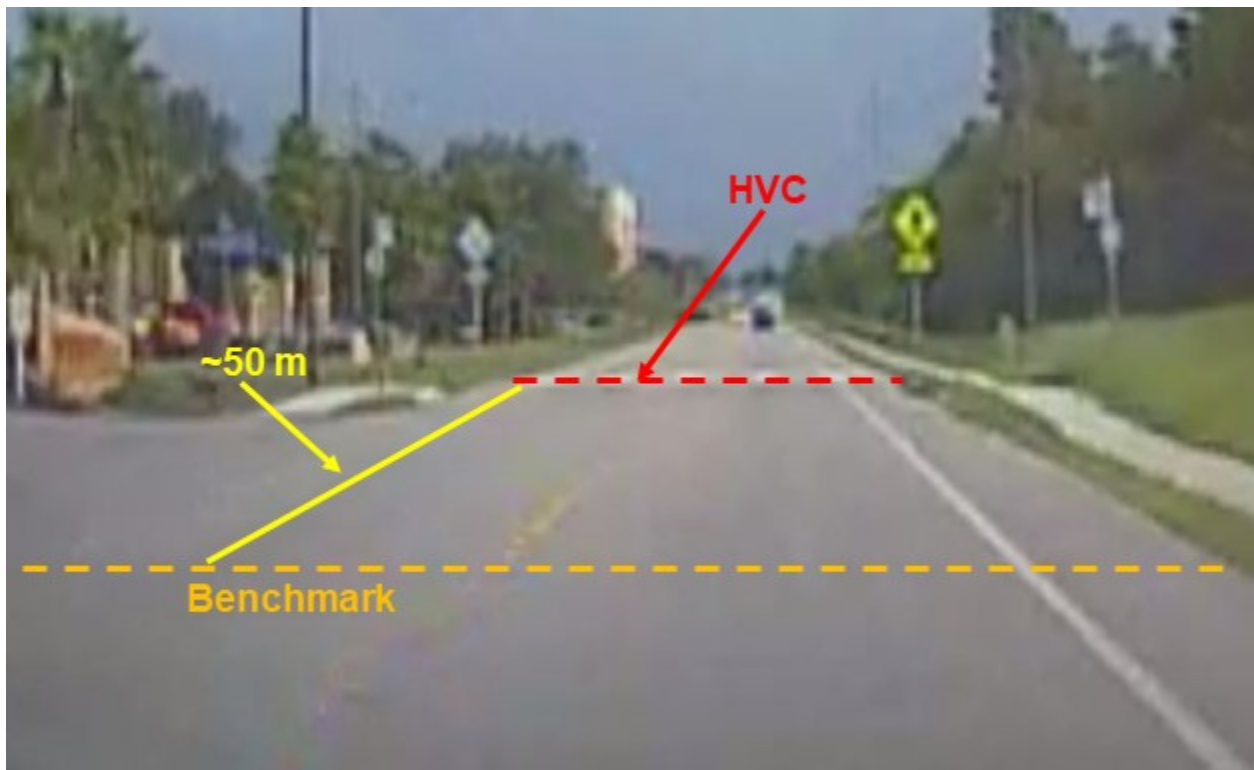
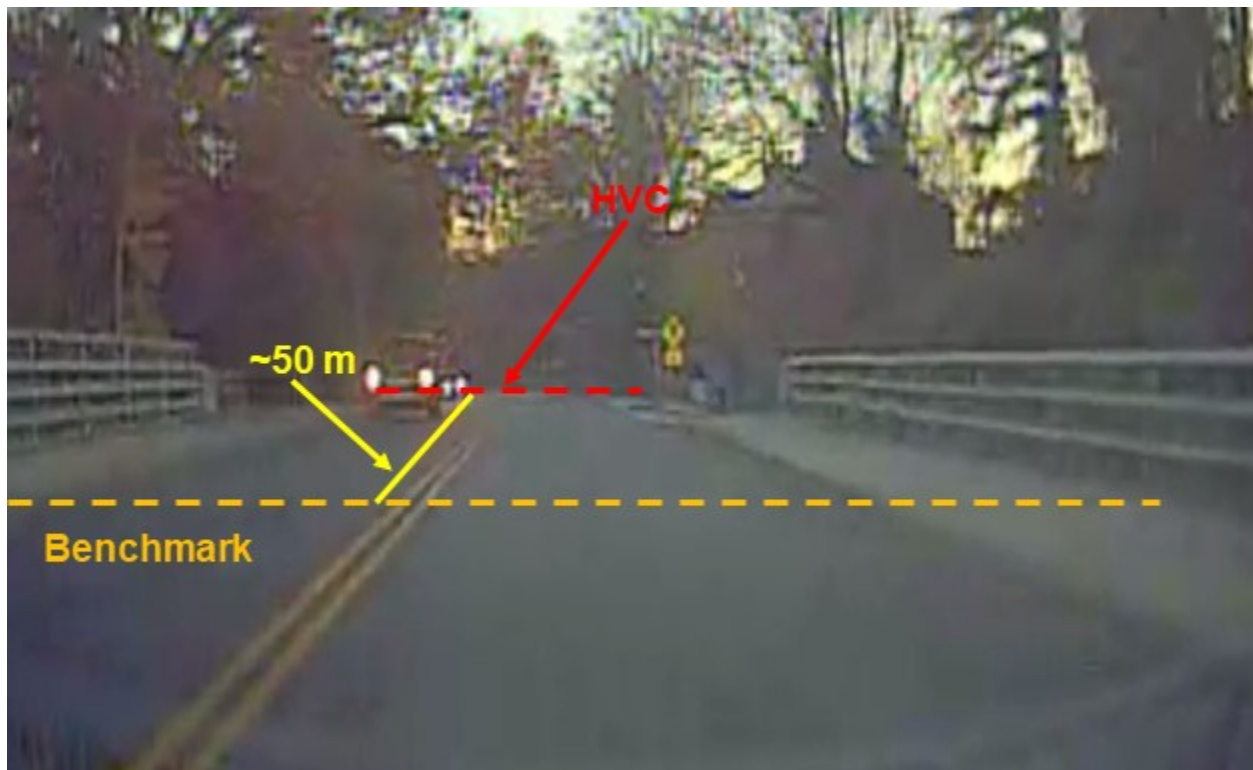
Benchmark points for all locations were determined based on the available visibility of the HVC location from the benchmark point and the stopping sight distance. The main criterion in determining the benchmark location was the identification of the distance, across which drivers will be able to recognize and react to the HVC; to that end, the benchmark point was located 50 m before the crosswalk for all sites. Figure 7 through Figure 19 illustrate the benchmark and crosswalk points for selected HVC locations.

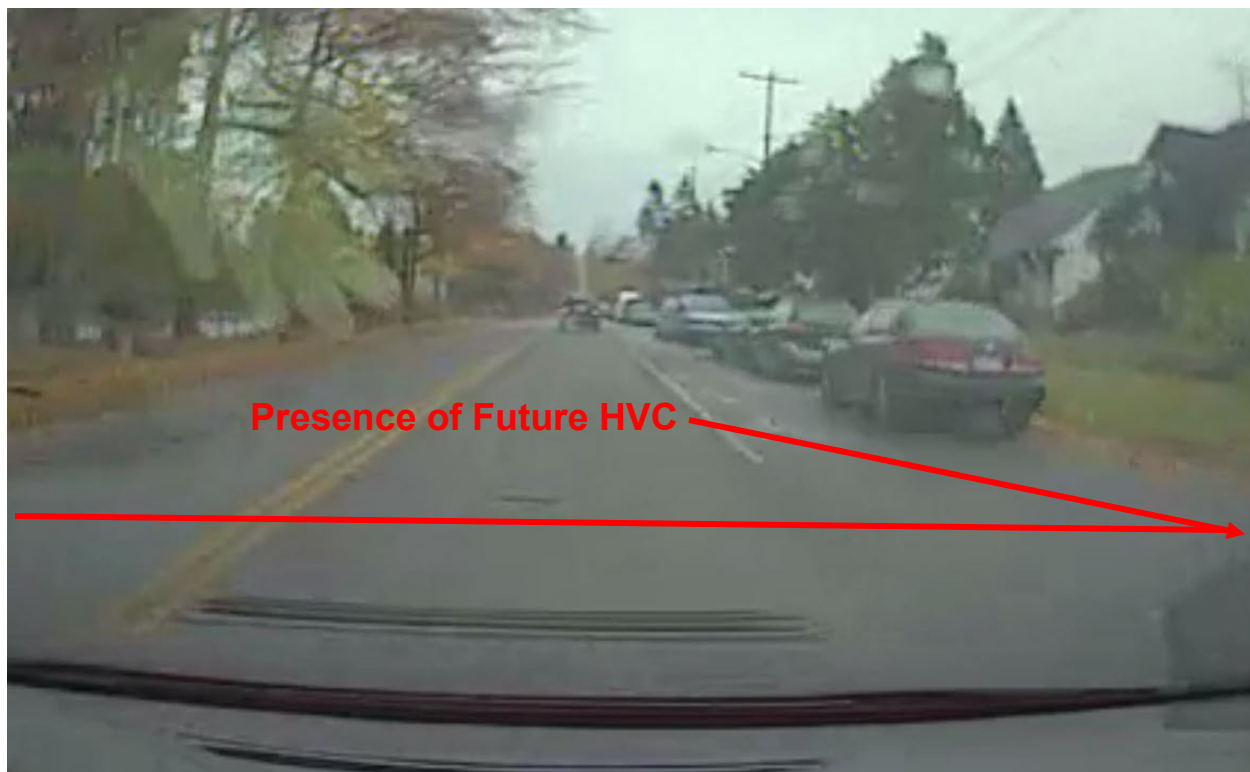
Figure 21. Illustration of HVC fully constructed in HVC site 13.

- The number of on-street parked vehicles visible from the benchmark point. For example, in Figure 21, the number of parked vehicles visible at the benchmark is three. It can also be observed that all three vehicles are passenger cars.

- The timestamp at the HVC location.
- The construction state of HVC. If a HVC is not present then “0” is assigned to the corresponding variable (as seen in Figure 21). If the HVC is fully constructed then “1” is assigned to the specific variable (as seen in Figure 22). If HVC is under construction, the value “2” is assigned (as seen in Figure 23).

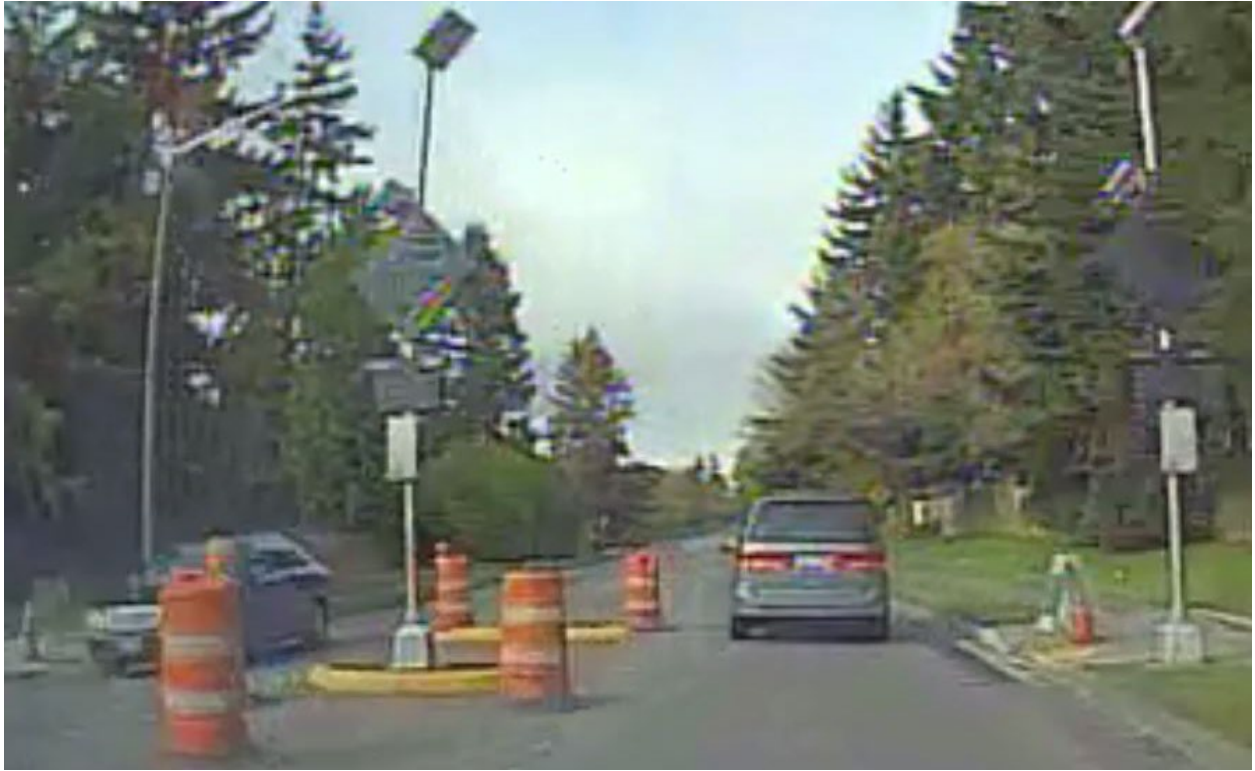
Figure 23. Illustration of HVC under-construction in HVC site 18.

- The number of non-passenger vehicles (other than passenger cars) visible from the benchmark point.
- The presence of lead vehicle as observed from the benchmark point. For example, in Figure 23, a lead vehicle is observed; in this case, the variable indicating the presence of a lead vehicle will assume value of “1”.

- For example, in Figure 28 the windshield condition would be 3 as the video is blurred, whereas in Figure 23 the windshield condition would be 1 as the video appears very clear.

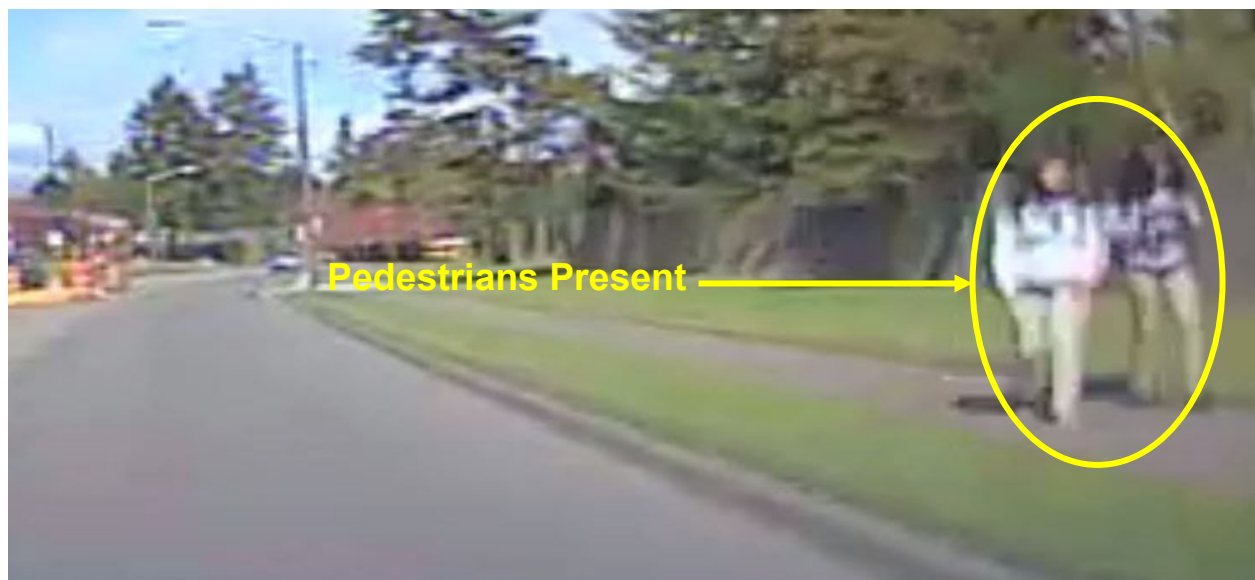
Figure 24. Illustration of presence of pedestrians near HVC site 13.

- The presence of pedestrians who might not be crossing the road but are present at the side of the road: If no pedestrian is present, the corresponding variable is equal to 0; when a pedestrian is present, the variable is equal to 1. If the pedestrian presence cannot be determined, then “-999” is assigned to this variable. As seen in Figure 24, the presence of pedestrians is clearly visible.
- The identification of pedestrians crossing the road anywhere during the trip: The specific variable takes the value “1” if any pedestrian crosses the road anywhere other than the HVC location and “0” if no pedestrian crossings are observed. For example, in Figure 25, a pedestrian is crossing an intersecting road so the value of this variable is “1”.

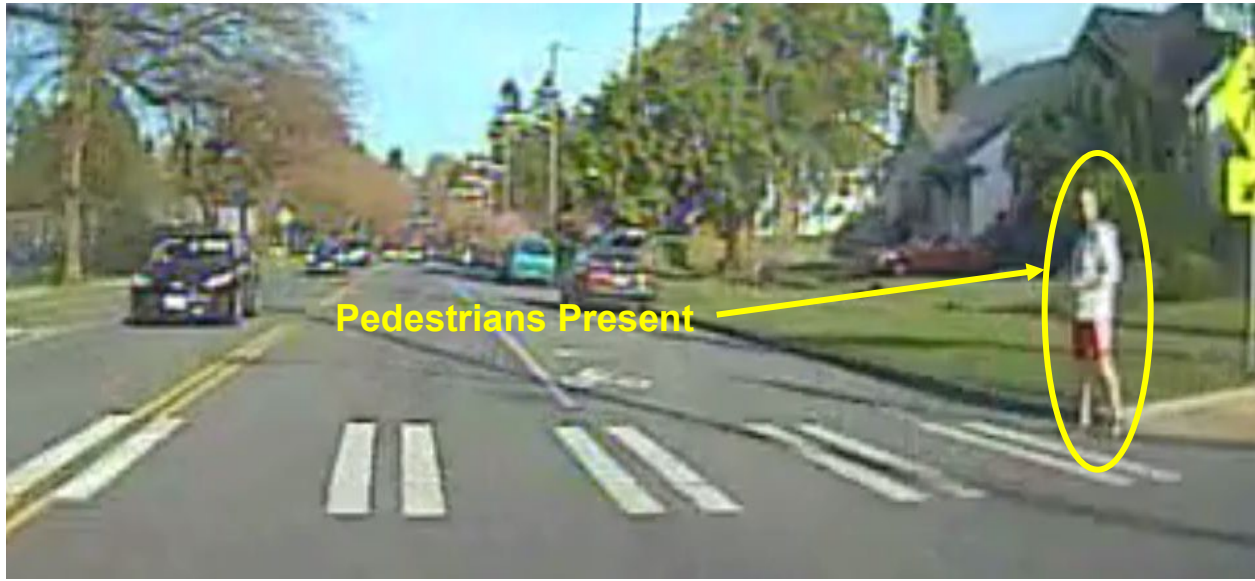
Figure 26. Pedestrian crossing HVC location for a trip in HVC site 13.

- The presence of pedestrians crossing the road near or at HVC location: The specific variable takes the value “1” if pedestrians are crossing the road at HVC, “0” if no pedestrians are crossing HVC, and “-999” if pedestrian crossing cannot be identified. For example, in Figure 26, a pedestrian is crossing the road at the HVC location and therefore the value assigned to the variable is “1”. In Figure 25, the pedestrian is crossing a road other than the road with HVC and in this case, the value of this variable is “0”.

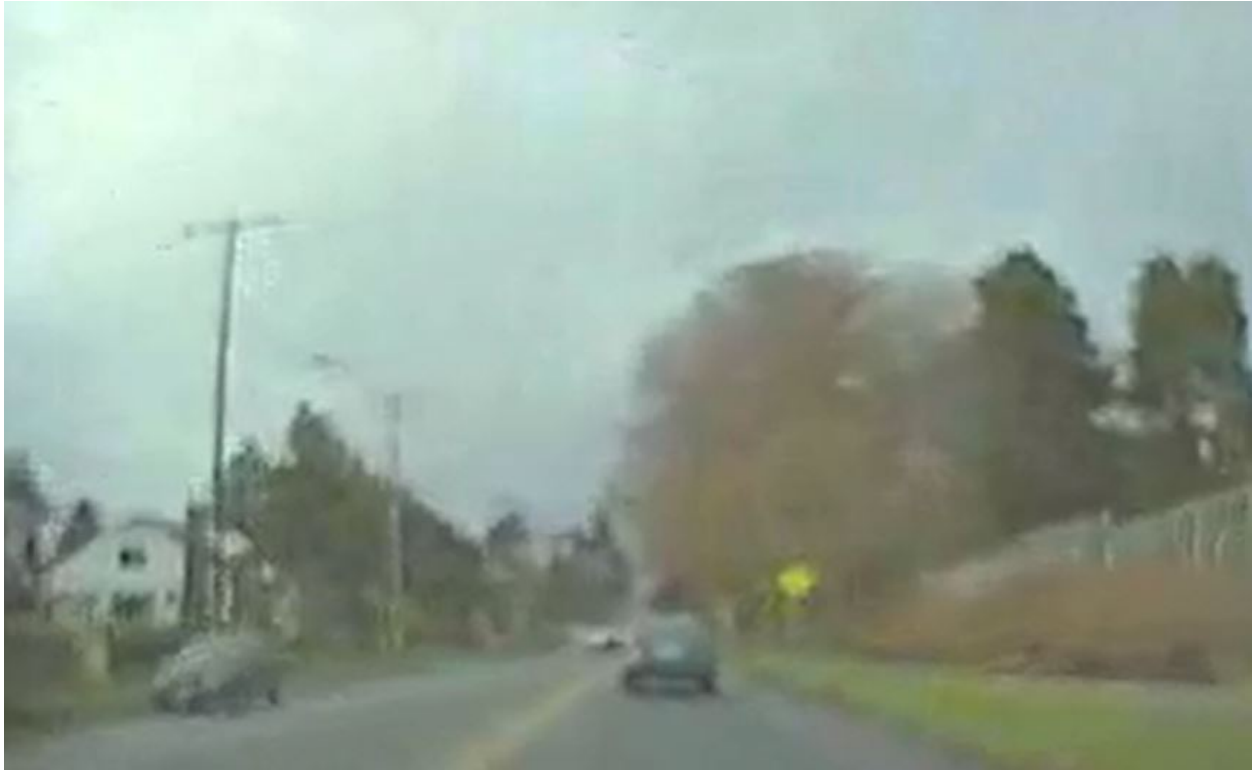
Figure 27. Illustration of cloudy weather (HVC site 13).

- Clear weather = 0,
 - Cloudy weather = 1 (refer to Figure 27)
 - Rainy weather = 2 (refer to Figure 28)
 - Snow = 3 (refer to Figure 29)
 - Foggy weather = 4 (refer to Figure 30)

Information for rows 5,8,11,12-15 and 21 was obtained from the forward-facing video at the benchmark location. This is illustrated in Figure 27. The timestamp at the benchmark can be seen at the lower-left corner of the figure. Presence of pedestrian signs can also be identified. The number of lanes in the direction of travel is 1 and the lane position is 0. The presence of lead vehicle can also be seen from the benchmark location; thus, the variable's value is 1. On the left-hand side of the picture three parked passenger cars can be observed and no obstructing vehicles are present. Also, the number of non-passenger vehicles is zero in this trip.

Other information is obtained from the HVC location. This is illustrated in Figure 27. It can be observed that the HVC is installed, therefore the HVC state variable is 1. No pedestrians are present roadside, and no pedestrians are observed crossing the road. It can also be observed in Figure 27 that the weather is cloudy and windshield wipers have not been activated. The windshield is clear but not to the largest extent possible, so the windshield condition is assigned a value of 1. It is also evident that the trip was undertaken during the day.

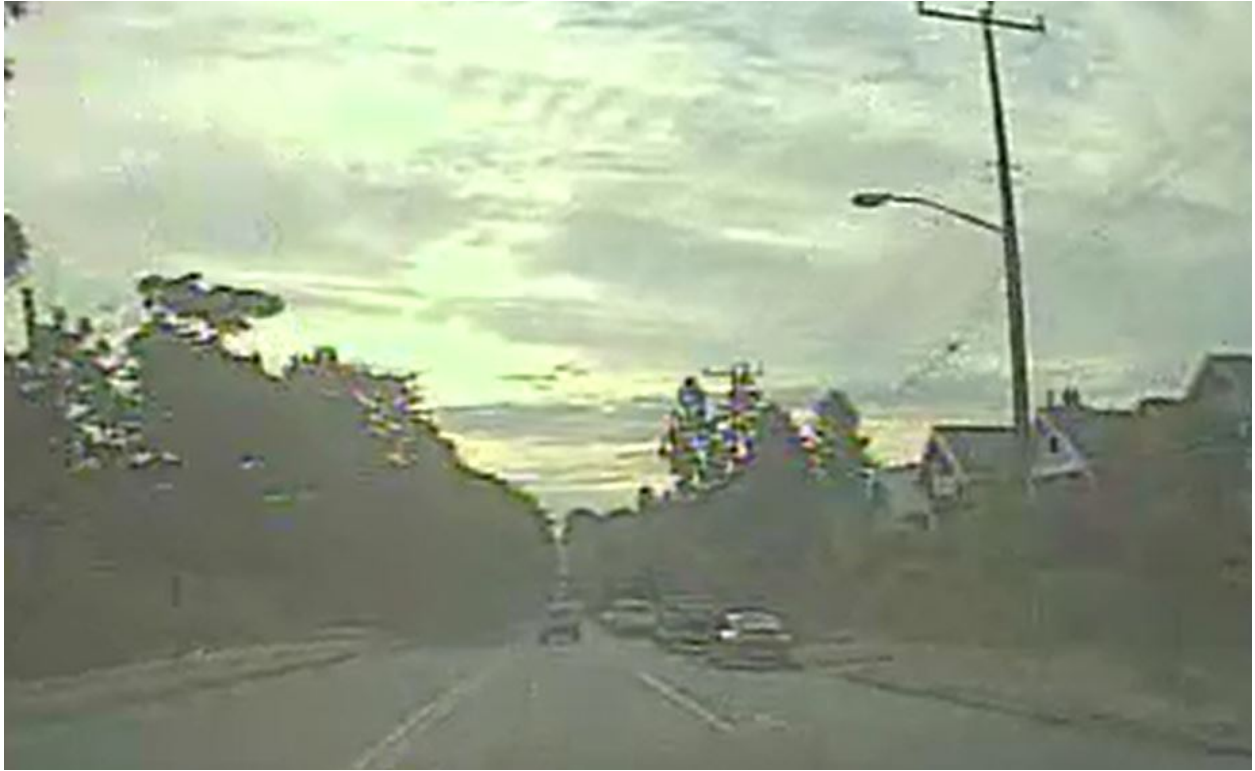
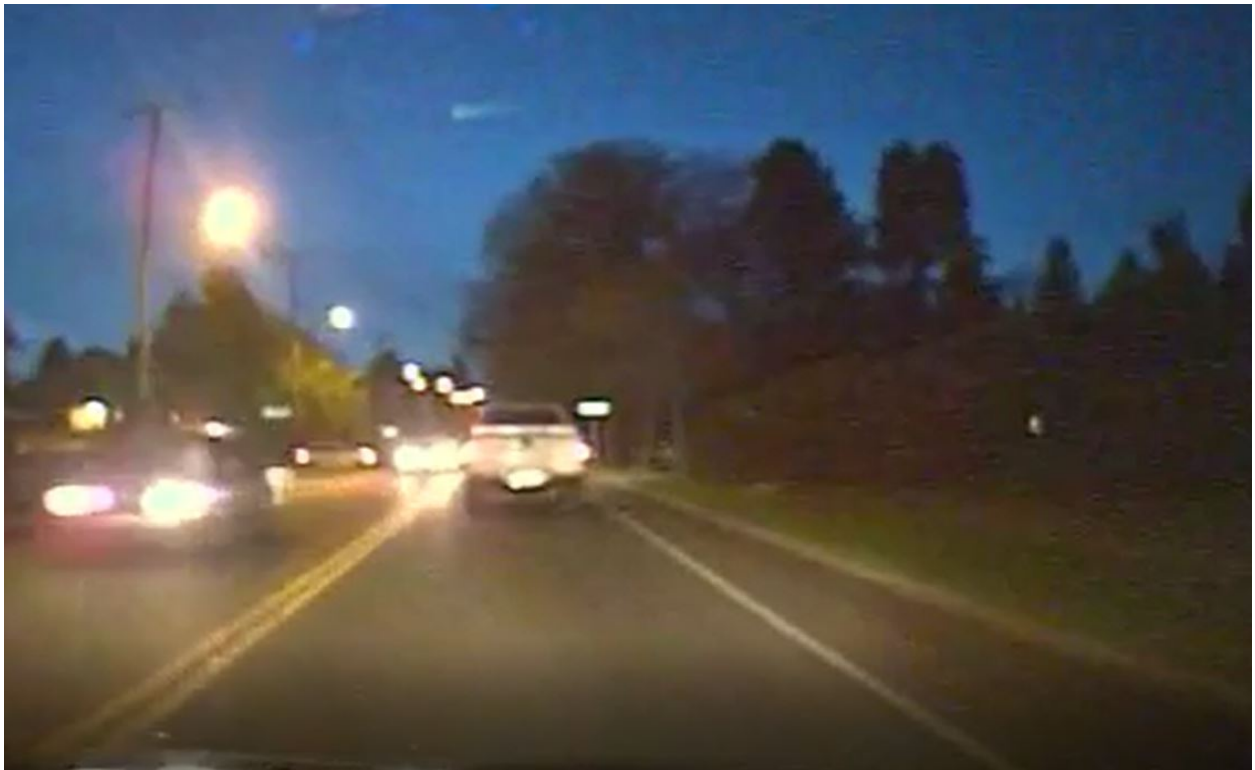
- Day = 1
 - Dawn = 2
 - Dusk = 3
 - Night = 4
 - For example, Figure 30 illustrates night, Figures 27 through 29 illustrate trips undertaken during day, and Figure 31 and Figure 32 illustrate dusk and dawn respectively.

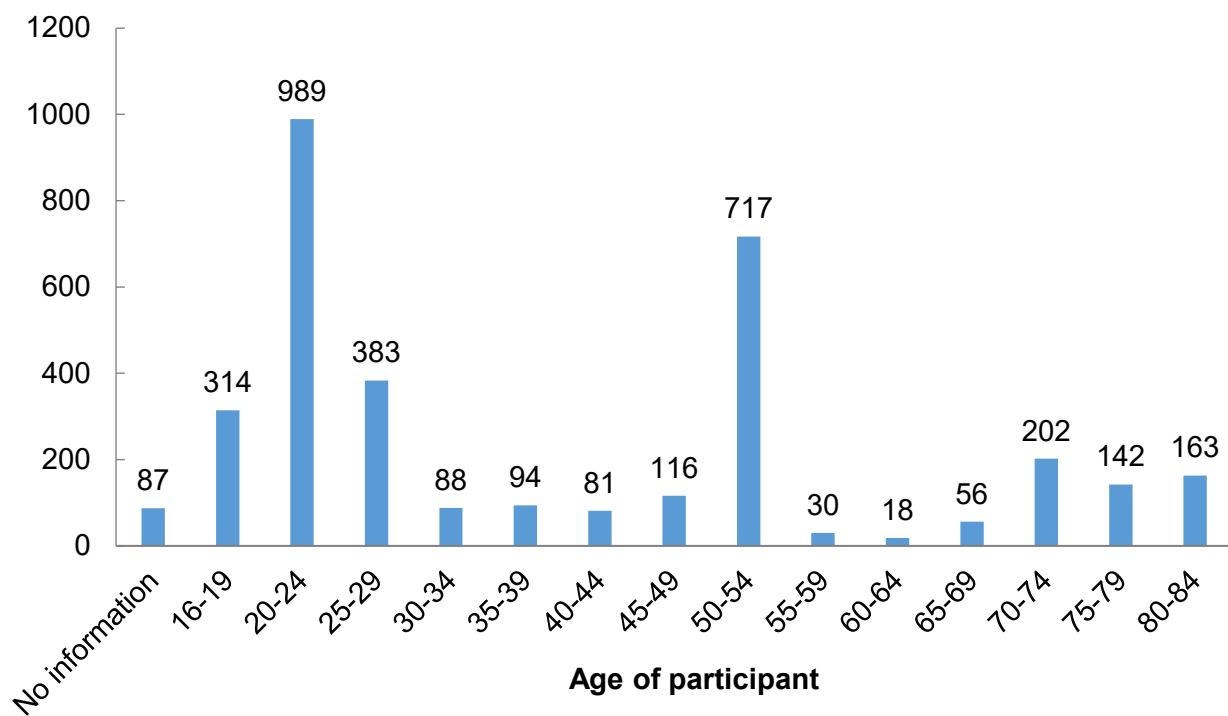
Figure 35 shows the distribution of traversals by the participant's gender, while Figure 36 illustrates the distribution of traversals by the participants' age group.
