# Automated and Connected Vehicle (AV/CV) Test Bed to Improve Transit, Bicycle, and Pedestrian Safety— Phase III: Technical Report

Technical Report 0-6875-03-R1

1. Report No. <b>FHWA/TX-22/0-6875-03-R1</b>		2. Government Accession No.		3. Recipient's Catalog No.	
4. Title and Subtitle <b>AUTOMATED AND CONNECTED VEHICLE (AV/CV) TEST BED TO IMPROVE TRANSIT, BICYCLE, AND PEDESTRIAN SAFETY—PHASE III: TECHNICAL REPORT</b>				5. Report Date <b>Published: July 2022</b>

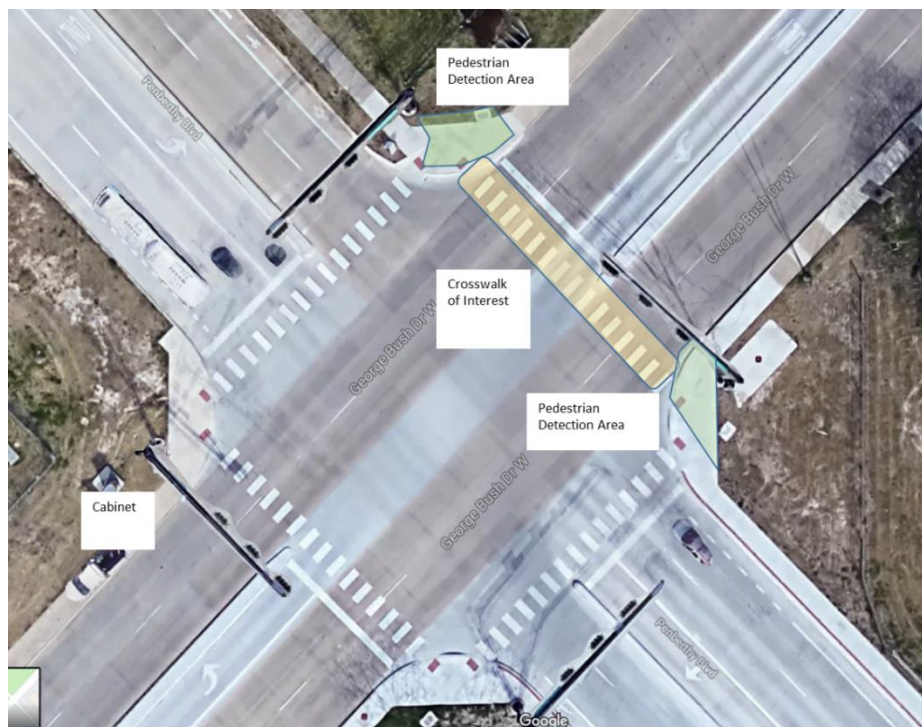
**Figure 5. Pedestrian Detection Area at GBD/PB.**

Figure 5 and Figure 6 show the location of the traffic signal cabinet, the traffic signal poles, the pedestrian detection areas, and the pedestrian push buttons. The following equipment was installed at the intersection for the smart intersection application.

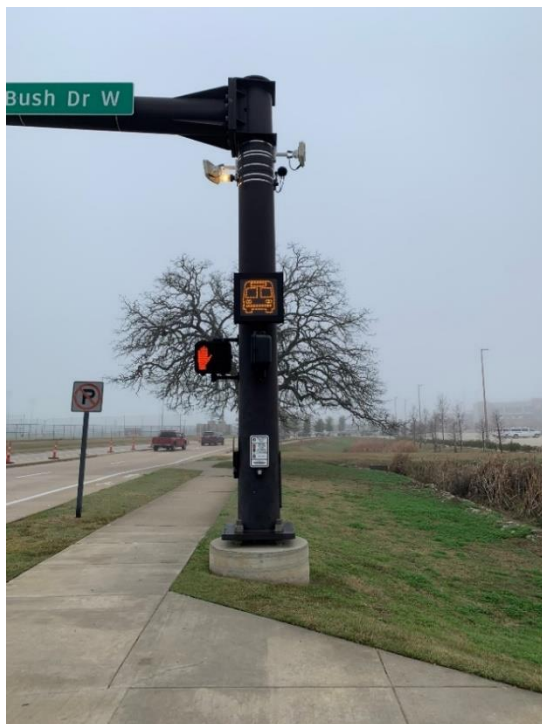
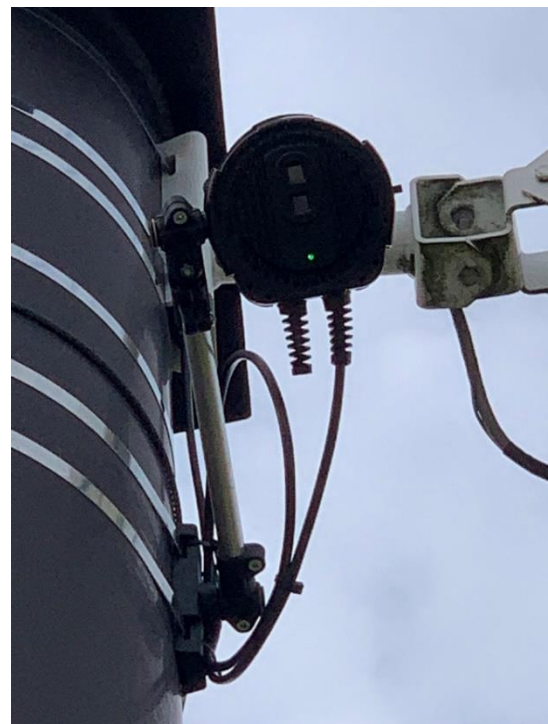
**Figure 7. Location of FLIR Sensors on Traffic Pole.**

- A Siemens M62 controller was installed in the City of College Station traffic signal cabinet. This controller allows the project to interface with the controller without connecting to the City of College Station network, ensuring the integrity of the security of the city communication network. The M62 controller does not influence the signal operations at the intersection. The existing M60 controller is still in the cabinet as a backup in case the M62 controller malfunctions.
- A field-hardened personal computer (PC) and a modem were installed in the traffic signal cabinet.
- FLIR<sup>®</sup> infrared sensors were installed on the signal poles at the northeast and southeast corners of the intersection. Figure 7 illustrates the location of the sensors, which detect

pedestrians and bicyclists on the sidewalk waiting to cross the intersection. The sensors were channelized into detector channel #49 using temporary wiring which can be removed at the end of the project. Channel #49 is not being used by the City of College Station, and the FLIR sensors do not have any impact on the operation of the signal system.

The FLIR sensors were adjusted in September 2020 to enhance the detection of pedestrians and bicyclists in the intersection waiting zones. The video tape of the zones and the log files were reviewed after this adjustment. The detection of pedestrians and bicyclists in the east side zone was enhanced with the adjustment.

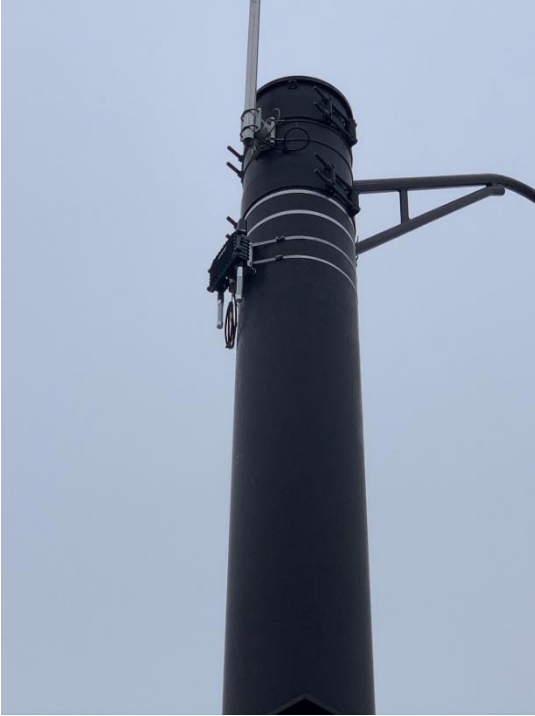
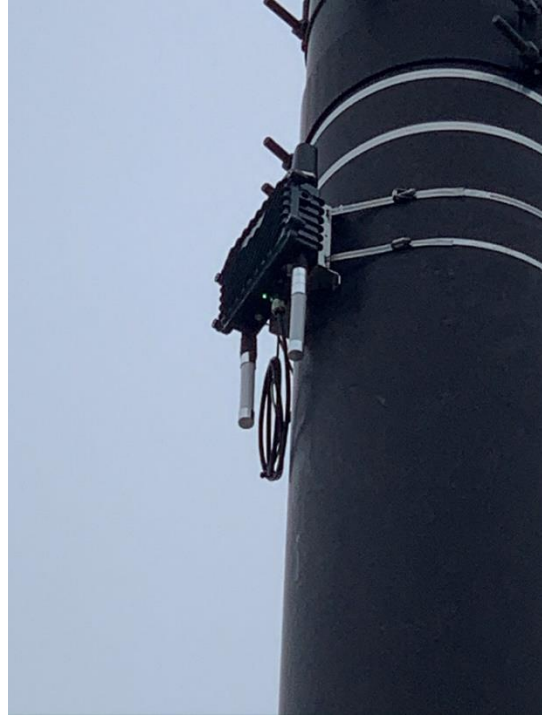
**Figure 8. Location of Cohda DSRC Radio.**

- A Cohda Wireless™ dedicated short range communication (DSRC) radio was installed on a pole at the northwest corner of the intersection. The location of the DSRC radio, which detects when a bus on Route 8 is arriving at the intersection, is shown in Figure 8.

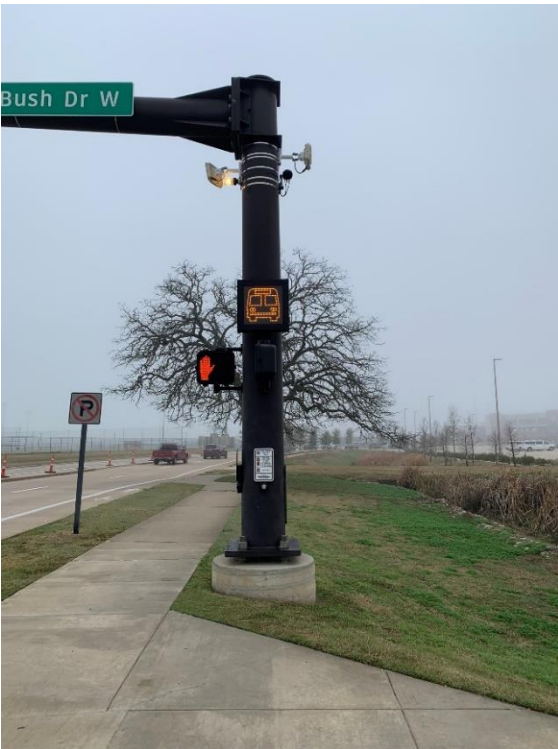
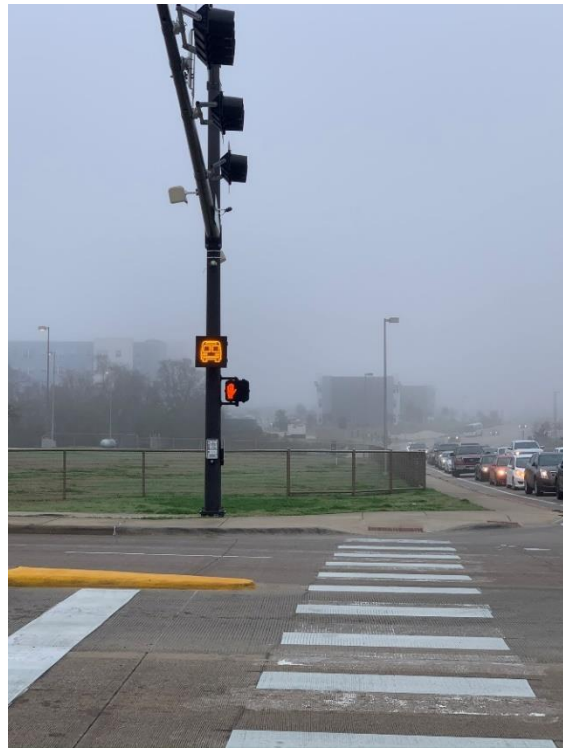
**Figure 9. Fiber Optic Bus Signs.**

- As illustrated in Figure 9, fiber optic supplemental bus signs were installed on the signal poles at the northeast and the southeast corners of the intersection. The bus signs are connected to Load Switch 1 Red in the signal cabinet and are illuminated when a Route 8 bus arrives at the intersection to turn by interfacing with the controller using Special Function 8. This special function was not being used by the City of College Station. The use of Special Function 8 does not have any impact on the function of the intersection.

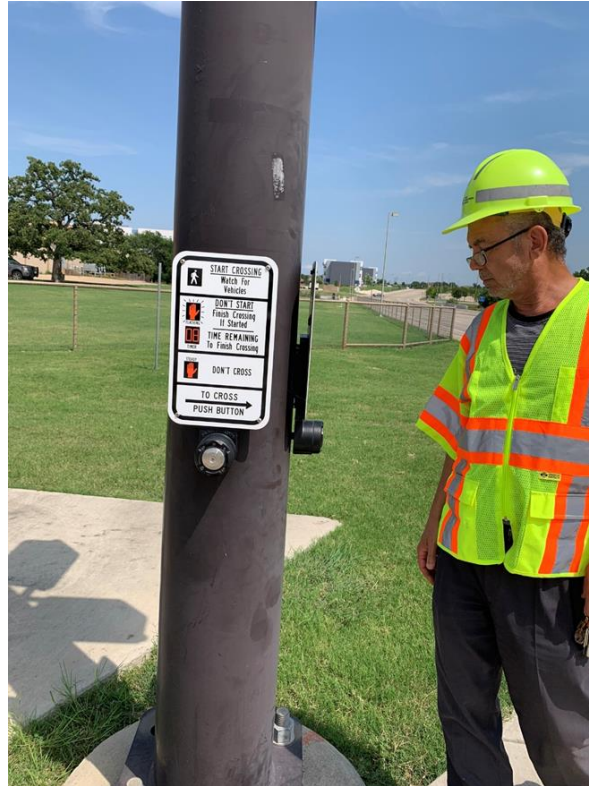
**Figure 10. Polara Accessible Pedestrian System.**

- Figure 10 shows the location of the Polara Accessible Pedestrian Systems (APSSs), which were installed on the signal poles on the northeast and the southeast corners of the intersection. The Polara APSSs provide an audio message (“Caution, Bus Turning” in English) when a Route 8 bus is turning at the intersection.

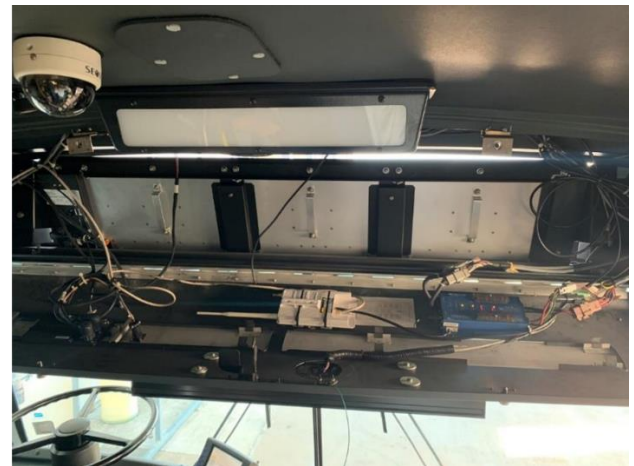
**Figure 12. Location of DSRC Radios on Texas A&M Buses.**

The radios were installed behind the destination sign panel above the windshield on the front of the buses, which is shown in Figure 12. The placement of the radios was selected to ensure no distraction to bus drivers or impact on bus operations. It was also selected due to ease of removing the panels for the initial installation and for ongoing maintenance and troubleshooting. Figure 13 illustrates the placement of the DSRC radio antennae on the roof of the bus. The installation took advantage of an existing opening in the bus roof. Texas A&M Transportation Services provided 12-volt power for the radios, with a switch connection so that the radio operates only when the bus engine is on.

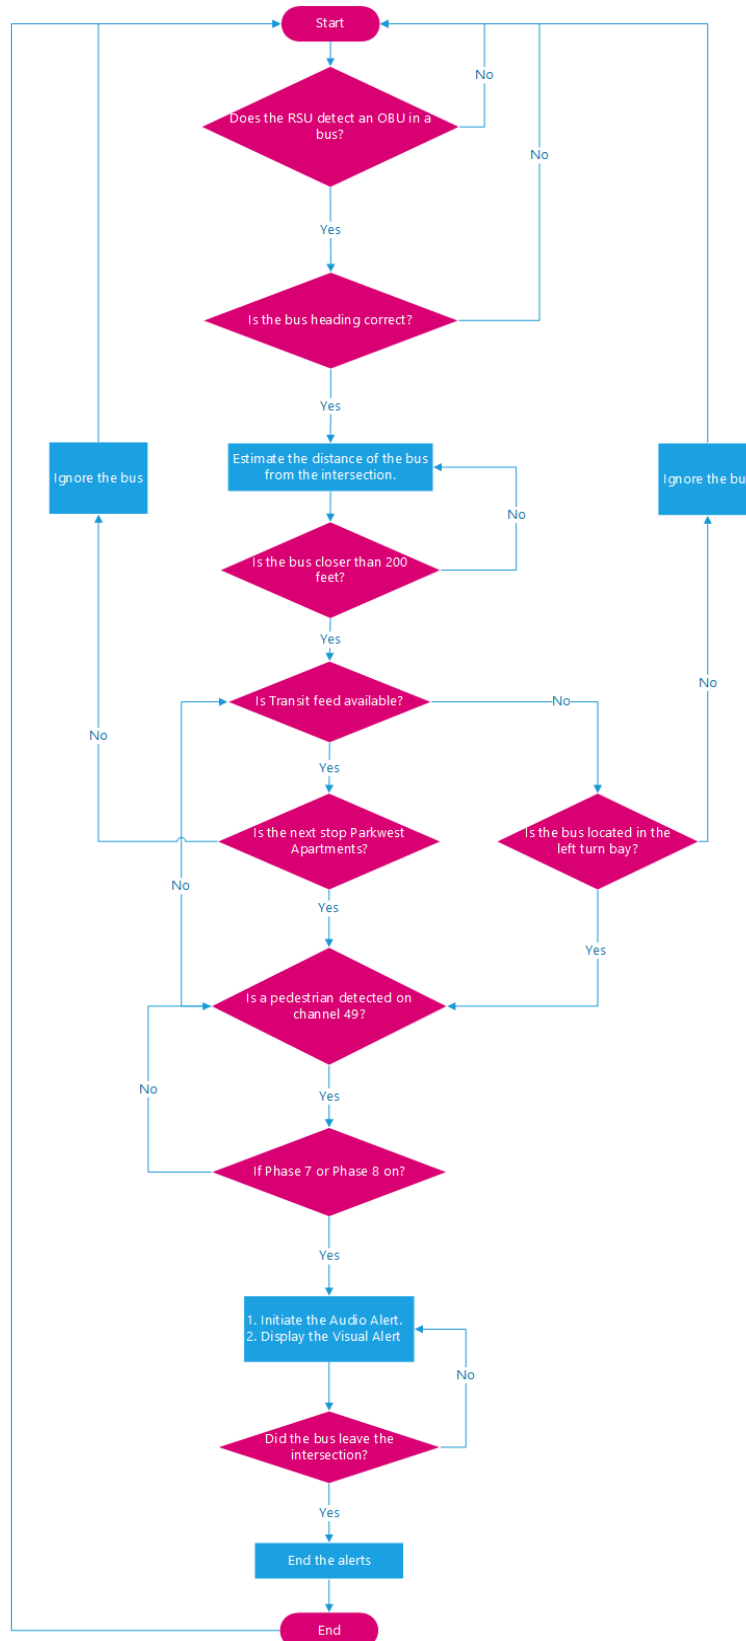
**Figure 14. Flowchart of the System Architecture.**

The system was configured as per the architecture illustrated in Figure 14. The system uses the various components in the following manner.

1. DSRC Roadside Unit (RSU) — Identify a bus with an onboard unit and obtain the coordinates and the heading of the bus along with a custom identification (ID).

- a. Coordinates are used to calculate the distance of the bus from the intersection.
  - b. Coordinates are used to determine if the bus is in the left-turn bay.

- c. Heading is used to determine if the bus is approaching the intersection from the correct direction.
2. Cellular modem — Monitor the live feed from Texas A&M Transportation Services to match the ID of the onboard unit (OBU) and determine the next stop of the instrumented bus.

3. FLIR detector — Detect a pedestrian on the sidewalk.
4. Traffic signal controller.
  - a. Monitor the presence of the pedestrian on detector channel # 49.

- b. Monitor if the signal phase is Phase 7 or Phase 8.
  - c. Call Special Function 8 to display the bus sign.
5. Polara APS — Initiate audio alert using a digital i/o card.

The data logged by the system include the current date, time, bus number, next time for the bus, bus description, route name and number, scheduled and estimated departure time for the next stop, current coordinates and heading, speed and passenger capacity and occupancy. The information in the live feed is used by the system to confirm if the buses next stop is Parkwest Apartments as illustrated the system architecture.

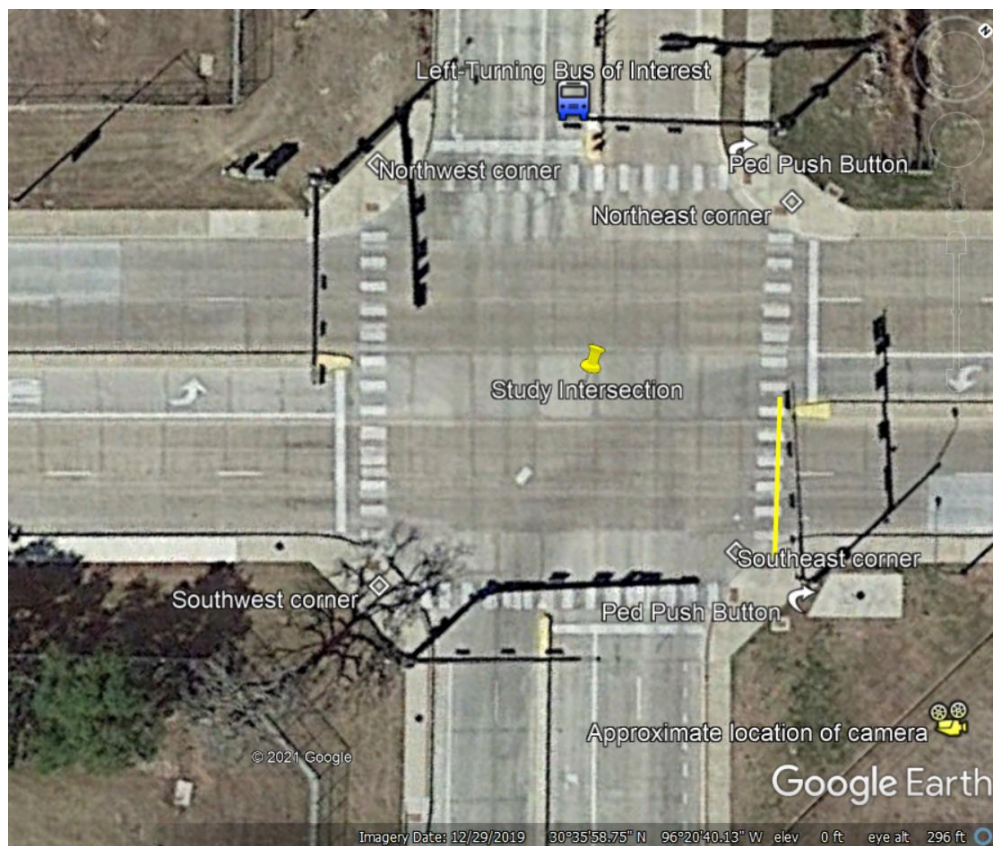
**Figure 16. Aerial View of Intersection.**

Figure 16 shows an aerial view of the intersection, with the pedestrian push buttons examined in the analysis highlighted. The northeast and southeast corners are the corners of interest along with the crosswalk that connects the two corners, in particular the area highlighted with a yellow line in Figure 16. Temporarily installed or city cameras were used to record the view of interest at the GBD/PB intersection. The characteristics of the crosswalk of interest are presented in Table 2. The posted speed limit for the east and west legs (George Bush Drive) is 50 mph, 40 mph for the south leg, and 30 mph for the north leg which is part of the Texas A&M campus. All legs at this intersection have four through lanes along with a left-turn lane.

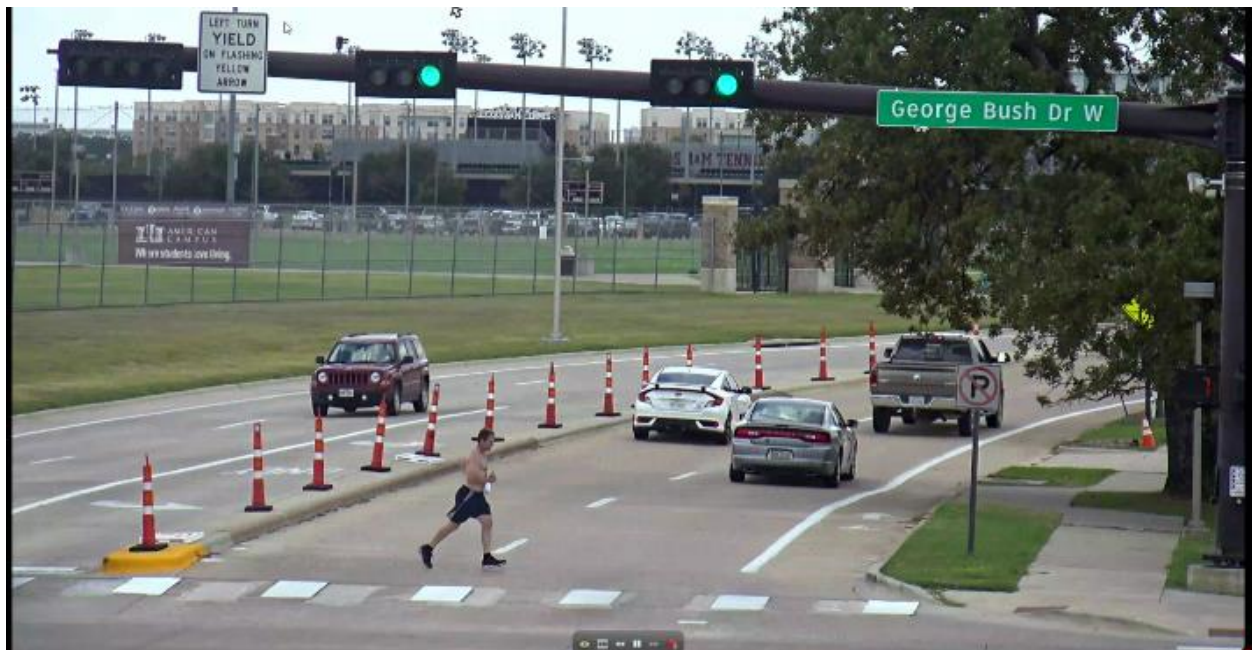
**Figure 17. Street-Level View of the Intersection (Before).**

Operation of the intersection was recorded in the before period from October 1 to October 22, 2019, with the assistance of Texas A&M University Transportation Services. A solar trailer was deployed with two cameras. The research team was able to position the cameras to provide both a street-level view (Figure 17) and a bird's-eye view (Figure 18) of the intersection. The two views allowed the research team to observe the following items:

- All vehicles and pedestrians passing through the crosswalk of interest.
- The waiting areas at both corners bounding the crosswalk of interest.
- The vehicular signal heads for the northbound intersection approach.
- The pedestrian signal head on the northeast corner for the crosswalk of interest.

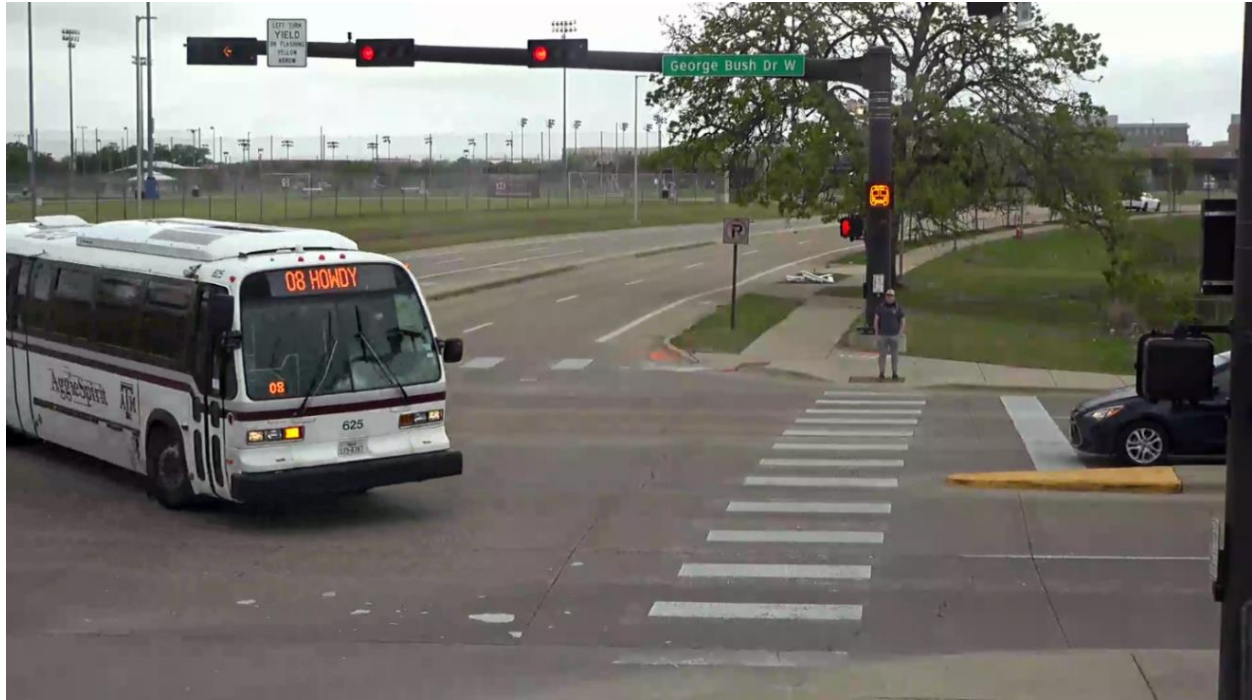
**Figure 19. Street-Level View of the Intersection (After).**

Operation of the intersection was again recorded in the after period from March 29, 2021, to April 12, 2021, with the assistance of Texas A&M University Transportation Services and the City of College Station. The research team used a different camera setup because the two-camera solar trailer from the before period was not available for the after period. The research team obtained street-level footage from a one-camera solar trailer provided by Transportation Services (see view in Figure 19) and bird's-eye footage from the permanently installed pan-tilt-zoom camera maintained by the city (see camera view in Figure 20). The activated bus warning sign is illustrated in Figure 19 and the presence of the solar trailer is shown in the upper-right corner of Figure 20.

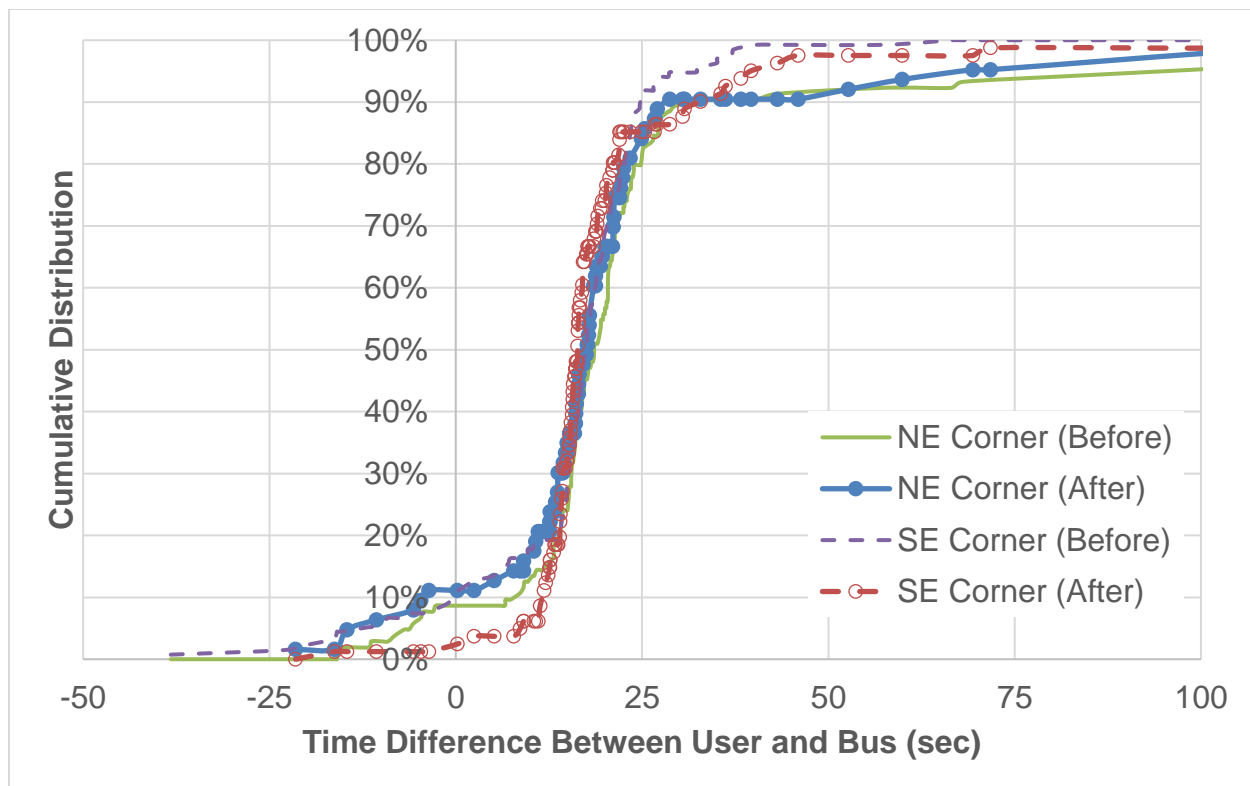
**Figure 22. Cumulative Distribution of Time Difference Between User Entering the Intersection and Bus Starting Left Turn.**

The timestamps were used to calculate the number of seconds between when the user entered the intersection and when the bus began the left turn. Figure 22 shows the cumulative distribution of the time difference between the crosswalk users entering the intersection and the bus starting the left turn. The graph separated the distribution for those starting from the northeast (NE) corner and those starting from the southeast (SE) corner, since people originating from the northeast corner can proceed halfway through the crossing before reaching the bus-ped/bike conflict zone, so an early start is less concerning for these people. Negative values (at the bottom portion of the graph) indicate that the pedestrian or bicyclist moved into the intersection before the bus began turning. In the before period, approximately 90 percent entered the intersection after the bus had initiated the left turn, with 10 percent entering the intersection before the bus turned. One notable change was observed in the after period. Specifically, only about 2 percent of the pedestrians originating from the southeast corner entered the intersection before the bus turned (see the red data series on the graph). Pedestrians originating from the southeast corner would be most likely to be exposed to a conflict with the left-turning bus, so it is desirable to reduce the number of early corner departures by these pedestrians.

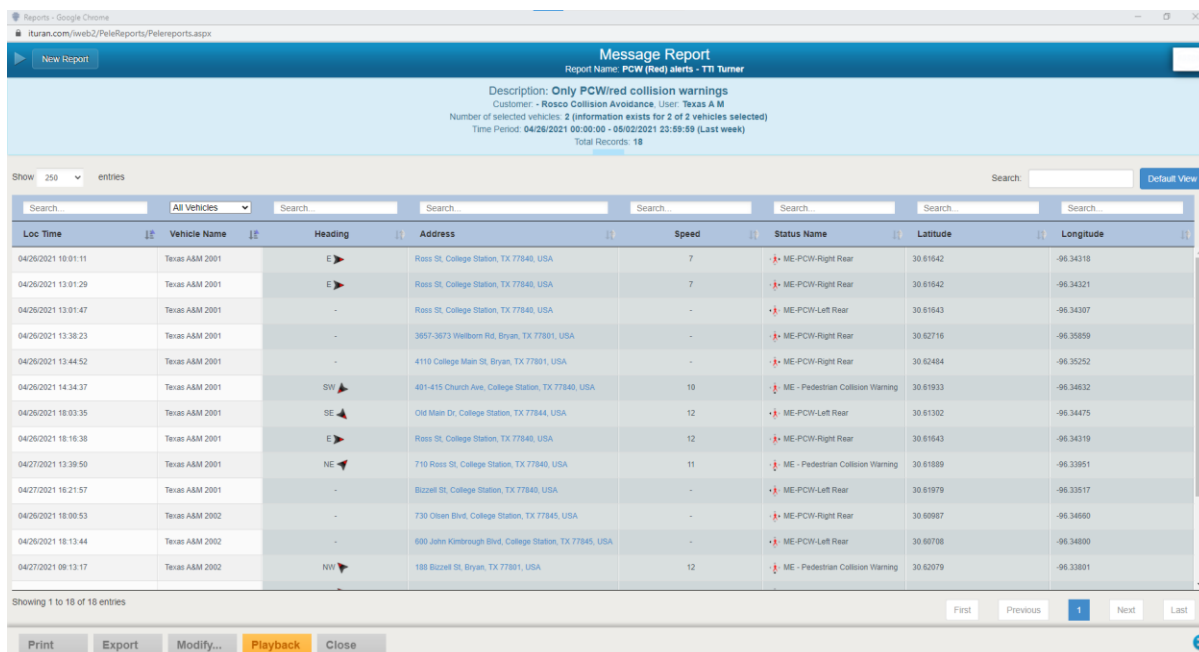
The screenshot displays a web-based interface for a telematics subsystem. At the top, a 'Message Report' header indicates the report name is 'PCW (Red) alerts - TTI Turner'. Below this, a description states 'Only PCW/red collision warnings' and provides details about the customer (Roscoe Collision Avoidance), the user (Texas A M), the number of selected vehicles (2), and the time period (04/26/2021 00:00:00 - 05/02/2021 23:59:59). The total records are 18. The main data is presented in a table with columns for Loc Time, Vehicle Name, Heading, Address, Speed, Status Name, Latitude, and Longitude. The table lists 18 entries, each representing a collision warning event. The status names include 'ME-PCW-Right Rear', 'ME-PCW-Left Rear', 'ME-PCW-Right Rear', 'ME-PCW-Left Rear', 'ME - Pedestrian Collision Warning', and 'ME - Pedestrian Collision Warning'. The interface also includes search bars, filters, and pagination controls.

When reviewing red collision alerts, TTI used the following attributes from the Ituran telematics subsystem:

- Collision alert date and time
- Vehicle name: Bus 2001, Bus 2002
- Bus speed at time of collision alert
- Bus location and address at time of alert
- Specific sensor triggering the collision alert: Front, Left Rear, or Right Rear

The assessment included review of the bus-based video associated with pedestrian collision warnings highlighted in Figures 23 and 24. Researchers reviewed the video to determine whether pedestrian, bicyclists, or other vulnerable road users were near the operating bus and presented an imminent collision risk.

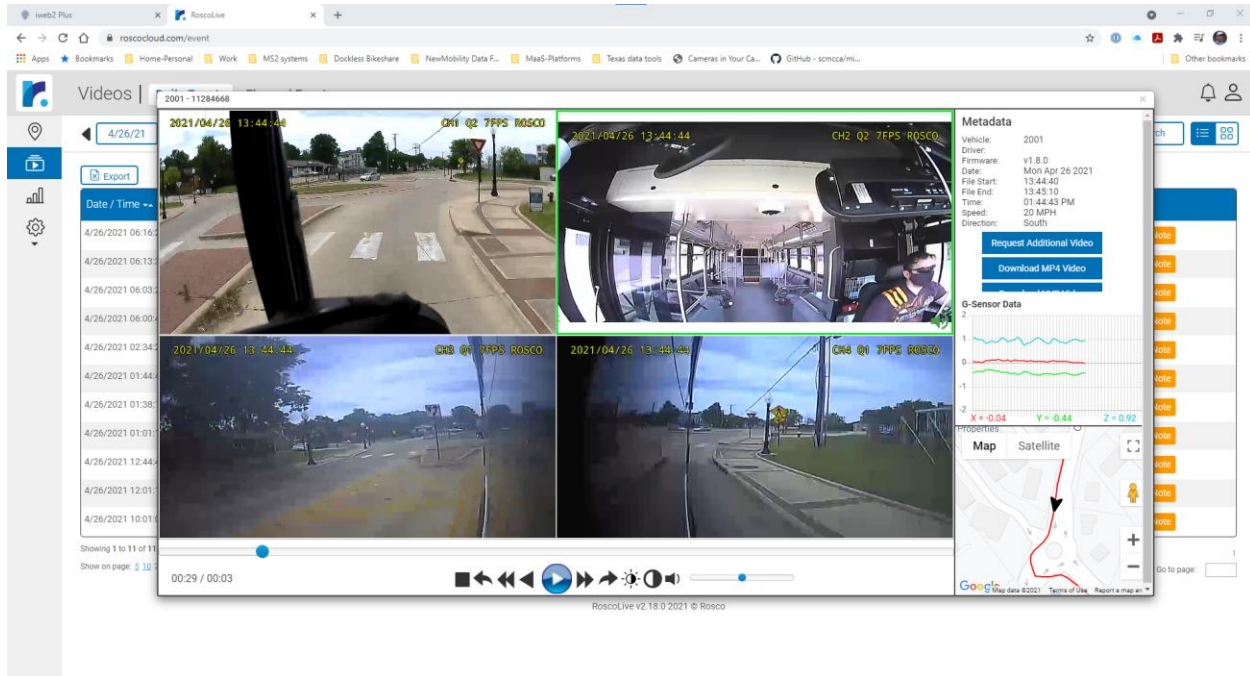
**Figure 24. Screenshot of Video Review Subsystem Used to Verify Collision Alert Accuracy.**

Researchers recorded the following attributes when reviewing the video associated with each red collision alert:
