Semi-autonomous aerial robot for ultrasonic assessment of crack depth and surface velocity in concrete structures

Luca Belsito^a, Diego Marini^a, Luca Masini^a, Matteo Ferri^{a,*}, Miguel Ángel Trujillo^b, Antidio Viguria^b, Alberto Roncaglia^a

^a Institute for Microelectronics and Microsystems (IMM), National Research Council of Italy (CNR), Italy

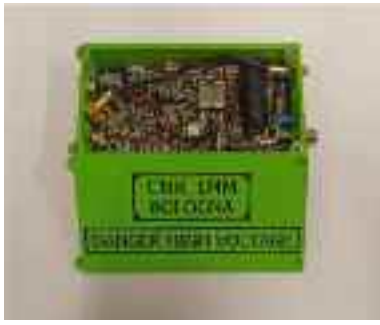
Fig. 4. Custom pulser/receiver unit for ultrasonic measurements.

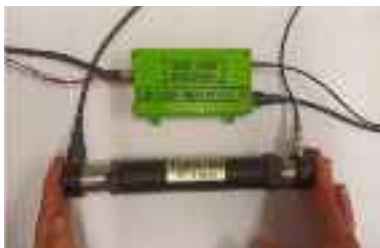
Fig. 5. Ultrasonic measurement performed for the system calibration.

measurement on a metal specimen with a known ultrasound transit time, as illustrated in Fig. 5. This calibration step was used to estimate the ToF offset introduced by the plasticine layers, which was subsequently subtracted automatically from all the measurements performed in the tests carried out on concrete samples.

Making use of plasticine as an interface layer, possible variations of the coupling layer thickness may potentially influence the accuracy of the measurement. However, during the laboratory tests it was observed that plasticine is relatively hard at room temperature and is not easily deformed during the ultrasonic measurements, even applying a force corresponding to 1.5 kg on the transducers. Consequently, frequent recalibration of the ToF offset with the method shown in Fig. 5 was not necessary in the experiments.

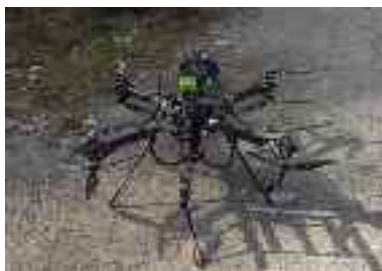
Fig. 8. UAV with ultrasonic measurement system.

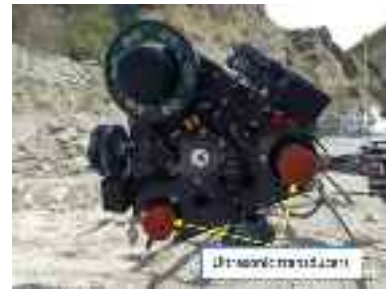
Fig. 9. Integration of the ultrasonic sensors on the end effector of the UAV.

The two 54 kHz high-power piezoelectric transducers utilized for the crack depth measurements were mounted on the UAV end effector at a distance of 15.4 cm from each other, as shown in Fig. 9. As mentioned before, such spacing was chosen after a careful evaluation of several factors, including the acoustic attenuation of ultrasound in concrete, the constraints related to the accuracy of the crack depth measurements, and the need to limit the size and weight of the end effector.

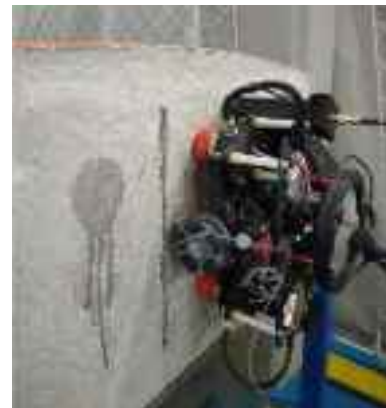
Fig. 10. End effector placement on specimen for surface velocity measurement.

In the measurements, two different placements of the PZT transducers were employed, following the measurement procedure formerly outlined in Section 2. Initially, the sensors were positioned beside the crack (as shown in Fig. 10). This configuration was utilized to conduct a straightforward ultrasound surface velocity measurement on the specimen. Subsequently, the sensors were repositioned across the crack (Fig. 11) to perform the depth measurements.

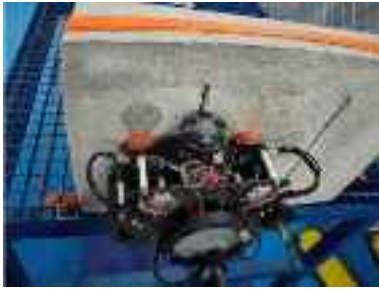
Fig. 11. End effector placement on specimen for crack depth measurement.

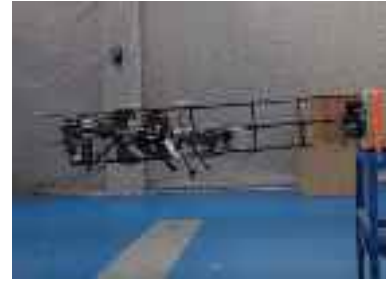
Fig. 12. Airborne crack depth measurement performed on artificial specimen in a controlled flying environment.

After completion of the static tests performed with the end effector tool, the system was tested in a controlled flying environment, as shown in Fig. 12. The sequence of operations executed in the tests was the following:

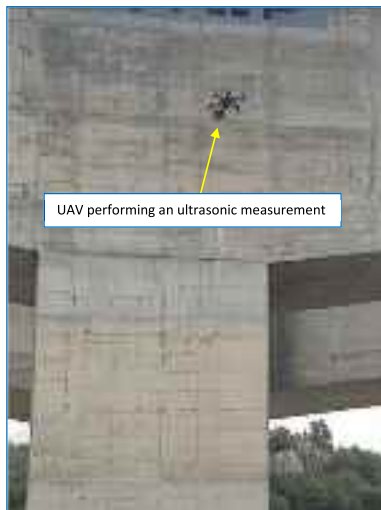
Fig. 14. Ultrasonic measurement performed on the T9 Metsovo bridge (Greece) by the UAV.

The system was additionally tested during an on-field trial conducted as part of the European project RESIST (<https://www.resistproject.eu/>), which took place on the T9 Metsovo bridge in Greece in an outdoor environment and on a high-rise structure. In these tests, the ultrasonic measurements were executed at an elevation of approximately 35 m above ground, as shown in Fig. 14.
