Recording of bridge damage areas by 3D integration of multiple images and reduction of the variability in detected results

Tatsuro Yamane¹ | Pang-jo Chun² | Ji Dang³ | Riki Honda¹

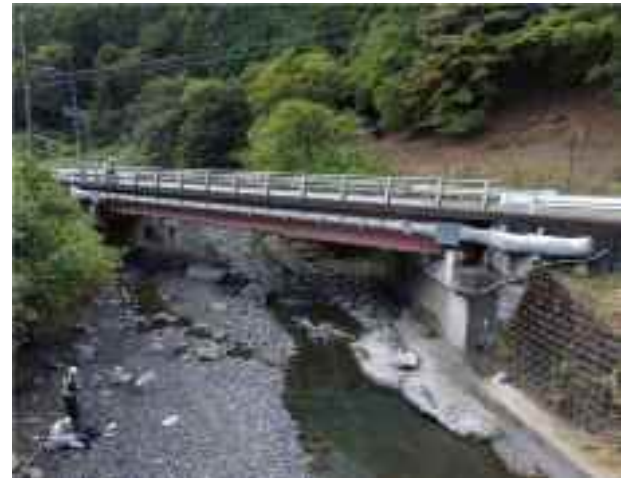
FIGURE 12 Steel girder bridge used in this study

The bridge used in this field test was a steel girder bridge, as shown in Figure 12, managed by the Japanese MLIT. As shown in Figure 13, the span length and total width of this bridge were 25.4 and 9.8 m, respectively. The bridge was

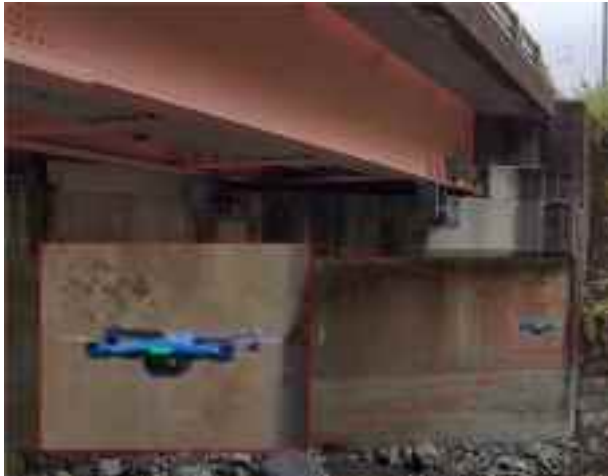
FIGURE 14 Photographing bridges using an unmanned aerial vehicle

In this study, Skydio 2, a small UAV developed by Skydio, was used to capture photographs of this bridge as shown in Figure 14. The focal length of the camera mounted on the UAV was 4 mm, the 35 mm focal length was 21 mm, and the pixel count was approximately 12.3 megapixels (4056×3040 px). This bridge was inspected using inspection vehicles as shown in Figure 15. If the UAV-based inspection method shown in this study is realized, it will greatly contribute to improving the efficiency of maintenance.

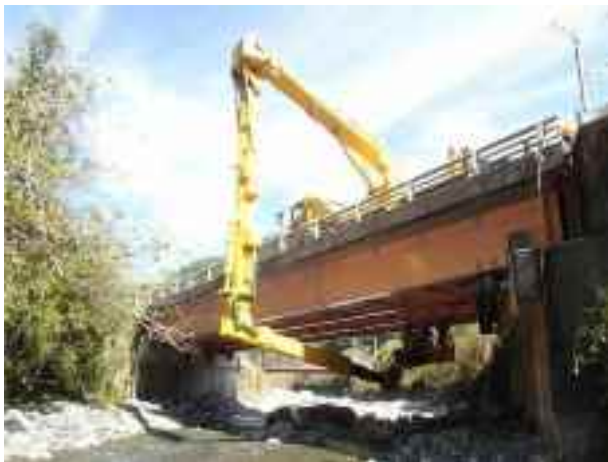
FIGURE 15 Inspection using bridge inspection vehicles

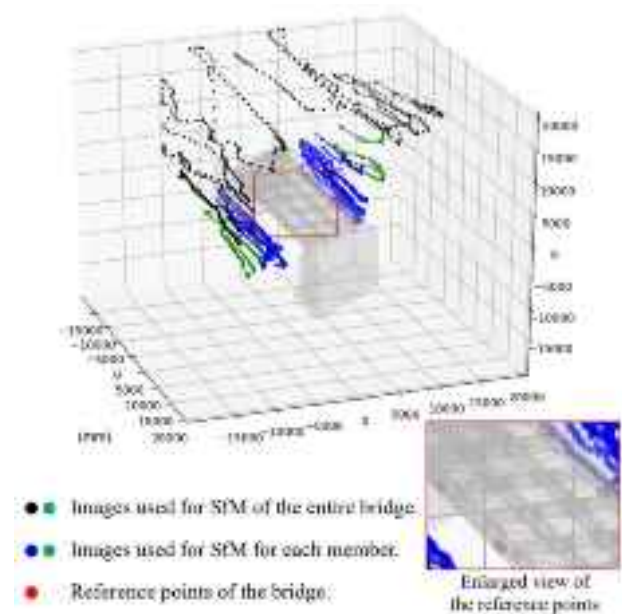
FIGURE 16 Coordinate position of each camera estimated using structure from motion (SfM)

era position can be accurately estimated, the framework proposed in this study is independent of the type of UAV and SfM software used. The camera coordinates estimated using SfM are shown in Figure 16.

Reference points (indicated by red markers in Figure 16) were set on each exterior girder of the 3D model to match the camera coordinates estimated in this manner with the coordinate positions of the 3D model of the bridge. Then, a coordinate transformation was performed using the least-squares method such that the reference points on the model constructed using SfM matched those on the 3D model.
