INSTALLATION SHEET

Project Name: V80 IL DR NS BN CLR AGI3

Customer: DAVID-06
Location: 2415 TEXAS
Quantity: 1
Project #: 10074021-I-B3

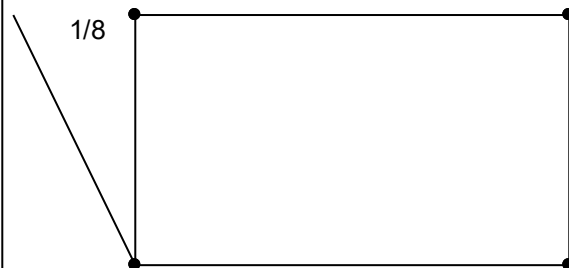
OUT OF PLUMB / LEVEL CONDITIONS

Showing Centerline Void
