**Haynes**
*shows you how***BMW 3-Series (92-98) & Z3 (96-98) Haynes Online Manual**

5 Throttle pedal - removal and installation

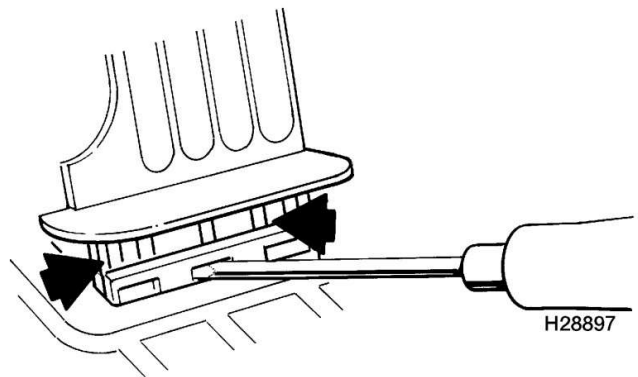
- 1 Pry off the clip securing the top of the pedal assembly to the throttle cable operating lever.
- 2 Press down on the carpet under the pedal, then bend back the lower pedal retaining clips, and lever the pedal upwards to release it from the floor (see illustration) . Discard the pedal - a new pedal must be used on installation. Withdraw the pedal.

5.2 Releasing the throttle pedal from the floor
