**BMW 3-Series (92-98) & Z3 (96-98) Haynes Online Manual**

## 12 Piston/connecting rod assembly - inspection

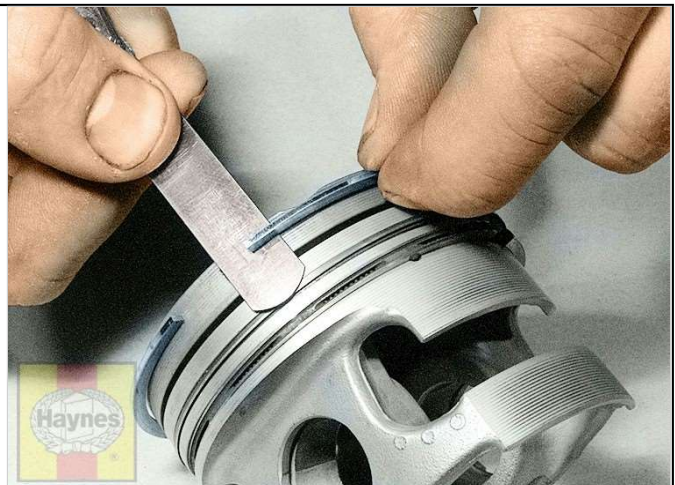
### 12.2 Removing a piston ring with the aid of a feeler gauge

2 Carefully expand the old rings over the top of the pistons. The use of two or three old feeler gauges will be helpful in preventing the rings dropping into empty grooves (see illustration) . Be careful not to scratch the piston with the ends of the ring. The rings are brittle, and will snap if they are spread too far. They are also very sharp - protect your hands and fingers. Note that the third ring incorporates an expander. Always remove the rings from the top of the piston. Keep each set of rings with its piston if the old rings are to be re-used. Note which way up each ring is fitted.

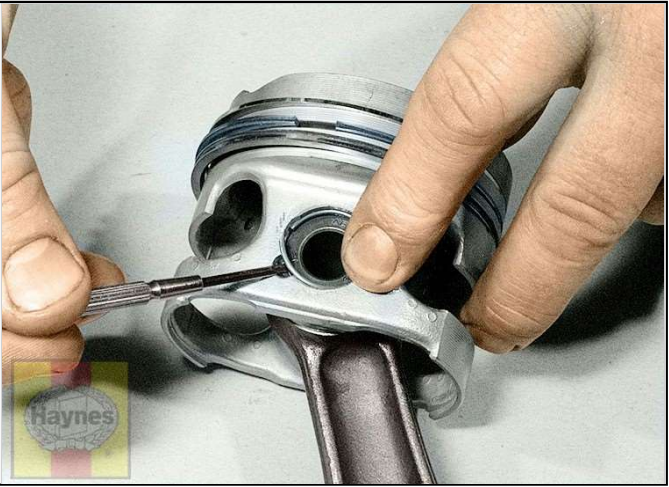
**12.13a Prying out the circlips . . .**

13 Using a small flat-bladed screwdriver, pry out the circlips, and push out the piston pin (see illustrations) . Hand pressure should be sufficient to remove the pin. Identify the piston and rod to ensure correct reassembly. Discard the circlips - new ones *must* be used on installation.

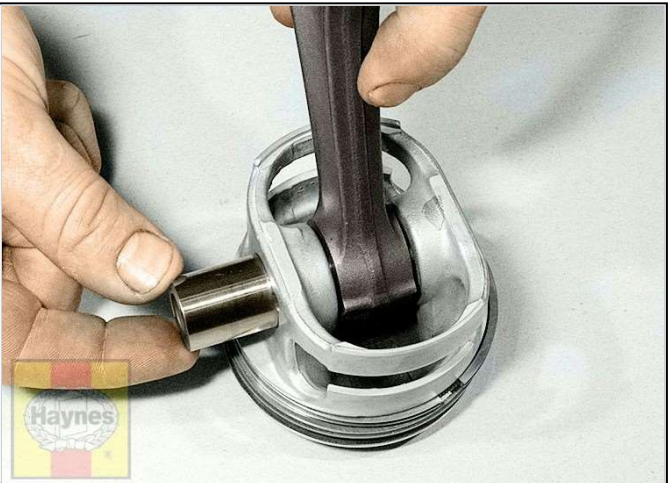
**12.13b . . . to remove the piston pins from the pistons**
