BMW 3-Series 320i & 320xi (12-14), 325i, 325xi, 330i & 330xi (06) & 328i & 328xi (07-14) Haynes Online Manual

## 4 Accelerator Pedal Position (APP) sensor - replacement

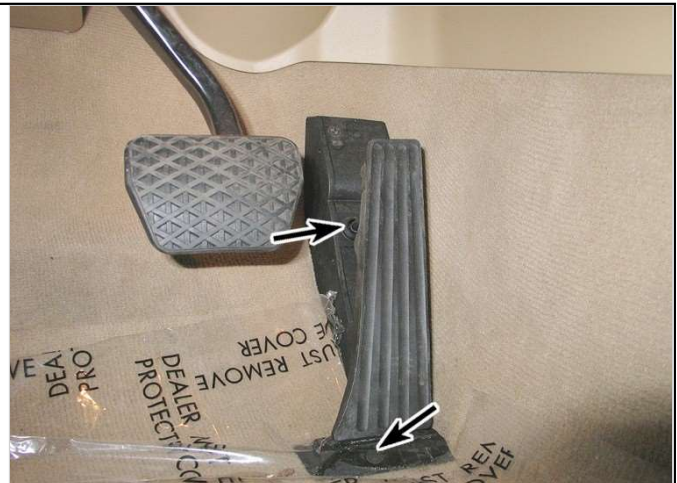
**4.3 Remove the bolts at the top and bottom of the accelerator pedal assembly**

3 Remove the bolts securing the throttle pedal assembly, then disconnect the electrical connector (see illustration) .

4 Lift the throttle pedal assembly upwards, and disconnect the wiring plug. Note that the throttle pedal is only available as a complete assembly, which includes the position sensor. If defective, the complete assembly must be replaced.
