BMW 3-Series 320i & 320xi (12-14), 325i, 325xi, 330i & 330xi (06) & 328i & 328xi (07-14) Haynes Online Manual

9 Cooling system check (every 7,500 miles or 6 months)

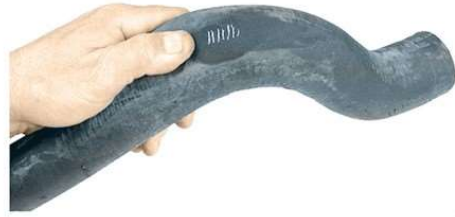
Check for a chafed area that could fail prematurely.

9.4 Hoses, like drivebelts, have a habit of failing at the worst possible time - to prevent the inconvenience of a blown radiator or heater hose, inspect them carefully as shown here

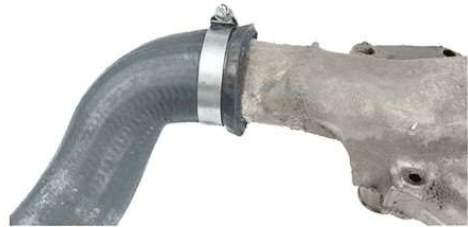
Overtightening the clamp on a hardened hose will damage the hose and cause a leak.

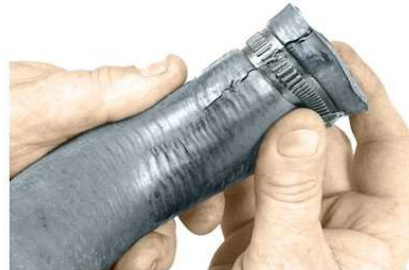
Check each hose for swelling and oil-soaked ends. Cracks and breaks can be located by squeezing the hose.

4 Carefully check the radiator hoses and the smaller diameter heater hoses (see [Chapter 3](#)). Inspect each coolant hose along its entire length, replacing any hose which is cracked, swollen or deteriorated ([see illustration](#)). Cracks will show up better if the hose is squeezed. Pay close attention to hose clamps that secure the hoses to cooling system components. Hose clamps can pinch and puncture hoses, resulting in coolant leaks.
