**BMW 3-Series (92-98) & Z3 (96-98) Haynes Online Manual**

## 12 Piston/connecting rod assembly - inspection

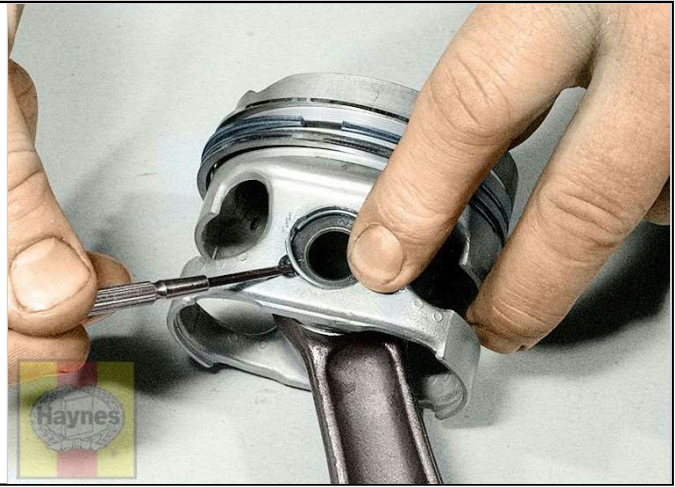
**12.13a Prying out the circlips . . .**

13 Using a small flat-bladed screwdriver, pry out the circlips, and push out the piston pin (see illustrations) . Hand pressure should be sufficient to remove the pin. Identify the piston and rod to ensure correct reassembly. Discard the circlips - new ones *must* be used on installation.

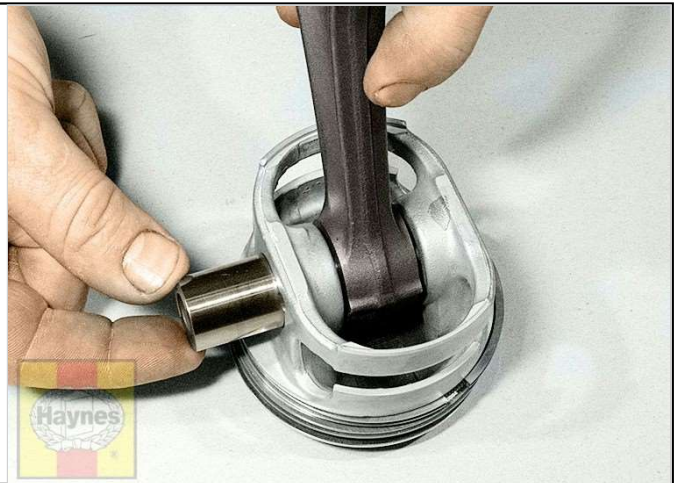
**12.13b . . . to remove the piston pins from the pistons**
