#	Location	Reaction
1

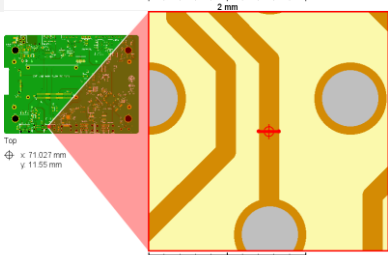
<p>It seems there is a round off error. The PCB is designed in mil unit and the width of the trace is 9.842 mil. When turned into mm it is equal to 0.2499868 which is less than 0.25.</p> <p><b>Does it impact the fabrication?</b></p>
4

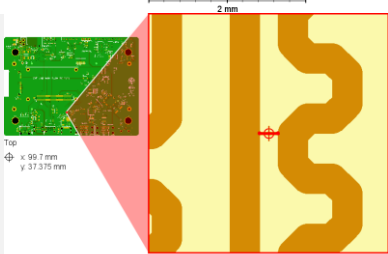
<p>It seems there is a round off error. The PCB is designed in mil unit and the width of the trace is 9.842 mil. When turned into mm it is equal to 0.2499868 which is less than 0.25.</p> <p><b>Does it impact the fabrication?</b></p>
5

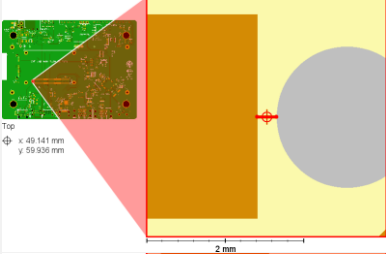
<p>Top  <math>\phi</math> x 89.041 mm  y 10.263 mm</p> <p>2 mm</p>	<p>This is standard device footprint.  <b>Is there any problem in fabrication?</b></p>
9

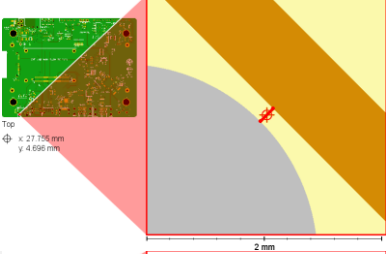
<p>Top  <math>\phi</math> x 49.141 mm  y 55.936 mm</p> <p>2 mm</p>	<p>Both cooper and plated circle are not connected to anywhere. They are designed to fortify the socket position with no connection.  <b>Does it make any impact on the fabrication?</b></p>
10
