## BELZONA SUPERWRAP II

PURSUANT TO ASME PCC-2 ARTICLE 401 NONMETALLIC COMPOSITE REPAIR SYSTEMS: HIGH-RISK APPLICATIONS

**BBH 4639**

Prepared on: August 25, 2022

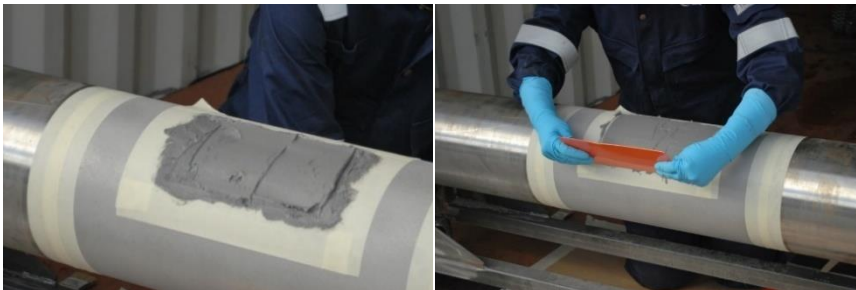
Step No.	Step
<b>5.0</b>	<b>Substrate Preparation</b>
5.1	FILL pitted areas with specified Belzona paste grade material PRIOR to application of the composite repair system. If a through wall, SEAL or COVER it to prevent any ingress of product into the pipe through the defect.

NOTE	The paste grade material should be used to re-build the substrate to its original wall thickness. The paste grade material must be mixed and applied in accordance with its relevant IFU
5.2	Use paste grade material to smoothen transition for SuperWrap II.
5.3	Allow paste grade material to stabilize and become touch dry.

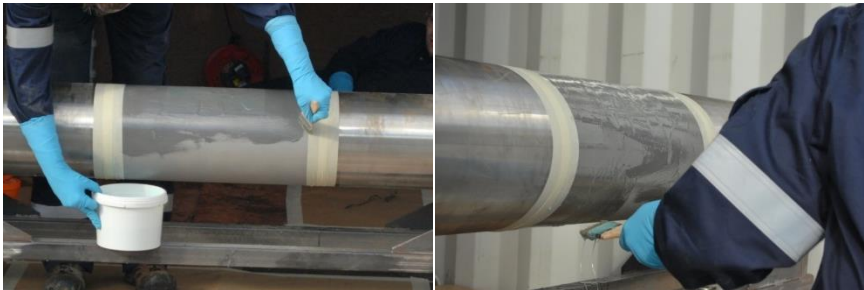
Step No.	Step
7.0	<b>Wetting Out Substrate</b>
7.1	APPLY Belzona SuperWrap resin to the repair substrate. MAKE sure that all the repair area is wetted out. PAY special attention to the 3-9 o' clock position.

NOTE	Environmental conditions shall be monitored through the application process. The temperature of the substrate shall always remain 3°F(5°C) higher than the dew point temperature.
7.2	ENSURE that 100% coverage of the substrate area to be repaired has been achieved.
NOTE	As the resin is fluid grade, it will spread quite easily and can be brushed in. The excess material will drip off the substrate.

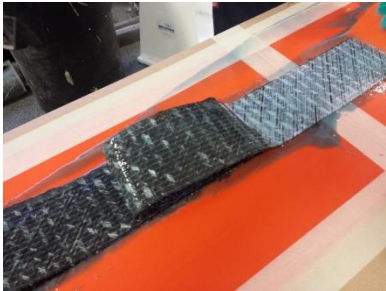
Step No.	Step
8.0	<b>Wetting Out Belzona 9381 Reinforcement Sheets</b>
8.1	LAY pre-measured Belzona 9381 onto a rigid working surface in an organized manner.
8.2	Using an applicator, brush, roller, or rubber squeegee SATURATE Belzona 9381 with resin. For ease of application, it is recommended that the resin be applied onto the fiber glass side of Belzona 9381. Once the fiber is saturated, the fiber glass will become dark rather than translucent. Both sides of Belzona 9381 can be impregnated with the resin, if desired.

8.3	FOLD or ROLL fully wetted out Belzona 9381 in an organized manner to facilitate implementation of the reinforcement onto the section to be repaired.
NOTE	Resin should be used within its respective working life. Refer to relevant SuperWrap II resin IFU for working life times.

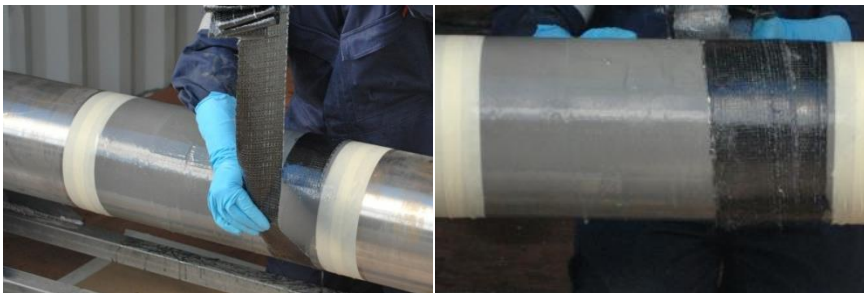
Step No.	Step
9.0	<b>Implementing Wrap onto Piping System</b>
9.1	Starting from either end of the repair area, APPLY fully wetted Belzona 9381 onto the substrate applying hand pressure.
NOTE	Apply moderate tension onto the repair. There should be resin exuding through the fibers. When wrapping around the repair area, the reinforcement should not be sliding. Using one hand to hold the wrap in place while using the other hand to pull Belzona 9381 may help in the wrapping process.
CAUTION	The only masking tape that should be on the substrate at this point is the masking tape marking the two ends of the repair.

9.2	CONTINUE wrapping around the pipe with AT LEAST 50% OVERLAP until the other end of the repair area is reached. ENSURE that the end of Belzona 9381, after a full wrap, lands onto wetted-out substrate and never onto the masking tape limiting the repair area.

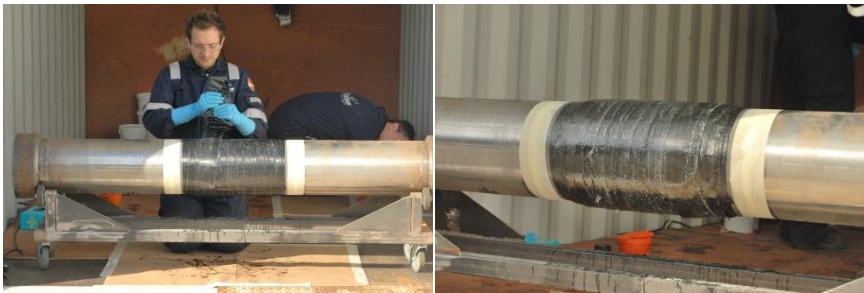
NOTE	At times, to avoid creases in the wrap, more than 50% overlap will be required. Air bubbles and creases should also be worked out with free gloved hand during each wrap. While keeping wrap in tension use free gloved hand to press repair onto and around pipe.
NOTE	The subsequent wraps should start where the previous one finished and end where the previous one began
NOTE	The same technique used in the first wrap shall be used for all succeeding wraps until proper repair thickness (number of wraps) as per the design outputs has been achieved
NOTE	Each wrap shall be applied along the circumference in the same direction.

CAUTION	Each wrap shall be applied within the maximum overwrapping time. Refer to relevant Belzona SuperWrap II resin IFU for overwrapping windows.

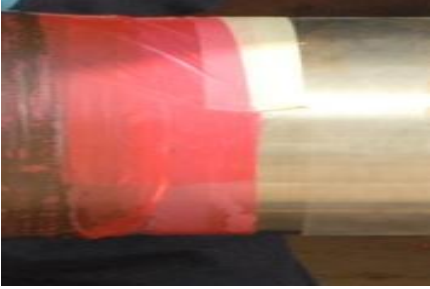
Step No.	Step
<b>10.0</b>	<b>Belzona 9382 Release Film Implementation</b>
10.1	USE Belzona 9382 to consolidate the repair. BEGIN wrapping from the end of the final wrap.
NOTE	Taping Belzona 9382 to the substrate adjacent to one end of the repair will help in securing the release film in place.

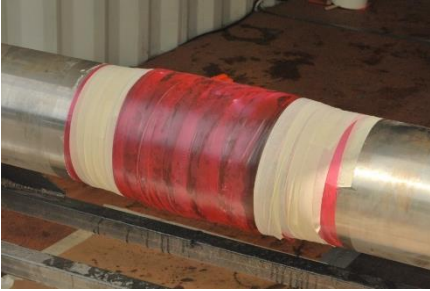
NOTE	Belzona 9381 should be spiraled around the repair in the same direction as the reinforcement sheet.
10.2	APPLY at least TWO wraps of Belzona 9382 across the repair area with a minimum 75% overlap.

<b>CAUTION</b>	It is recommended that high hand pressure tension be applied to Belzona 9382 for effectively consolidating the repair.
