Wheelchair Users' Accessibility Problems in Public Transportation- Case of Metro Bus

FIELD STUDY: PROBLEMS OF ACCESSIBILITY TO ISTANBUL METRO BUS FACED BY WHEELCHAIR USERS

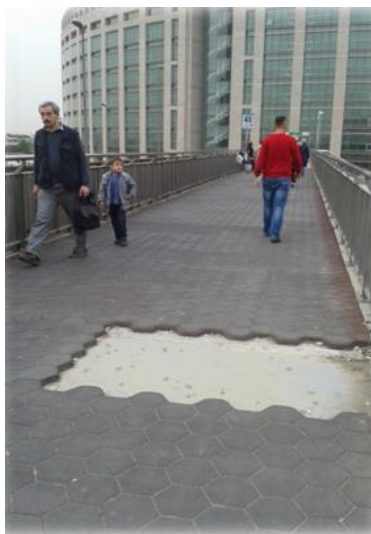
Figure 1.

Figure 1, 2. Çağlayan Metrobus Station-Floor covering deficiency, Zincirlikuyu Metrobus Station-40 cm height kerb to reach the

To bring the platform width to the standard level and remove the floor covering defects are actually very low cost, but it is a result reached by conscious and willing technical personals. It is not a design problem; it is a management problem. The standard width of the platform is many times obstructed by adscititious elements (water machine, flower pots, etc.). Instead of putting them arbitrary, municipalities should them allow under the standards. The stations' floor covering defects, are a result of the insufficient maintenance and repair works of the municipality.

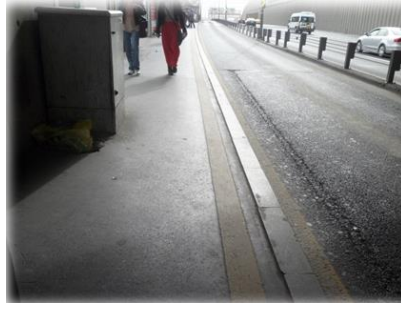
Figure 3.

Figure 3, 4. Too narrow platform (80 cm)Edirnekapi, Too narrow entrance for wheelchair users (67 cm) Bayrampaşa.

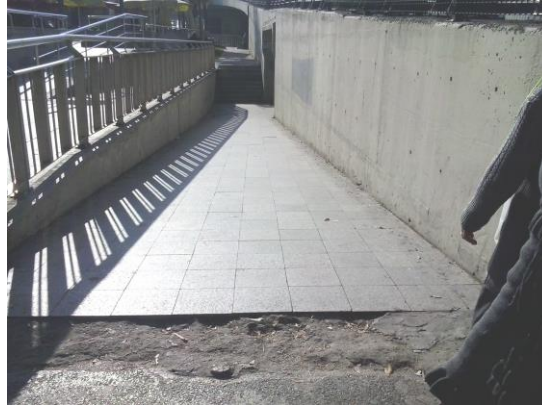
Figure 7. Ramp on the way to Söğütluçeşme Station (Photograph: Selhan Usal, 2013).
