CLIENT	BOSTON HOUSING AUTHORITY		STV	
PROJECT	NEIGHBOR RETAINING WALL	MADE	CHK.	REV.
SUBJECT	INITIAL NOTES	ARG		
		12/28/16		
				JOB NO.
				SHT NO.
				1/3

- ELEVATION
- PLAN
- SECTIONS

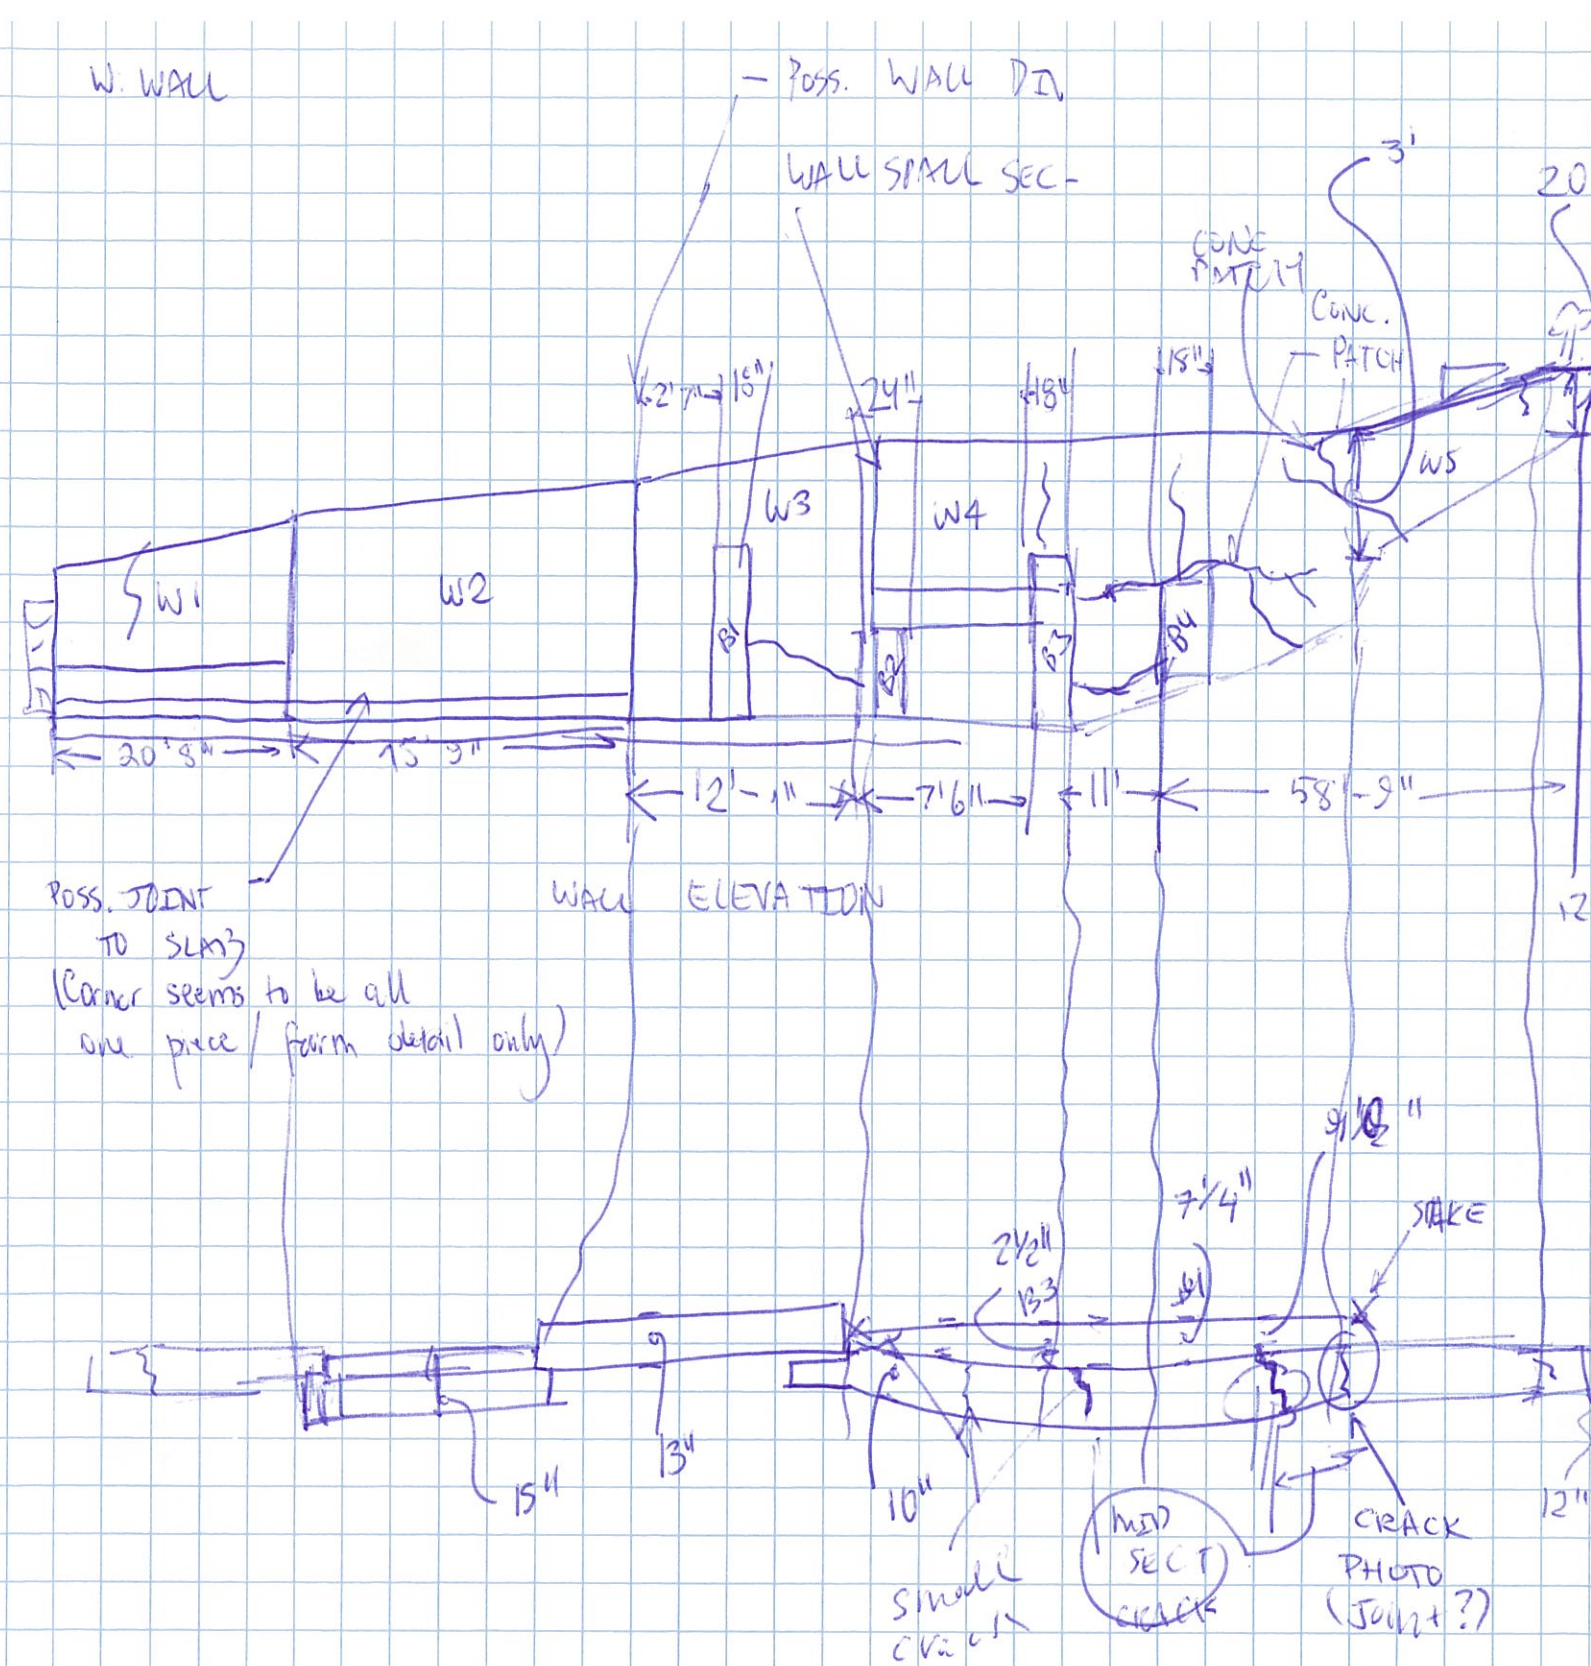
S-3 (BUILD OR RE-BUILT  
STONE WALL)

REVIN  
OBSERVATIONS IN THE PAST ~ 6 YRS  
HAS NOT NOTICED ANY MOV.

WALL SHOWS DIFF. SETTLEMENT  
AREAS ARE OUT OF PLUMB.

DRAWING ORIGINALS 1976  
PICTURE SHOWS ELEVATIONS
