Report sheet appusbcarr

-Appusbcarr 1Port:

- **Appusbcar 2 ports:**

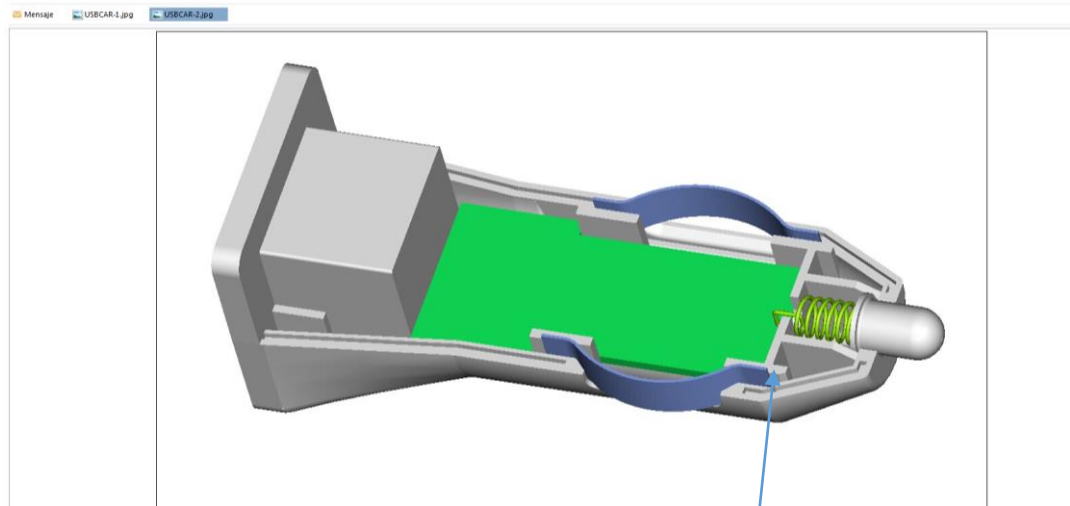
1. Problem. The metal lateral contact does not fix with the housing correctly.

Look:

Please solve this problem, it's dangerous if it make short circuit.

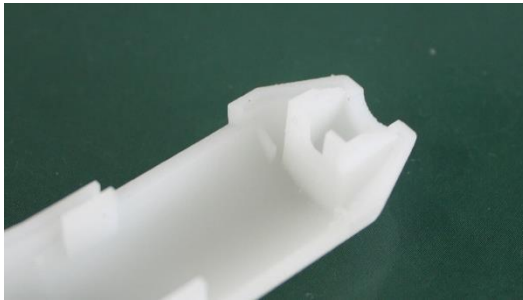
In the design:

The lateral metal contact fix in the housing for this system. In the mock up this system doesn't exist.

Look.

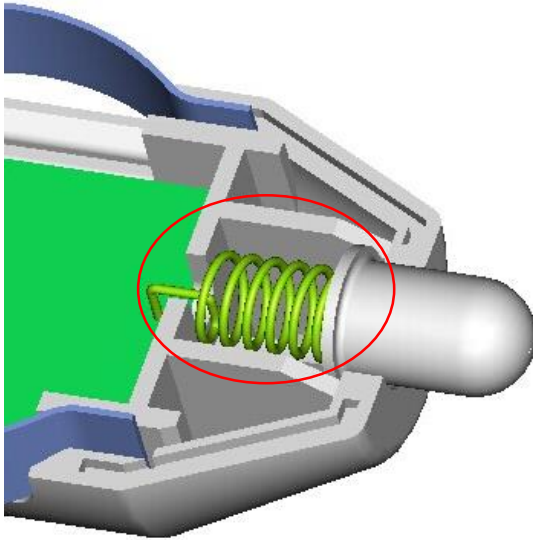
2. The spring should be into the box housign as picture...

Please, solve this problem.

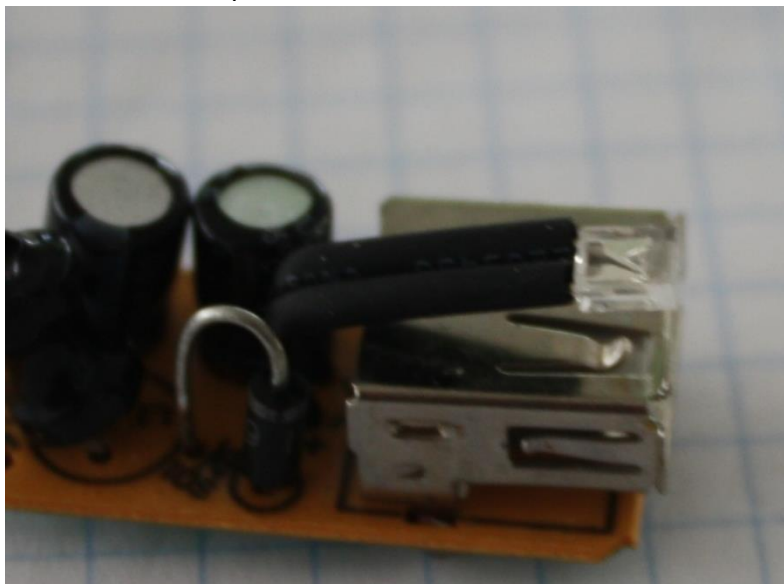
3. The led is circular, but it should be rectangular for it can introduce in the led hole.
OK?
As the led of this picture.

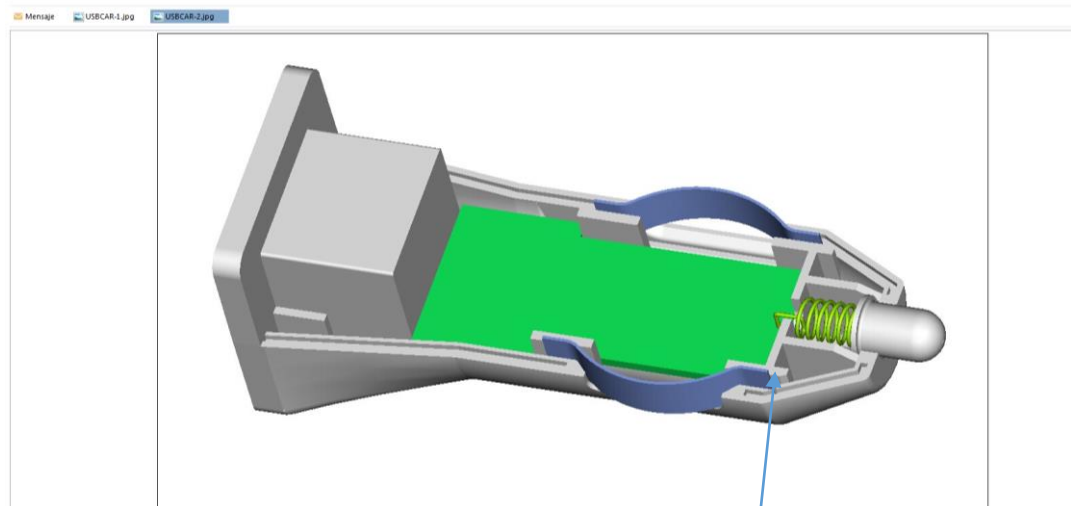
1. Problem. The metal lateral contact does not fix with the housing correctly.

Look:

Please solve this problem, it's dangerous if it make short circuit.

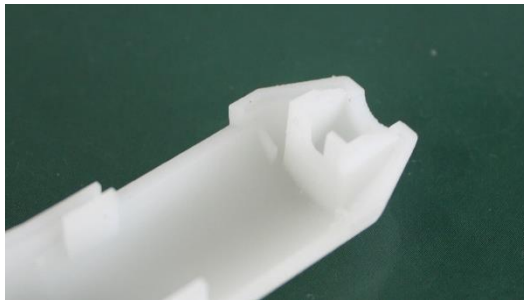
In the design:

The lateral metal contact fix in the housing for this system. In the mock up this system doesn't exist.

Look.

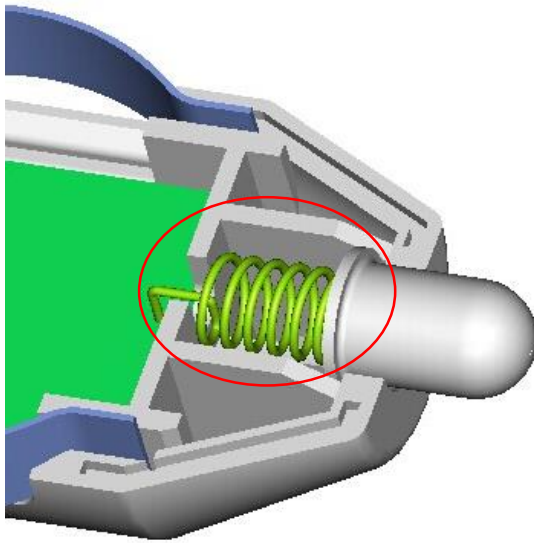
2. The spring should be into the box housign as picture...

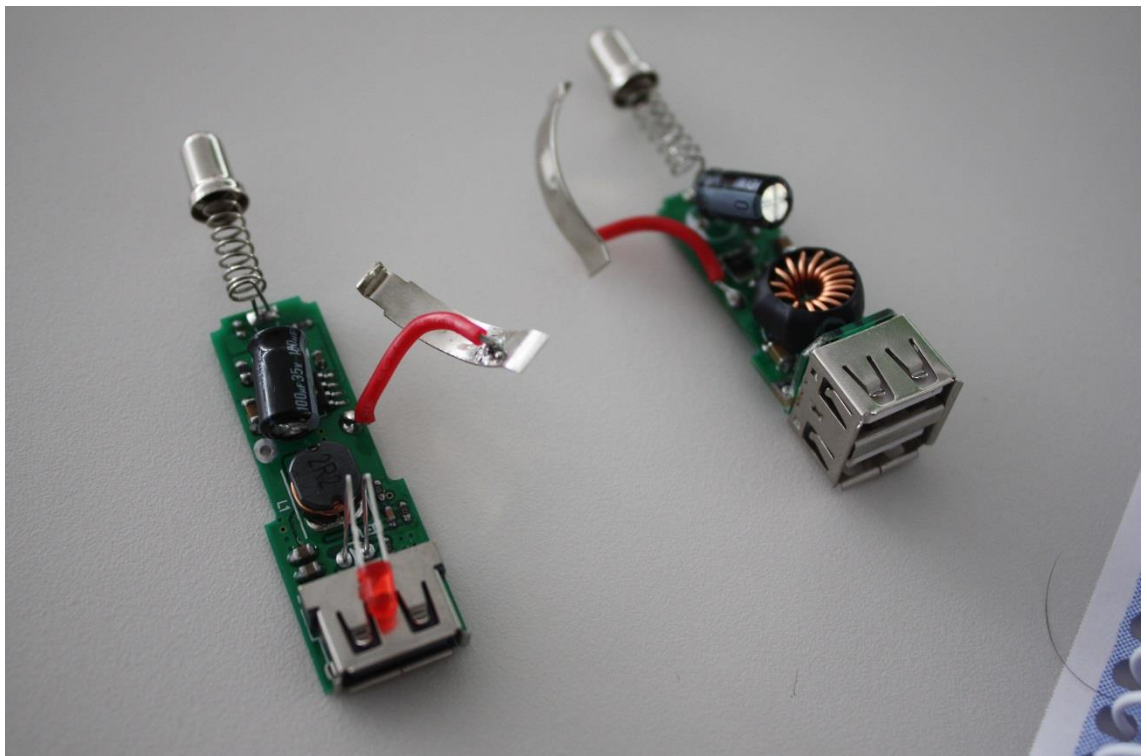
1. The red cable should be black in each cases
2. The Usbcar of two ports doesn't work, my partner applied 5 W of charge and the advice did not work.
Please solve these problem...
