External and Internal Loopback test of the GBT bank Quartus Example

Testing and verification of the HDMI daughter card

Testing and verification of the Serial interface

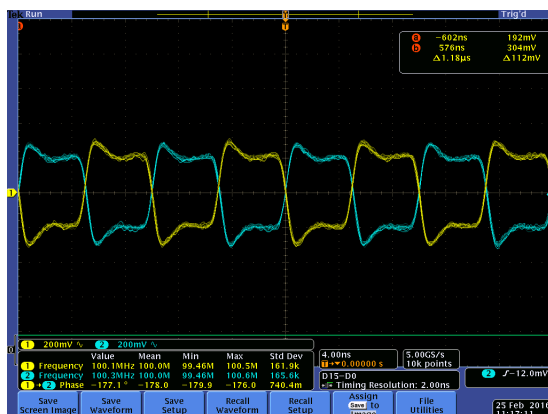
Figure 1.2: *Si570* Before configuration: 100 MHz.

To confirm correct operation, a quick measurement of the output clock was done using an oscilloscope. Figures 1.2 and 1.3 shows the output frequency, before and after configuration.
