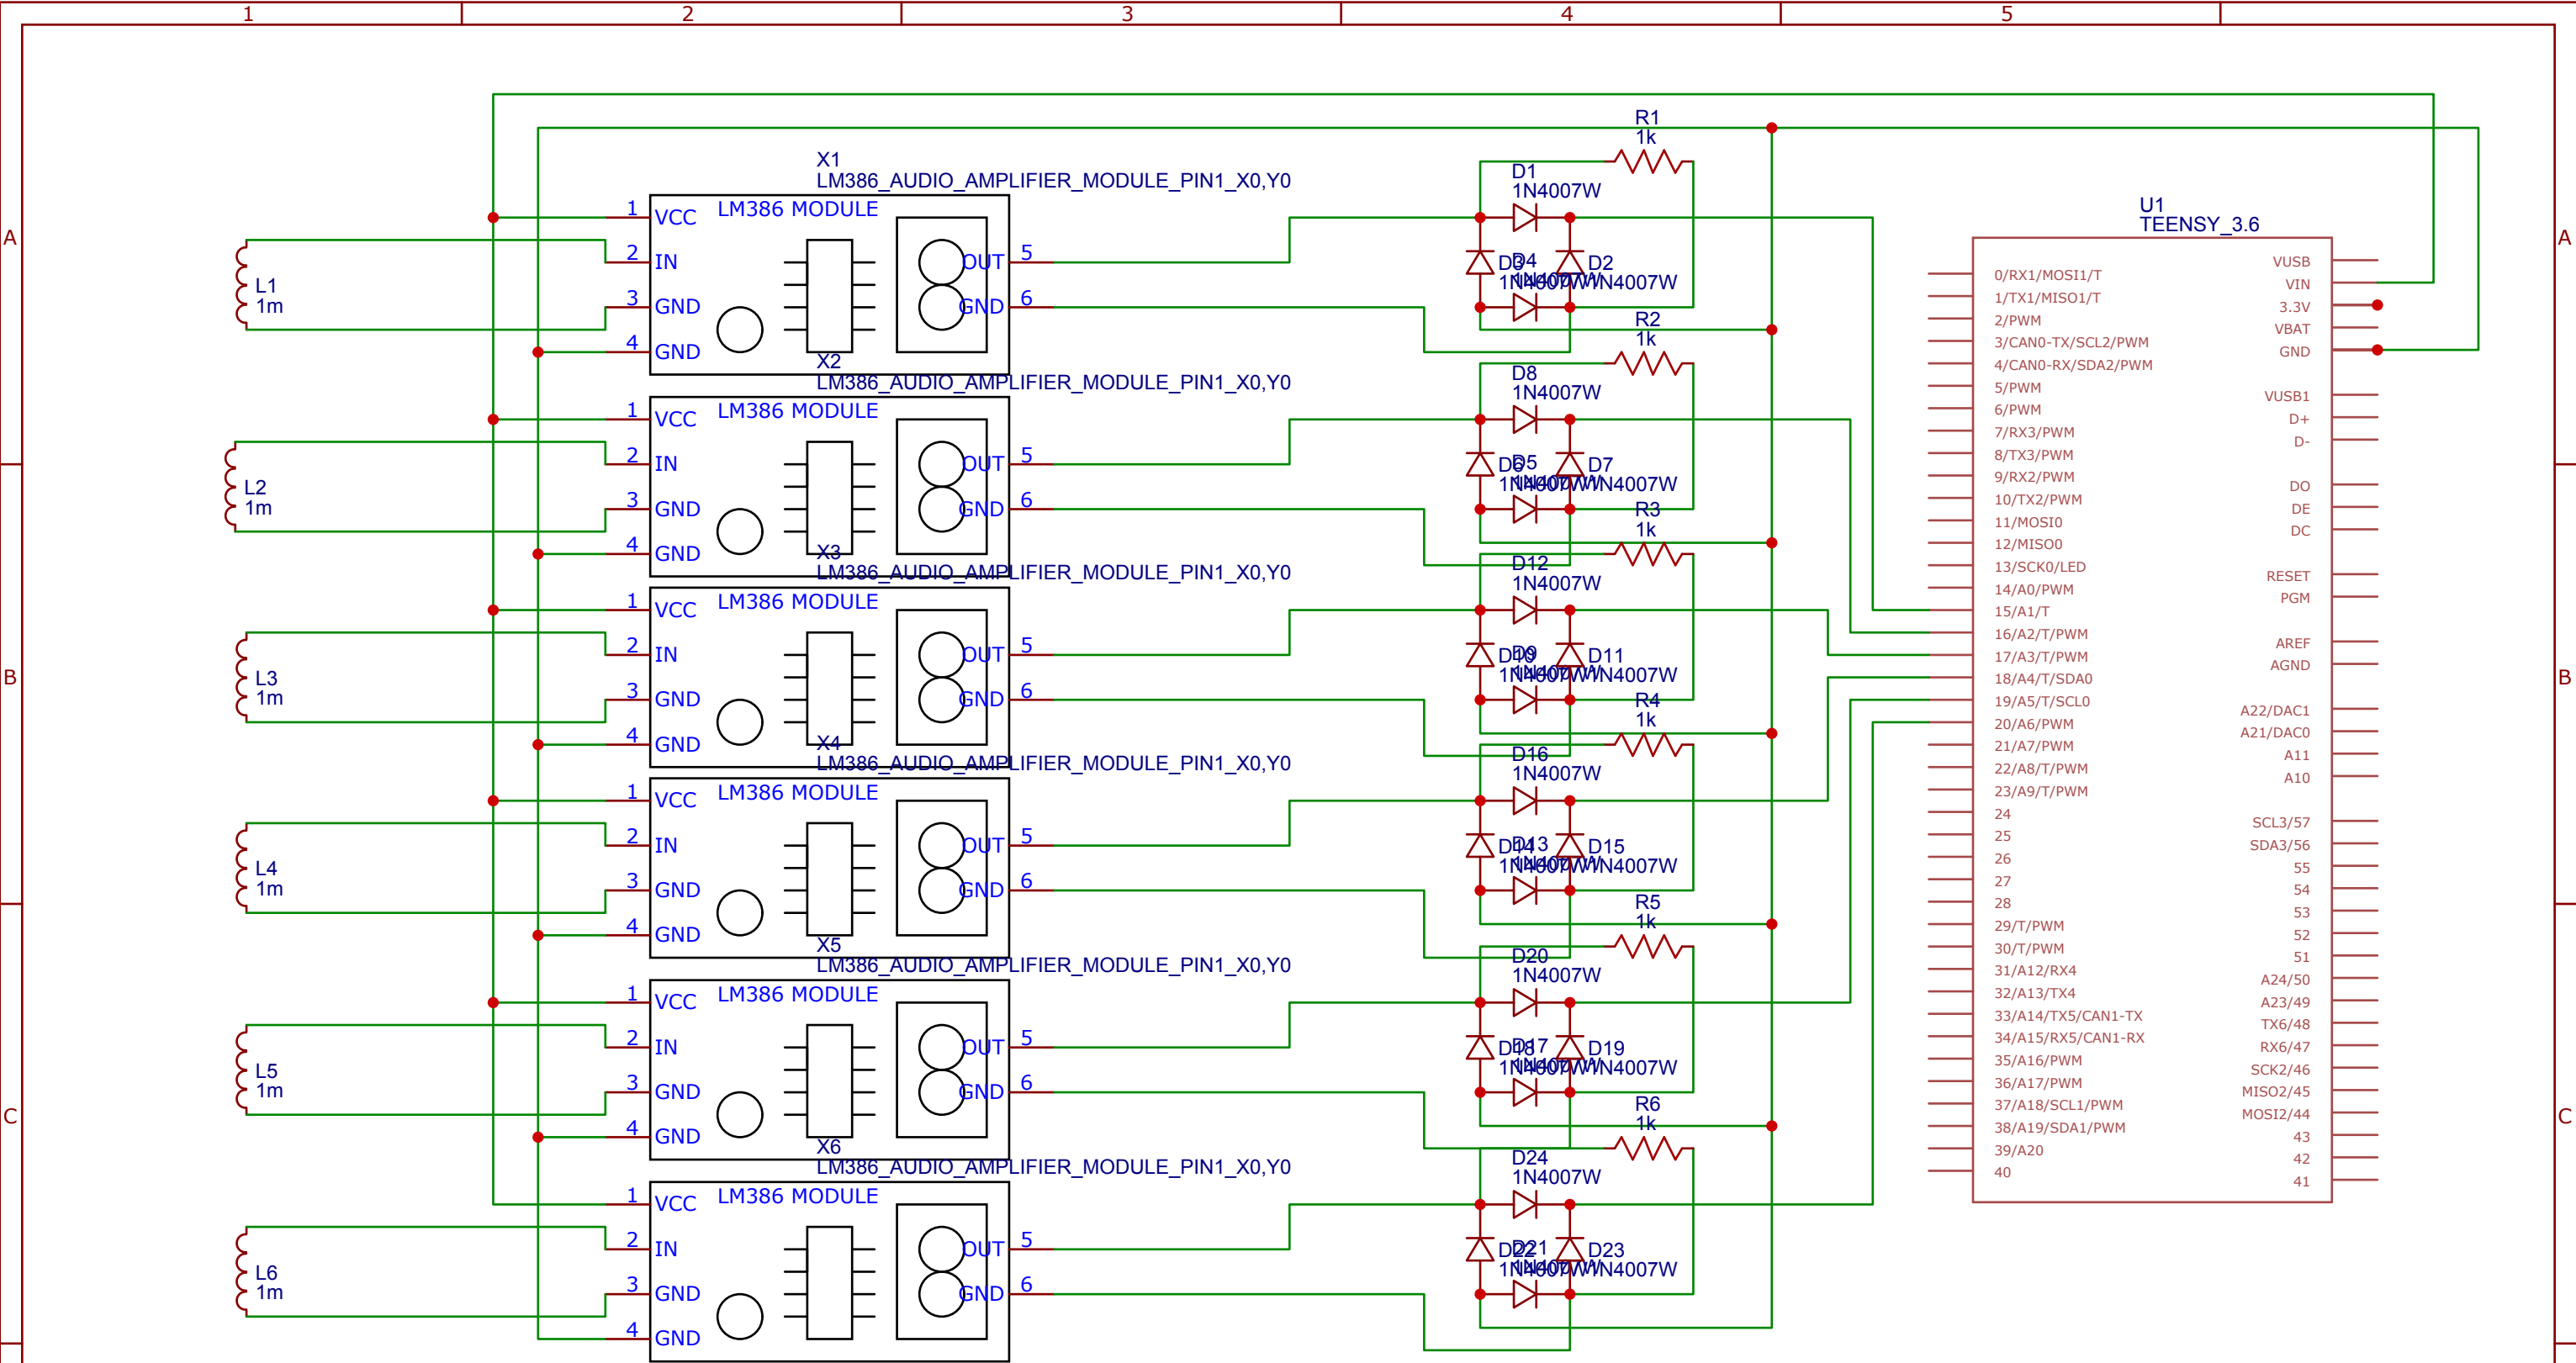
NOTE: Value of R1-R6 should be reviewed.

NOTE: A capacitor between the other two ends of the bridge rectifier (the ones not connected with R1) might further clean the signal
