# Case Study – Mechanical Design

## Automotive – Differential Noise

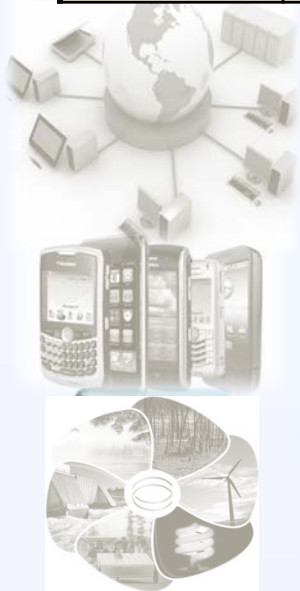
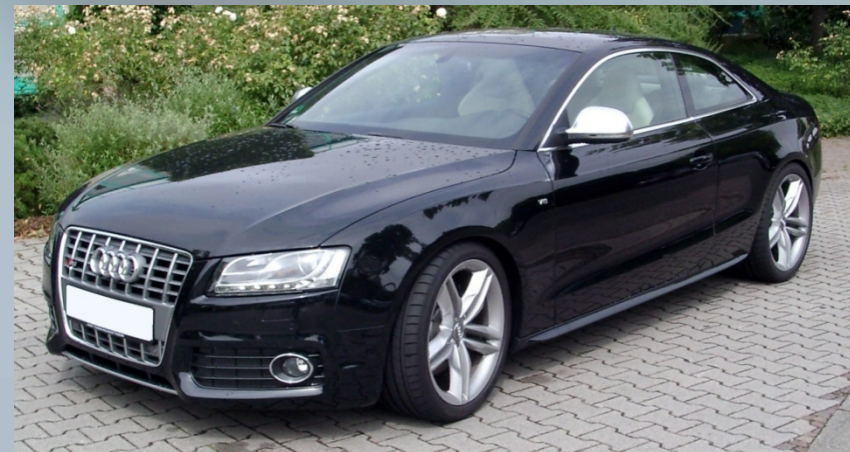
<b>Vehicle</b>	Audi S-5
<b>Project</b>	<p>The noise phenomenon in the F-B differential was identified from the trials and measurements. It was concluded that the reason for the noise observed is friction characteristics of rubbing surfaces. Preliminary trials proved this to be right direction. To optimize the solution, simulation model was developed and based on the solution of the model, design changes were suggested.</p>
