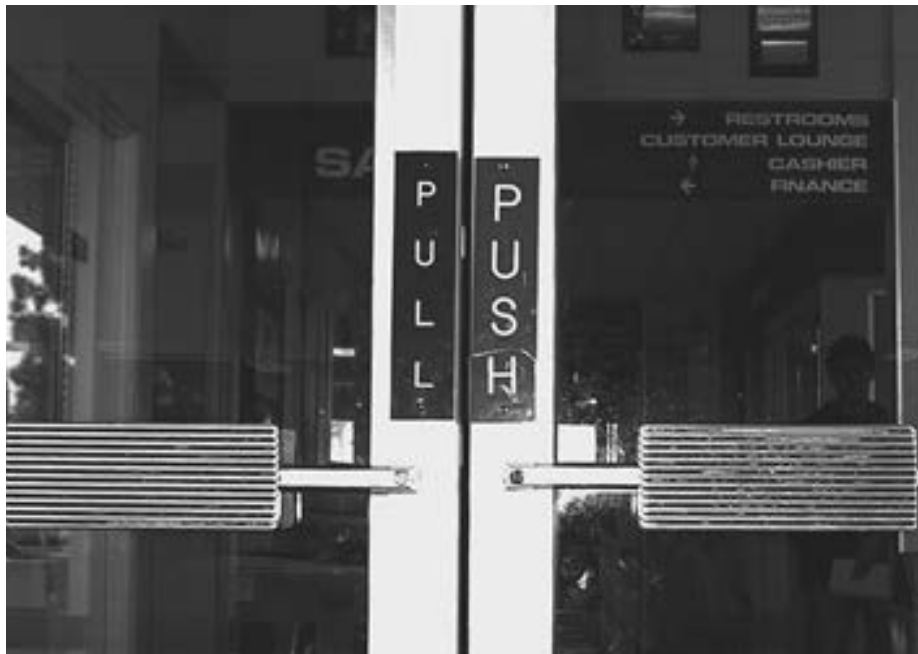
A.

FIGURE 1.2. Problem Doors: Signifiers Are Needed. Door hardware can signal whether to push or pull without signs, but the hardware of the two doors in the upper photo, A, are identical even though one should be pushed, the other pulled. The flat, ribbed horizontal bar has the obvious perceived affordance of pushing, but as the signs indicate, the door on the left is to be pulled, the one on the right is to be pushed. In the bottom pair of photos, B and C, there are no visible signifiers or affordances. How does one know which side to push? Trial and error. When external signifiers—signs—have to be added to something as simple as a door, it indicates bad design. (Photographs by the author.)
