## Lab Report: 4th Nov. 2015

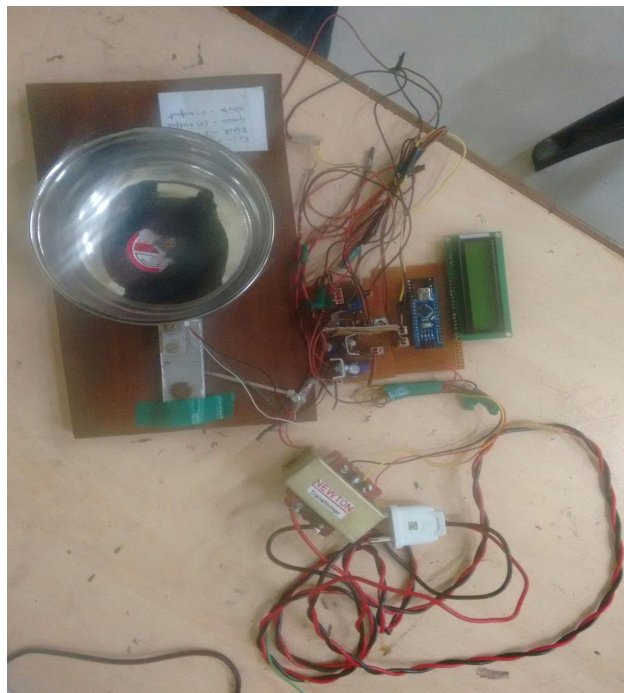
The project is almost complete with only thing that is left now is to improve the data stability on the LCD and to improve the resolution of the whole device. Both of these tasks are very much achievable and can be posted as an aim of an experiment to students.

Here is a picture showing the complete setup:

1. Various difficulties in the final circuits on PCB
  - a. Capacitor dysfunctional: Replaced by new one.
  - b. IC 7912 for negative voltage stopped functioning : Replaced by a new one.
  - c. Due to excessive heating at times, there were problems : Heat sinks are now in place.
  - d. LCD stopped working when soldered on PCB : Debugging complete
  - e. Microcontroller code having various issues : Debugging still left.
  - f. Offset voltage : Adjusted by adjusting gain properly and taking care of the power supply.

1. Low pass filtering using RC on the output of the sensor
2. Decoupling the sensor by using a capacitor across its power supply
3. In the microcontroller code, implementing a mode filtering function to improve the stability of the readings and accuracy
4. Using 1.1V reference voltage so as to measure weights of lesser resolutions as well.
5. Implementing higher order butterworth (or other) filters to improve the stability of the data.
