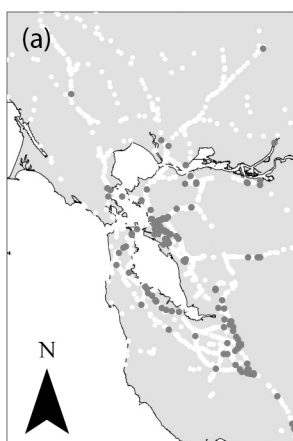
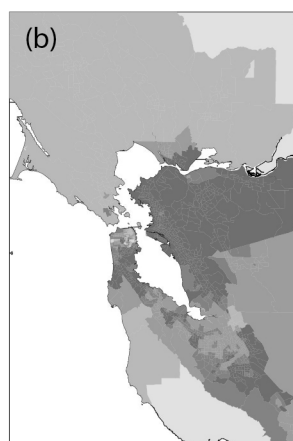
M6.85 Hayward

Component damage

Accessibility loss

Component State

- Damaged
- Functional

Expected accessibility decrease (utils)

- 0
- 0 - 0.1
- 0.1 - 0.2
- 0.2 - 0.3
- > 0.3

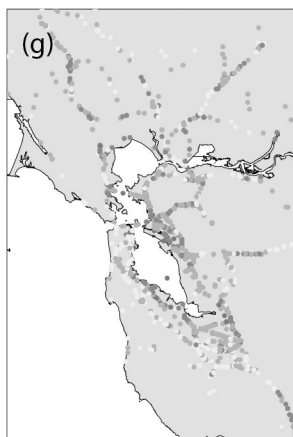
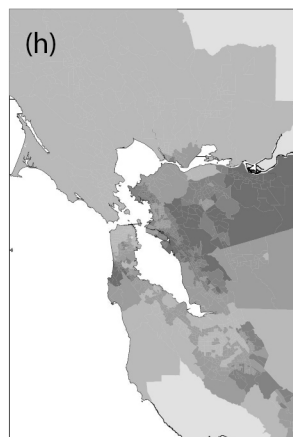
Expected value
(over all earthquakes)

Rate of damage

- Low
- Moderate
- High
- Very high
