MEMORANDUM

Permit: PS-7894

RE: Candorado Mines LTD. Proactive Review

Review of Historical Reports and Data from Candorado Mines Ltd. by Leilane Ronqui,
Auxiliary Environmental Impact Assessment Technician - Biologist, Mining Operations

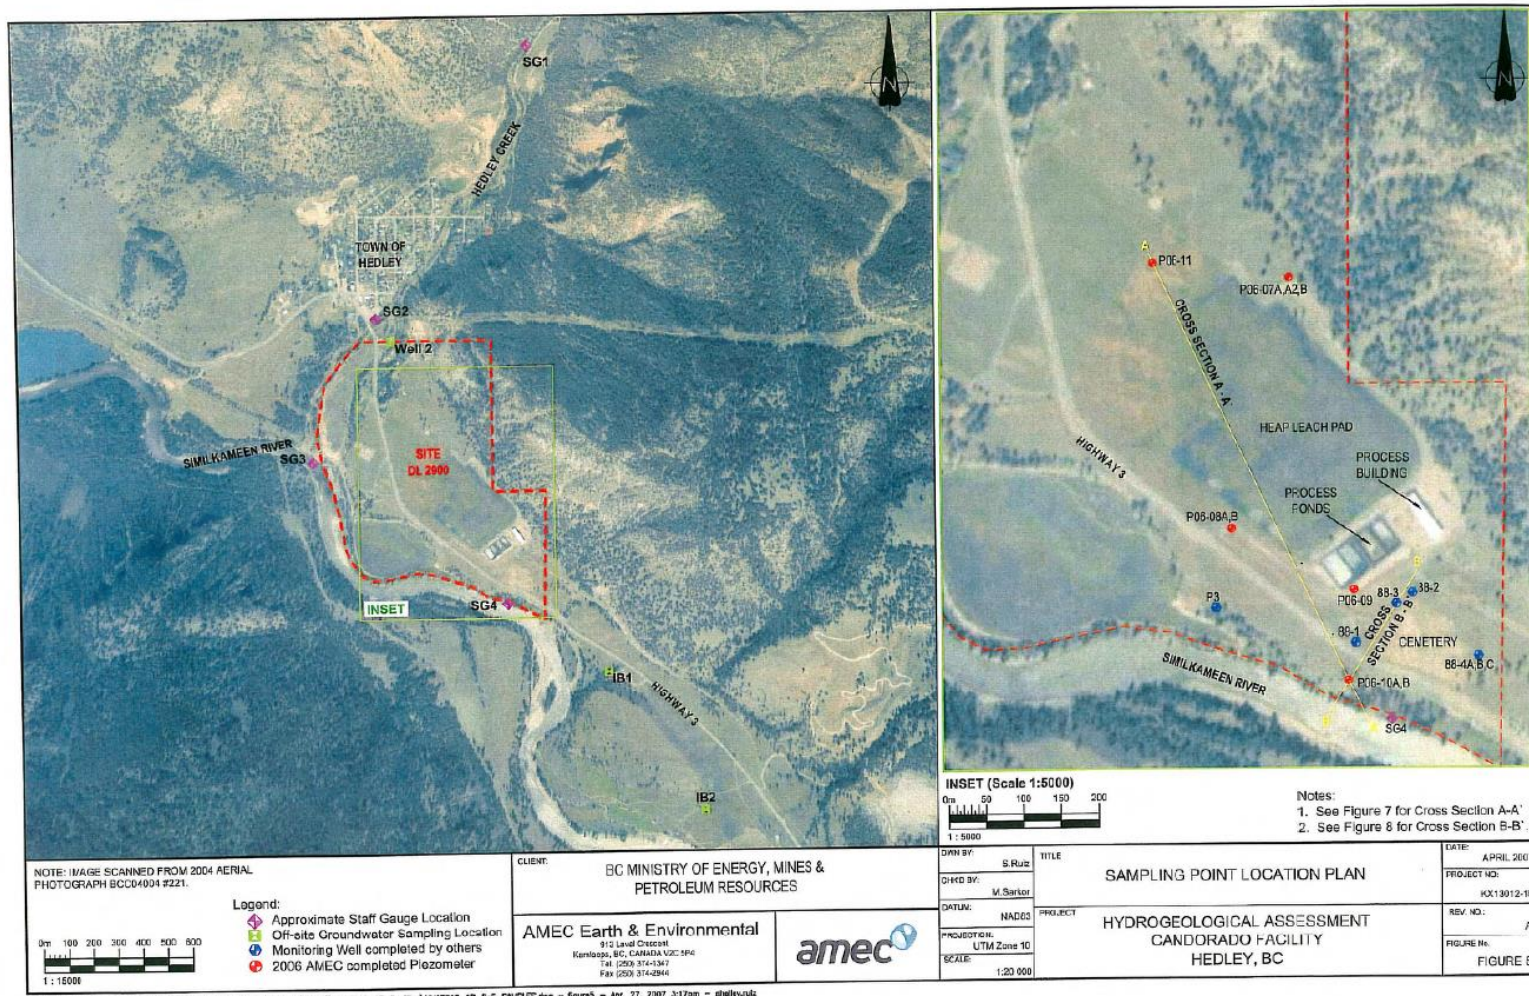
APPENDIX B: Sampling Point Location Plan (Surface water sites: SG1, SG2, SG3, and SG4). (Figure 5 from AMEC, 2007).

1. That a detailed surface water quality and sediment baseline assessment be performed with consideration to the findings of the hydrogeological assessment made by Alloisio (2018).
2. Conduct a one-year monitoring program in Hedley Creek and Similkameen River near Candorado Mine footprint, and if possible, to include the same sampling area of the surface water and groundwater monitoring survey conducted in the 2006-2007 program completed by AMEC (AMEC, 2007). The sampling stations sampled during the 2006-2007 program can be found in Appendix B.
