Mitigation of Soil-Side Corrosion on Storage Tank Bottoms in the Absence or Deficient of CP System

Dr. A. Meroufel
Desalination Technologies Research
Institute (DTRI)
P.O. Box 8328 Jubail 31951
Kingdom of Saudi Arabia

This paper demonstrates the concept of using an amine carboxylate based VCI slurry, coupled with ER corrosion probes, as an online soil-side corrosion control method for in-service water storage tanks.

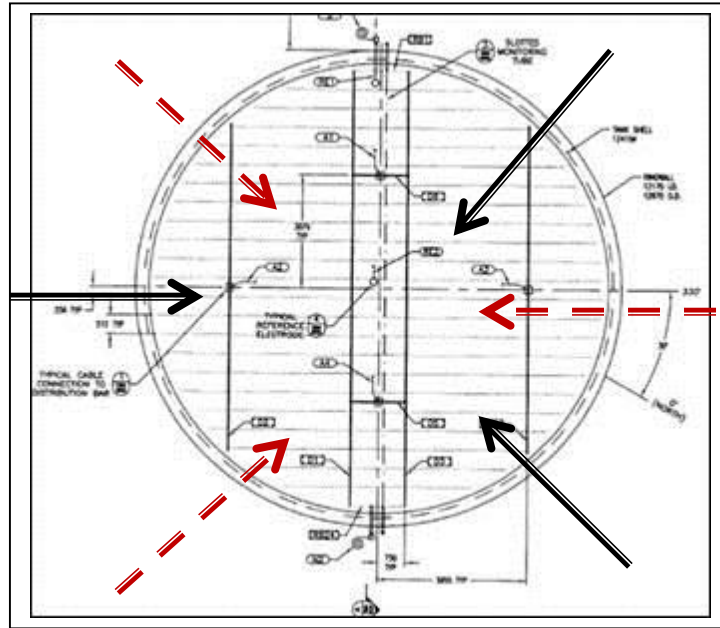
1. Three VCI injection tubes (continuous arrows in Figure 1) were installed by core drilling into the concrete ring wall.
2. A corrosion rate monitoring system using cylindrical ER probes (discontinuous arrows in Figure 1) was installed to monitor the corrosiveness of the under tank environment.
3. A seal system was installed to close any gaps between the annular plate and concrete ring wall.

Figure 1: Top View of the AST with locations of ER probes and injection points.

The online injection system proposed for this tank as shown in figures 1 and 2. The general description of the system is as follows:

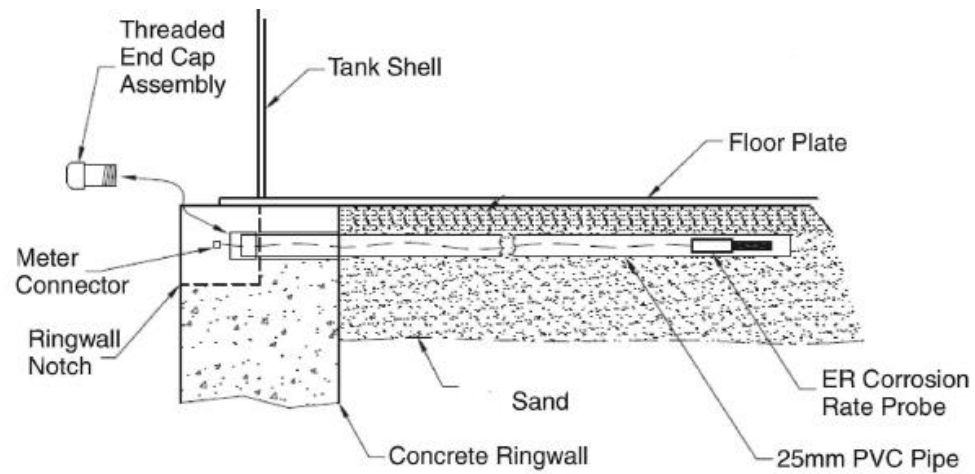
Figure 2. Details of the ER probe installation.

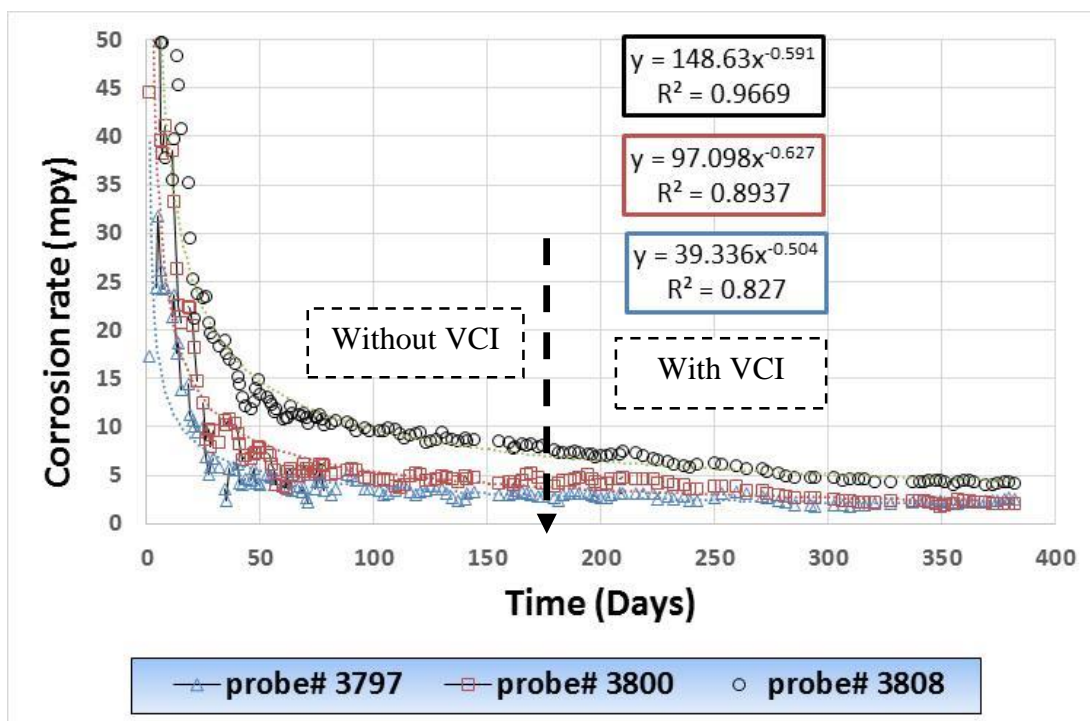
Corrosion monitoring was carried out using ER technique in the absence and presence of slurry carrying an amine carboxylate VCI. Figure 3 shows the three-day moving average corrosion rate data for the three probes during the whole project duration of 380 days.

Figure 3. Undertank Corrosion rate trend for the ER probes.

The decaying trend of the corrosion rate for all probes confirms the functionality of the ER probes. The noisy pattern of the readings is well known for the ER technique and can be explained by different interactions occurring in the probe surroundings such as vibration, temperature fluctuation, interference with electrical field.¹⁴ The corrosion rate data was treated using a three-day moving average as shown in Figure 3. Data after injection of VCI shows a fast decrease in the corrosion rate and convergence to a single corrosion rate, especially at probes 3797 and 3800. The slight differences in the corrosion rates could be due to the variation of soil conditions where heterogeneous chemistry is well known. On the other hand, it is well known that steady state establishment in field conditions is measured in years.

A closer look at after-injection data, shows a significant decrease in the general corrosion rate around 15 to 25 days post injection. Such behavior should be expected due to the nature of the environment (soil) where VCI takes time (transition period) to diffuse through the sand, and reach and adsorb onto the surface of the corroded ER probes. Thus, VCI action in soil conditions is not instantaneous as in liquid or gaseous environments. After 90 days post injection, the corrosion rate decreased below 5 mpy, which is equivalent to 0.13 mm/yr. It is interesting to note that probe 3808 showed different behavior with a higher corrosion rate and pseudo-steady state behavior even at 250 days of exposure. This could be explained by high corrosive soil conditions in the surrounding area compared to conditions for probes 3797 and 3800. In this case, if the expected life of the tank is 25 years, the total corrosion allowance per year will be equal to 3.25 mm. Then, this corrosion allowance is doubled to 6.5 mm as a safety consideration. As mentioned previously, the corrosion allowance is not defined in API 650 since it is dependent on the under tank environment conditions defined by the end user. However, the minimum nominal thickness of bottom plates is requested to be 6 mm. Most of the SWCC tank bottom plate thicknesses ranged between 7 mm and 12 mm depending on the stored liquid and location. Therefore, the action of VCI with regard to the general corrosion protection means the life extension could be doubled.

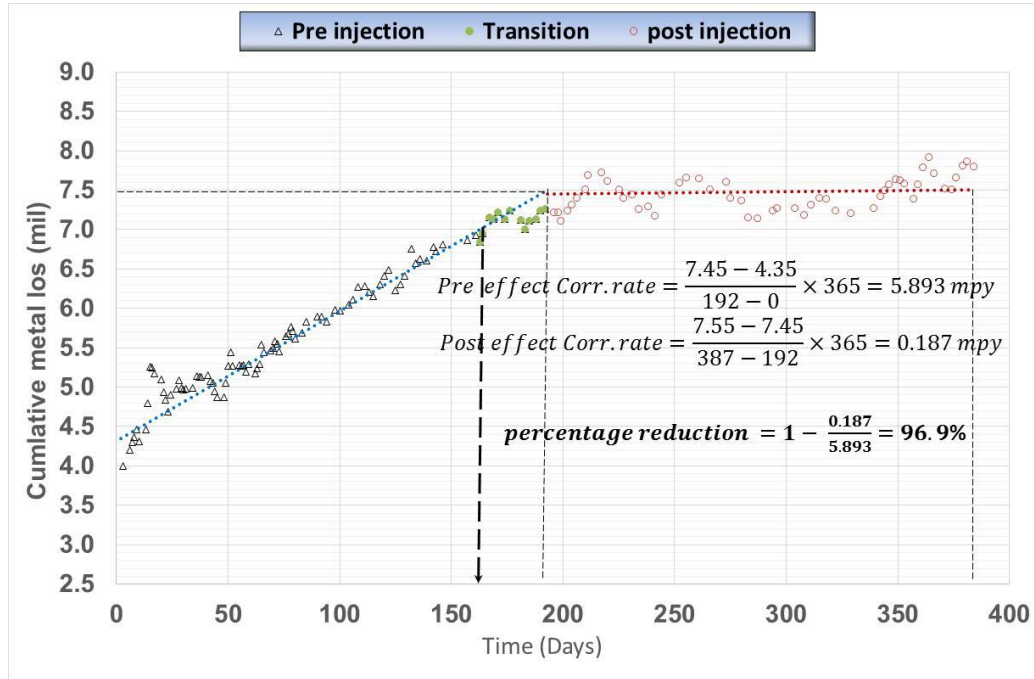
Figure 4 is typical corrosion rate graph derived from ER 3808 probe measurements where the metal loss is expressed in mils (1 mils = 0.0254 mm) versus time. The corrosion rate between any two measurement times is the difference in metal-loss measurements divided by the time difference and annualized, i.e., the slope of the metal-loss curve between the selected times.

Figure 4: Metal loss monitoring graph for ER 3808 probe.

Corrosion rate changes are detected by changes in the slope of the graph of metal loss against time. For a series of measurements, the average corrosion rate is calculated using regression analysis from the slope of the trend line as calculated by the least squares method. Most graphing programs, such as Microsoft Excel have built-in capability to calculate slopes. It appears clearly from the calculated slope in Figure 4, as a sharp decrease by two orders of magnitude. The average corrosion rate (C) can also be calculated using Equation (2).

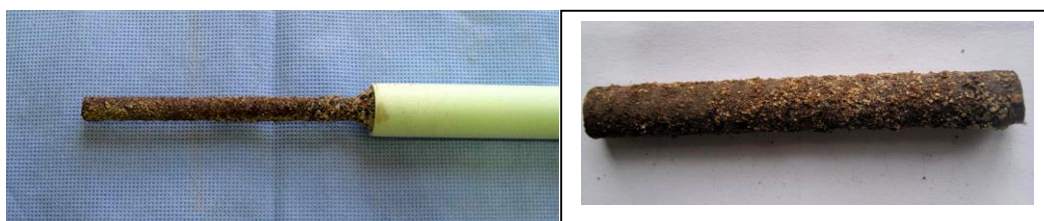
The visual inspection of the retrieved probe (Figure 5,) indicates a brownish color typical of iron oxide and/or hydroxide. This is a symptom of a significant level of oxygen otherwise, a grey or black corrosion layer would be observed meaning the formation of magnetite in low levels of oxygen. Sand soil particles were also present on the surface of the corrosion layer.

Figure 5: ER probe 3800 retrieved after 8 months of exposure to VCI inhibitor.

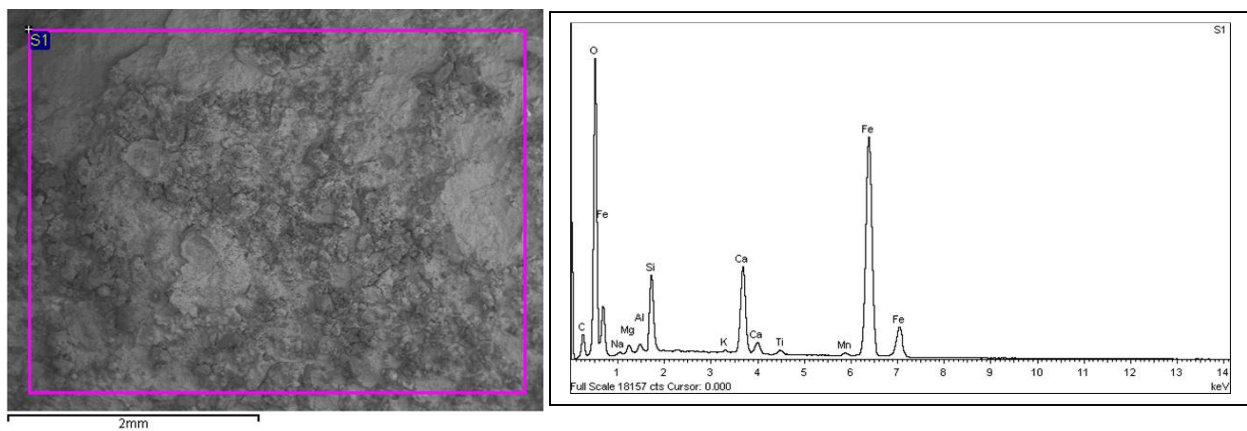
The analysis of the probe periphery showed the presence of iron oxide (and/or hydroxide) and most probably, calcium carbonates (Figure 6). However, the tip portion indicated the presence of calcium sulfate particles in addition to the iron oxide and/or hydroxide (Figure 7). Both calcium based compounds are part of the surrounding soil.

Figure 6: SEM and corresponding EDX analysis for ER 3800 surface layer periphery.

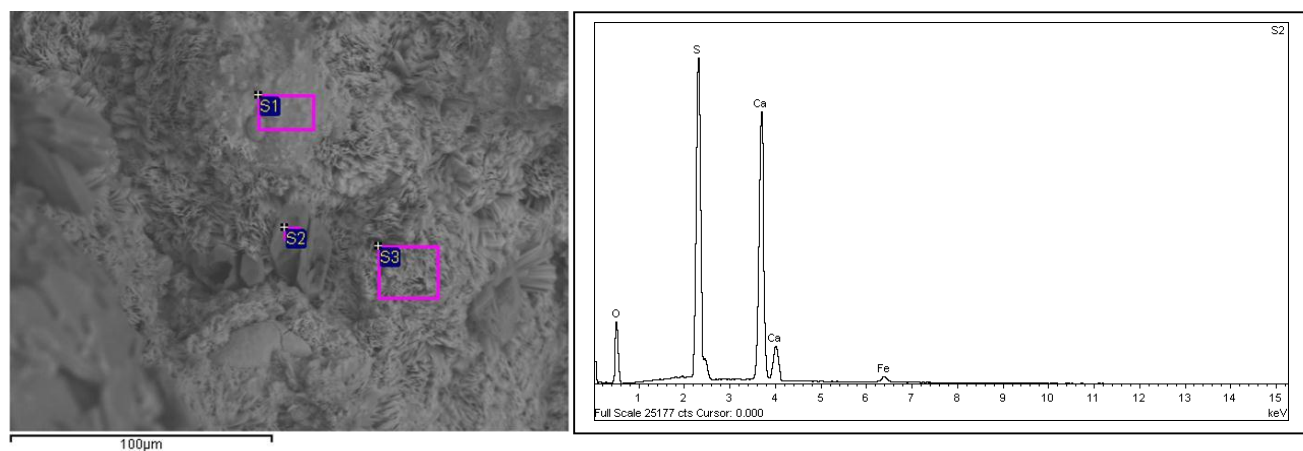
Figure 7: SEM and corresponding EDX analysis for ER 3800 tip surface layer.

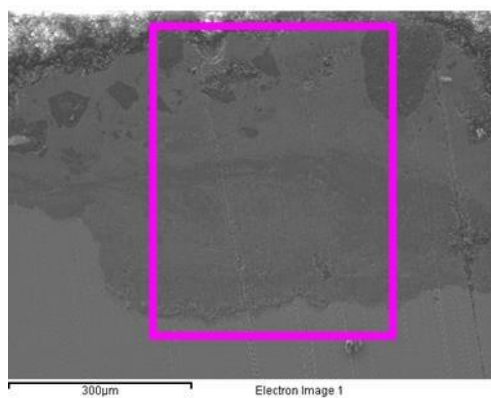
The cross section of the exposed ER 3800 probe element showed the thickness of the corrosion layer was $300 \pm 50 \mu\text{m}$ without any sign of porosity or cracking (Figure 8). Incorporation of silica particles originated from surrounding soil into the top layer of corrosion product is clearly observed. EDX mapping of the selected area shown in Figure 8 indicated the significant presence of chlorides at the interface corrosion layer/base metal (Figure 9). This finding has been confirmed in more than one location, and its origin needs more investigation.

Figure 8: SEM for ER 3800 cross section.

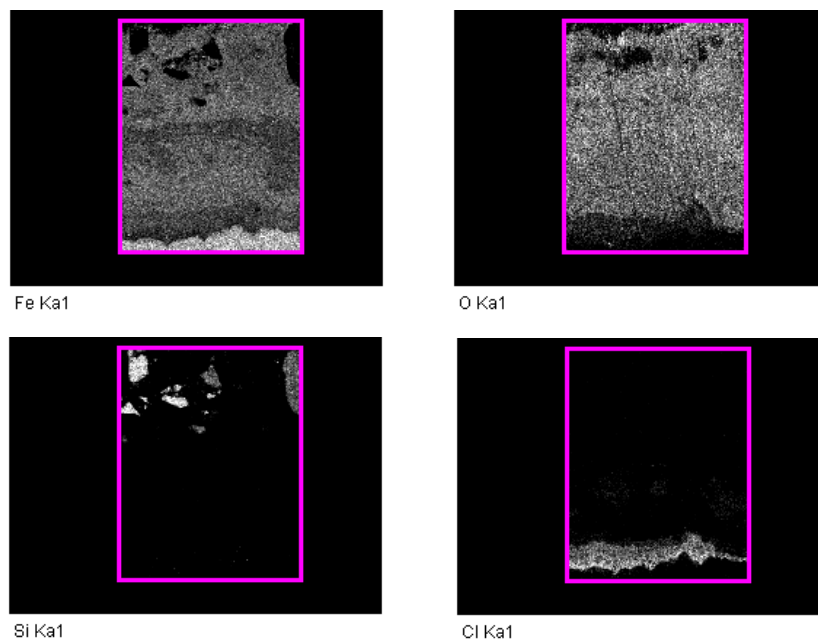
Figure 9: EDX map of ER 3800 cross section.

Figure 10 shows the XRD pattern of corrosion product collected from the surface of the ER3800 exposed probe element. The obtained XRD pattern shows typical steel corrosion product in neutral soil conditions including β -FeOOH (akaganeite), α -FeOOH (goethite) with the presence of some low intensity peaks of Fe_3O_4 (magnetite). The presence of akaganeite is related to the carbonates and chlorides content in the soil.¹⁷ Thus, the chlorides presence at the bottom of the corrosion layer in Figure 9 could be related to this variety of hydroxychloride iron product.

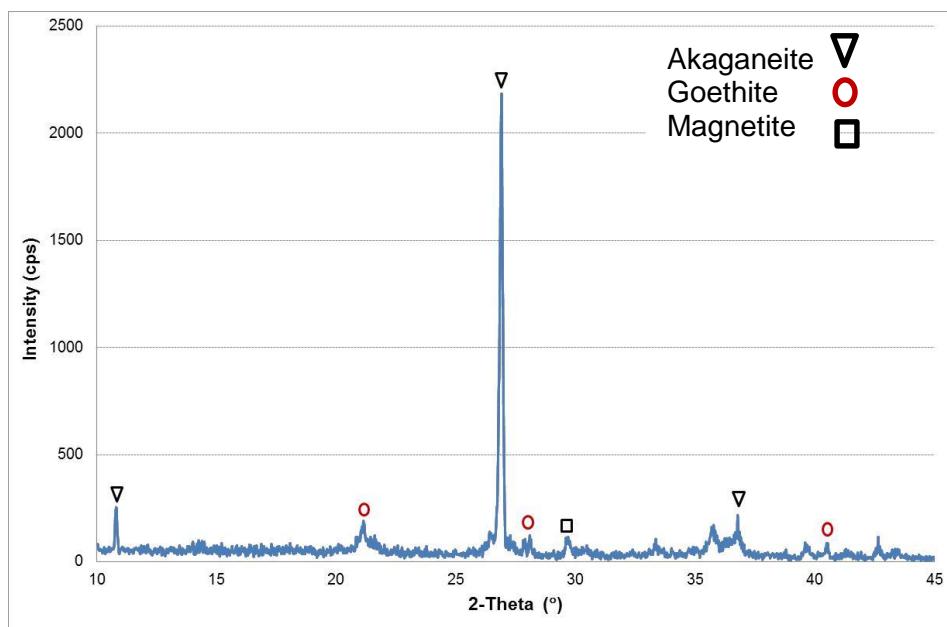
Figure 10. XRD spectra obtained for corrosion product on exposed element of ER3800 probe.
