Company: Eyhurst Court Ltd - GUS OLB  
Location: Maintenance  
Risk Assessment: Use of bench grinder  
Reference No. Maintenance  
Date of 29/10/2014  
Assessment:  
Completed By: Tim Whalley

## Use of bench grinder

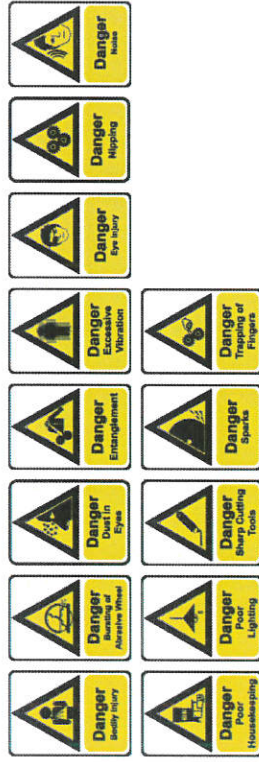
Bench grinder has its integral eye protection shield removed. A replacement part is not available for this tool.

Instead of the fixed shield, Eye protection must be worn in addition to other control measures.
